**DRAFT**  
**The Preserve at San Juan**  
**Tree Management and Preservation Plan**

**AUGUST 2013**

# The Preserve at San Juan Tree Management and Preservation Plan

**DRAFT**  
**The Preserve at San Juan**  
**Tree Management and Preservation Plan**  
**For Access Roadway Improvements**

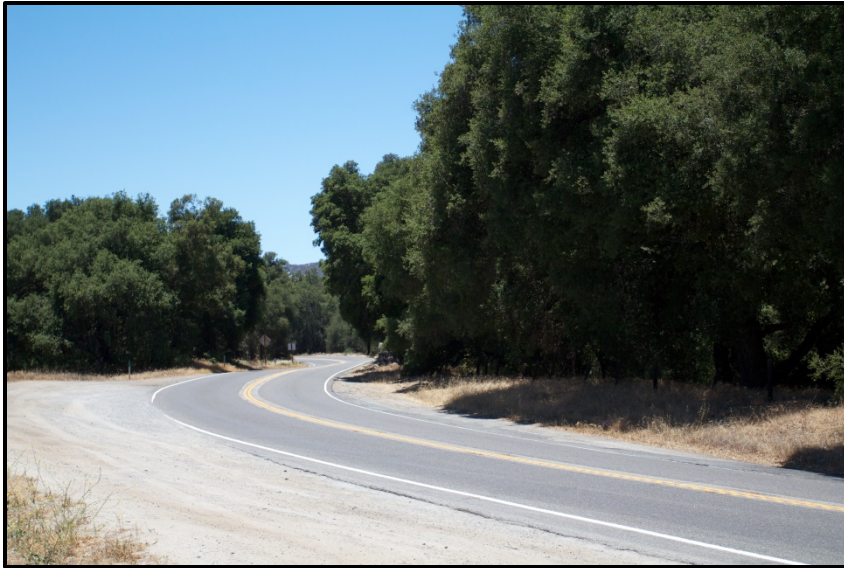
1. View looking south along Ortega Highway (Hwy #74) at the intersection of Long Canyon Road and Hwy 74. Notice that trees are set back from edge of existing road and will not be impacted during road improvements for the project.

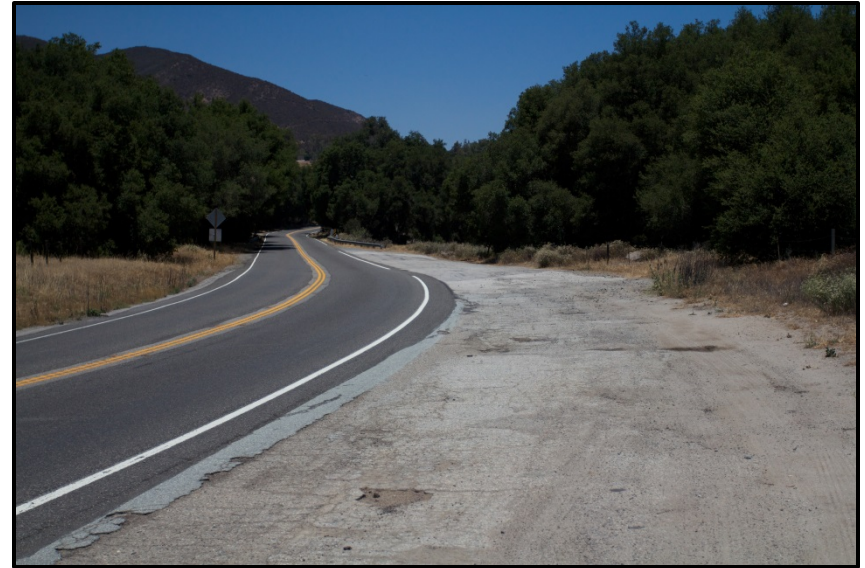
2. View looking north (opposite direction from photograph #1) along Ortega Highway (Hwy #74) at the intersection of Long Canyon Road and Hwy 74. The village of El Cariso is approximately  $\frac{1}{2}$  mile down the road from this location. Trees will not be impacted during road improvements for the project.

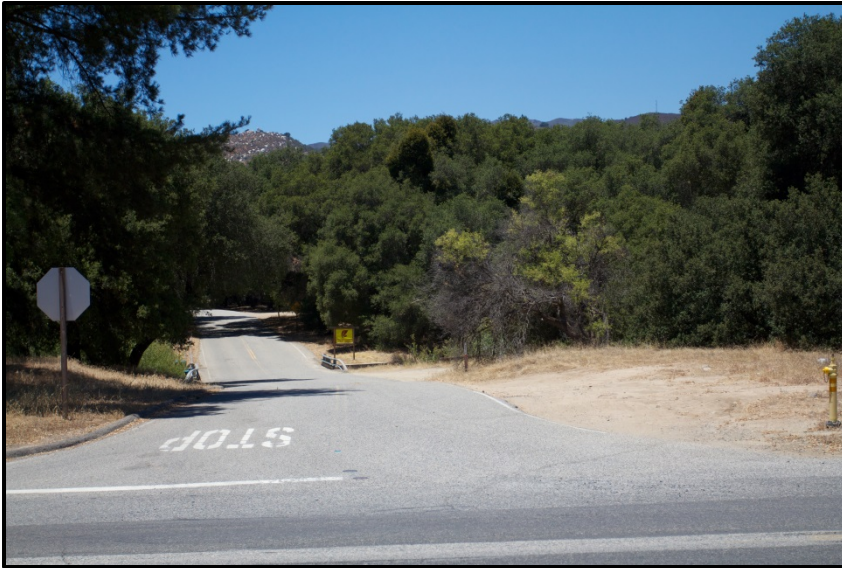
3. Photograph displays Long Canyon Road or Forest Service Route 6S05, which is currently the primary access road to the Preserve project site. Oak trees occur along both sides of the roadway. Photograph was taken looking west along the road.

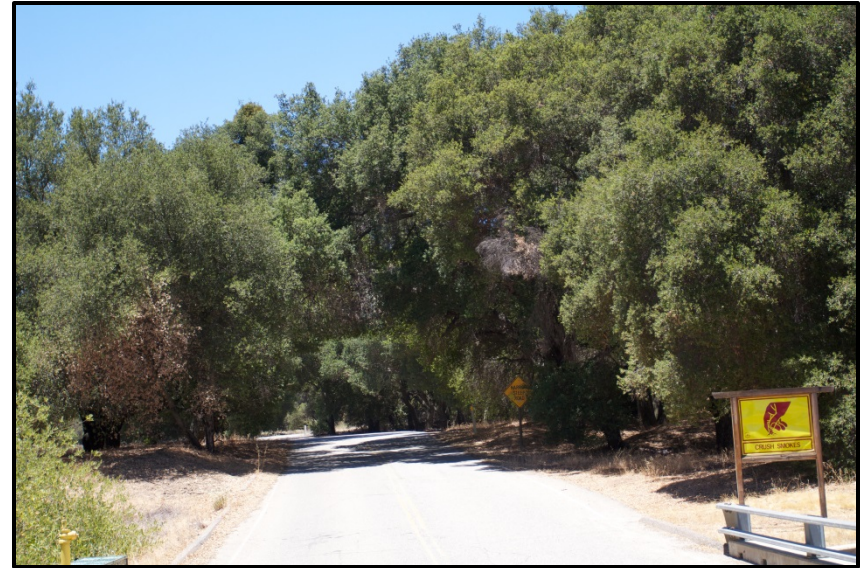
4. Photograph is a closer view of the tree canopies overhanging Long Canyon Road. Road improvements will encroach into some of the Oak tree root zones and their impacts are addressed in the report.

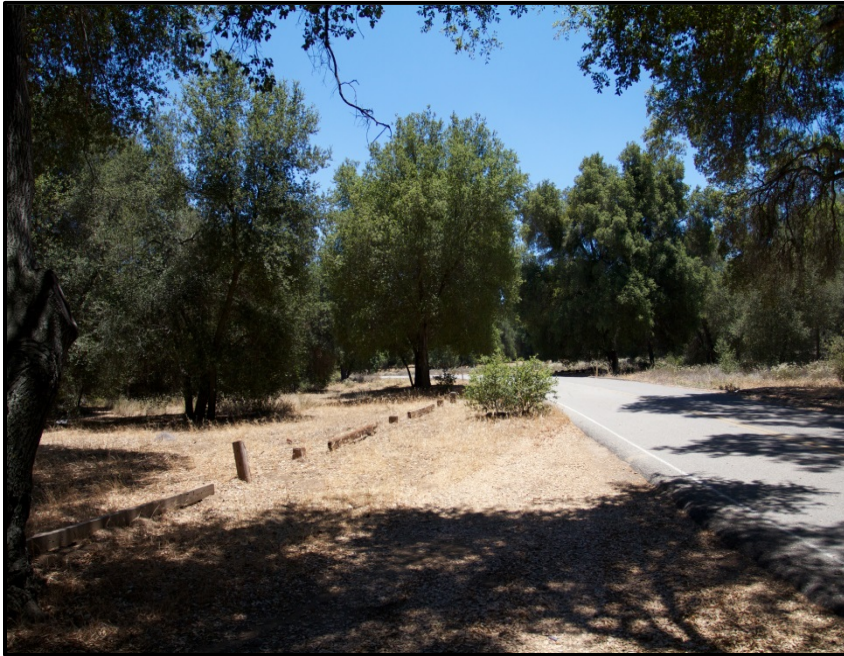
5. Photograph shows the typical grass understory found on the project study area. Fuel modification will be minimal with an occasional pruning of lower limbs to reduce ladder fuels along Long Canyon Road.

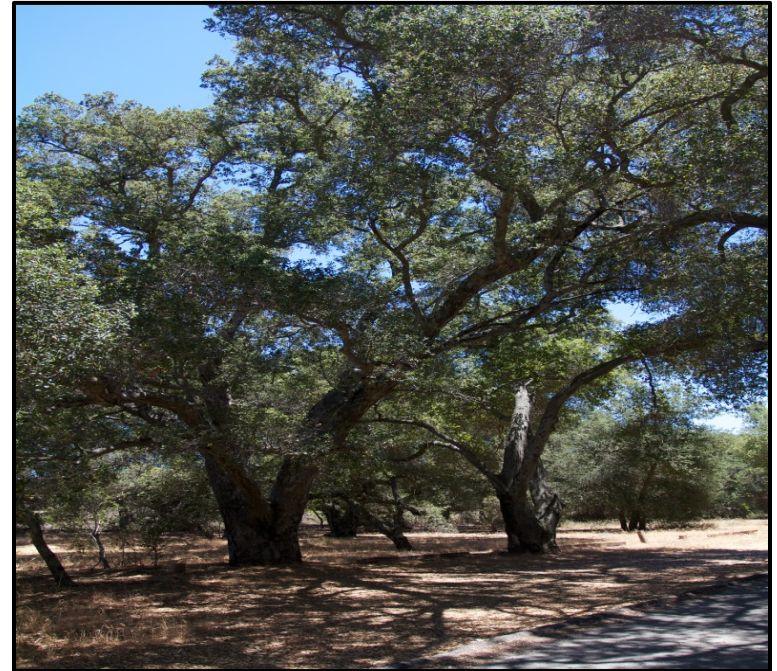
6. As displayed in the photograph, the majority of the larger diameter trees will not require pruning of branches overhanging roadway, since they already have adequate vertical clearance.

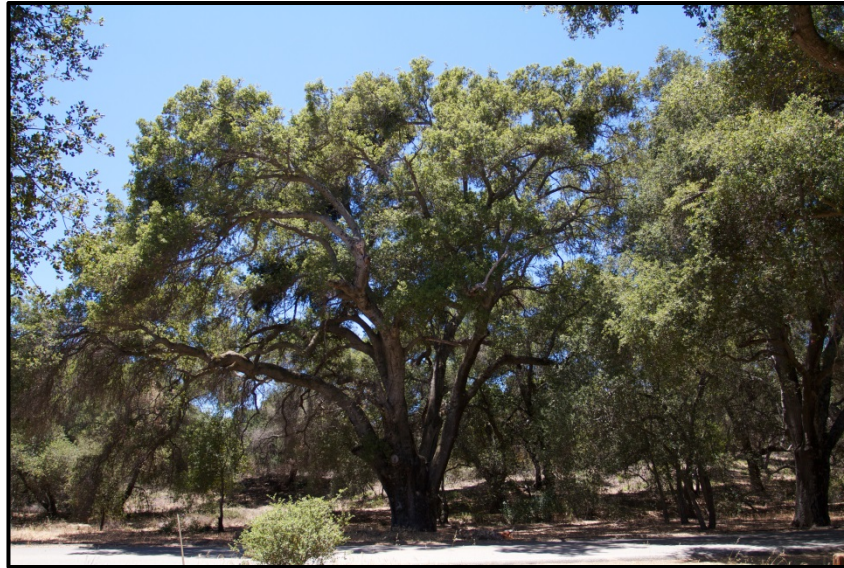
7. Photograph taken of majestic, 86-inch DBH Oak tree. Tree canopy is 40 feet tall and 55 feet wide. Oak woodlands near Long Canyon Road has an abundance of young and older trees.

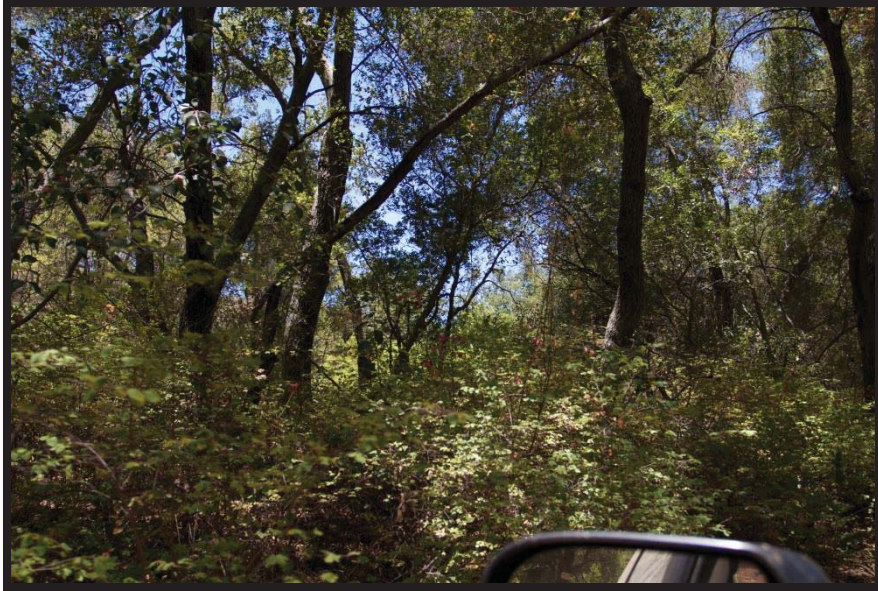
Photograph 7 – View of dense understory with  
“heavy” poison oak component

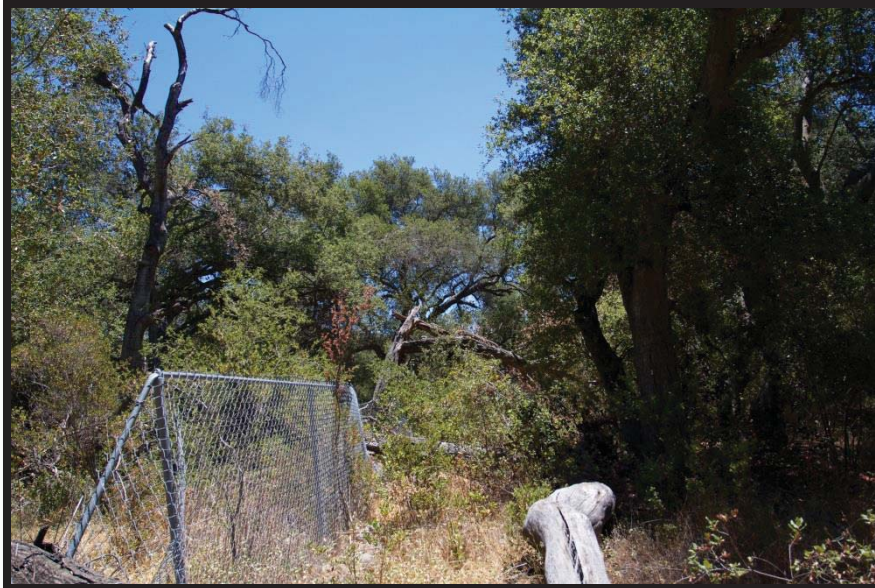
Photograph 15 – View of mortality in oak woodland – snag/wildlife trees

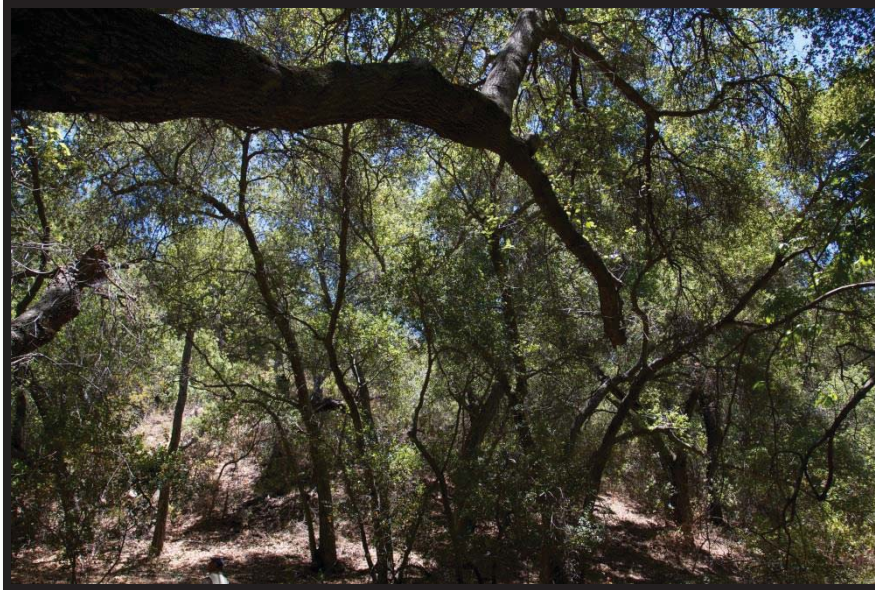
Photograph 19 – View of preserved oak woodland outside of development footprint with minimal seedling/sapling recruitment

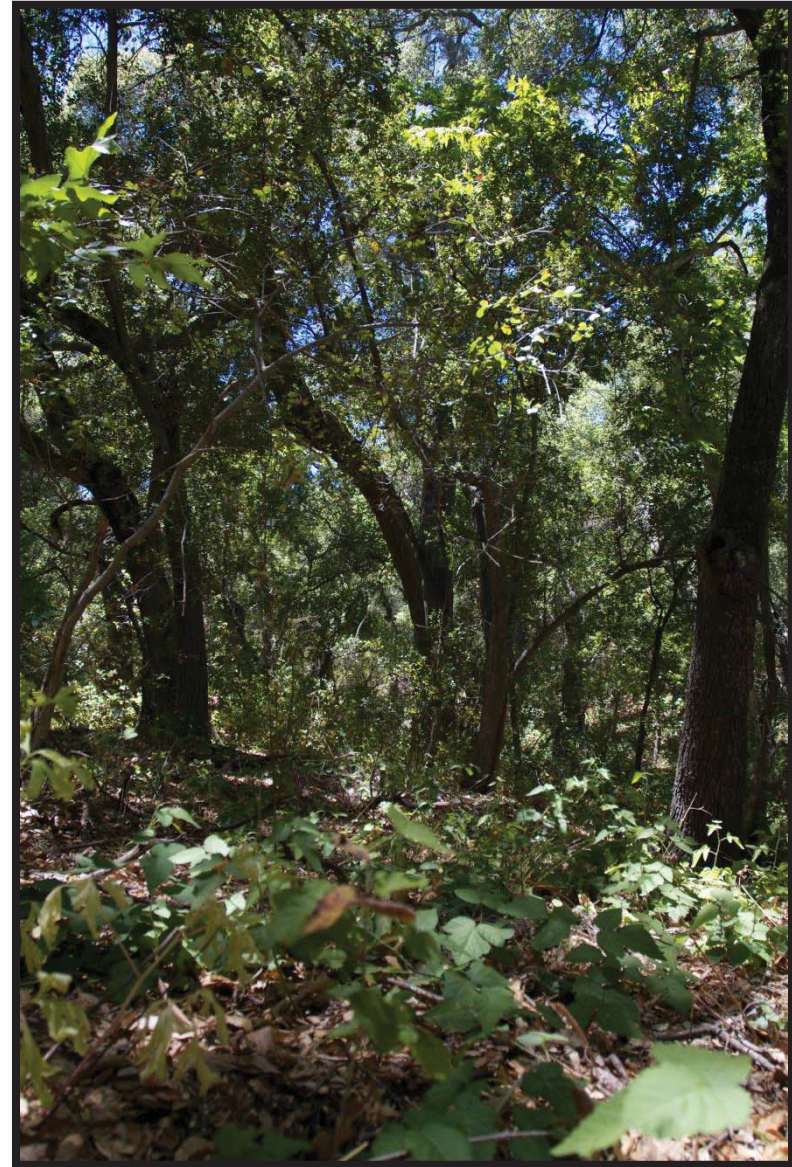
Photograph 20– View of preserved oak woodland outside of development footprint with minimal seedling/sapling recruitment

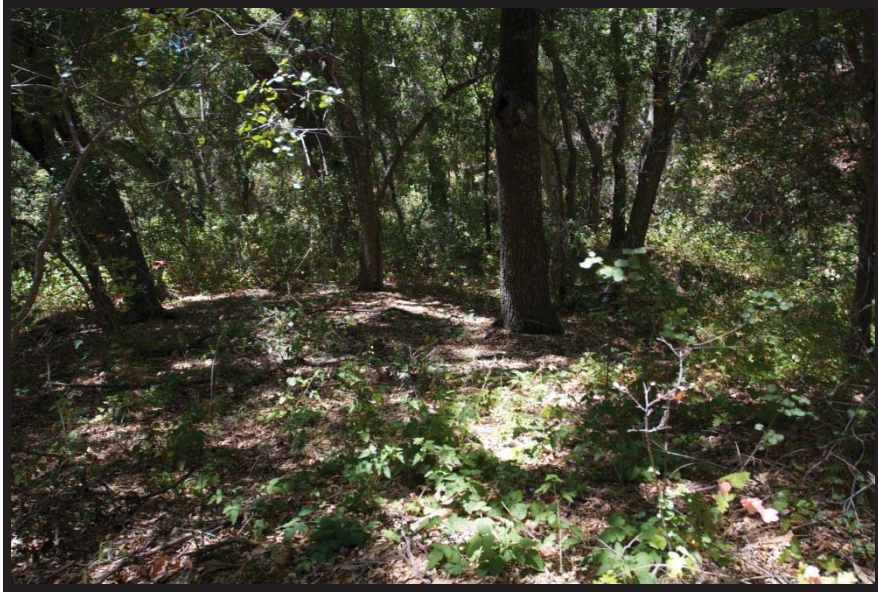
Photograph 21 – View of preserved oak woodland outside of development footprint with minimal seedling/sapling recruitment
