**CEQA INITIAL STUDY
PROPOSED MITIGATED NEGATIVE DECLARATION**

**Ranch Hills Community
PLANNING APPLICATION NO. PA180034
VESTING TENTATIVE TRACT MAP NO. TT18119
INITIAL STUDY NO. PA 180034**

**County of Orange
OC Public Works, Development Services/Planning
601 North Ross Street
Santa Ana, CA 92701-4048**

May 2020

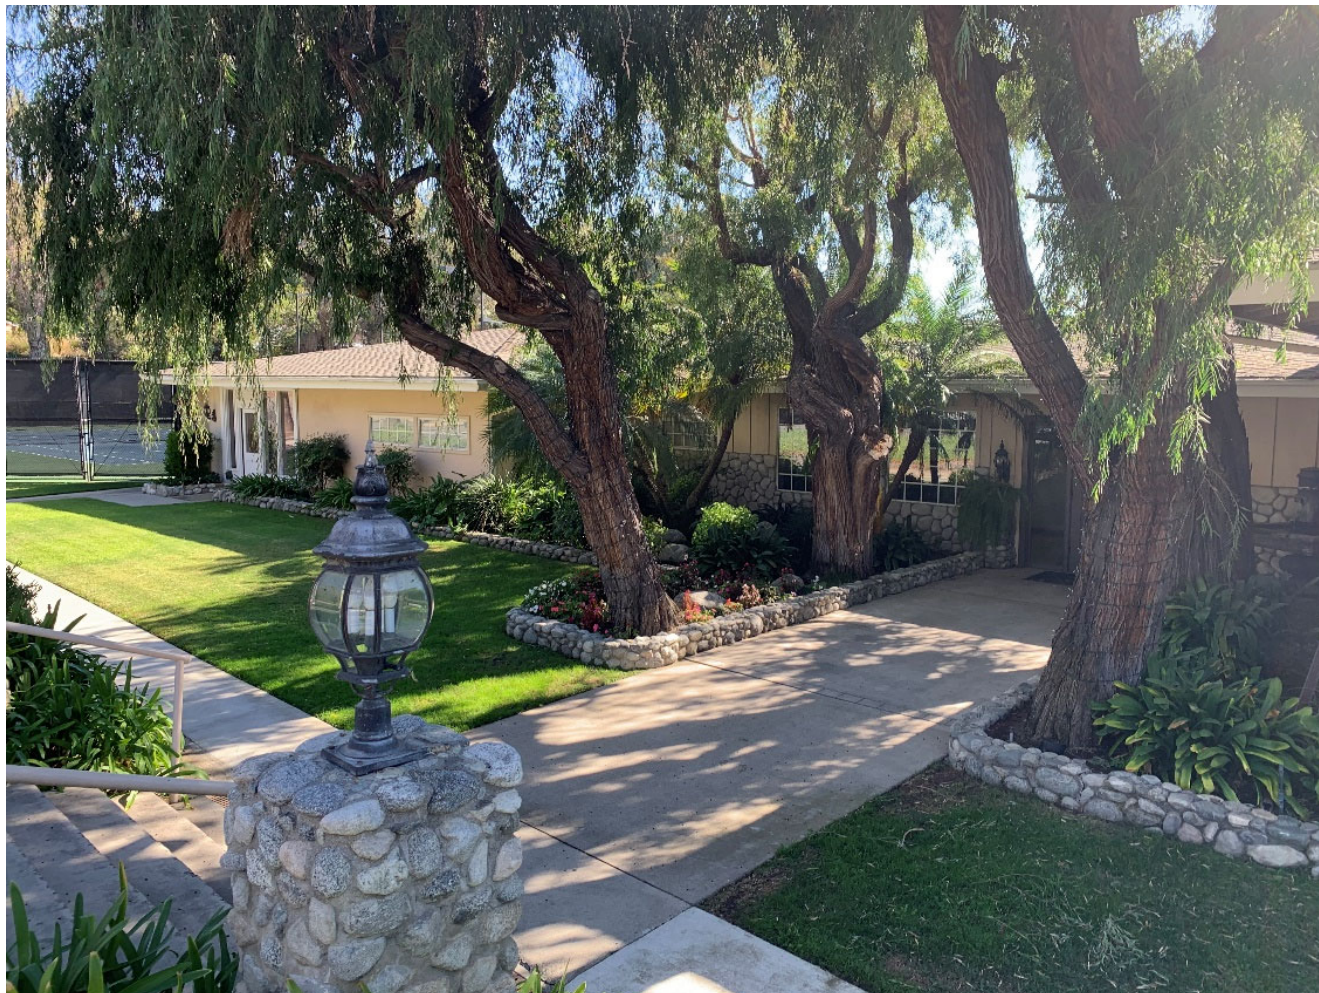
Clubhouse, northwest elevation, facing north

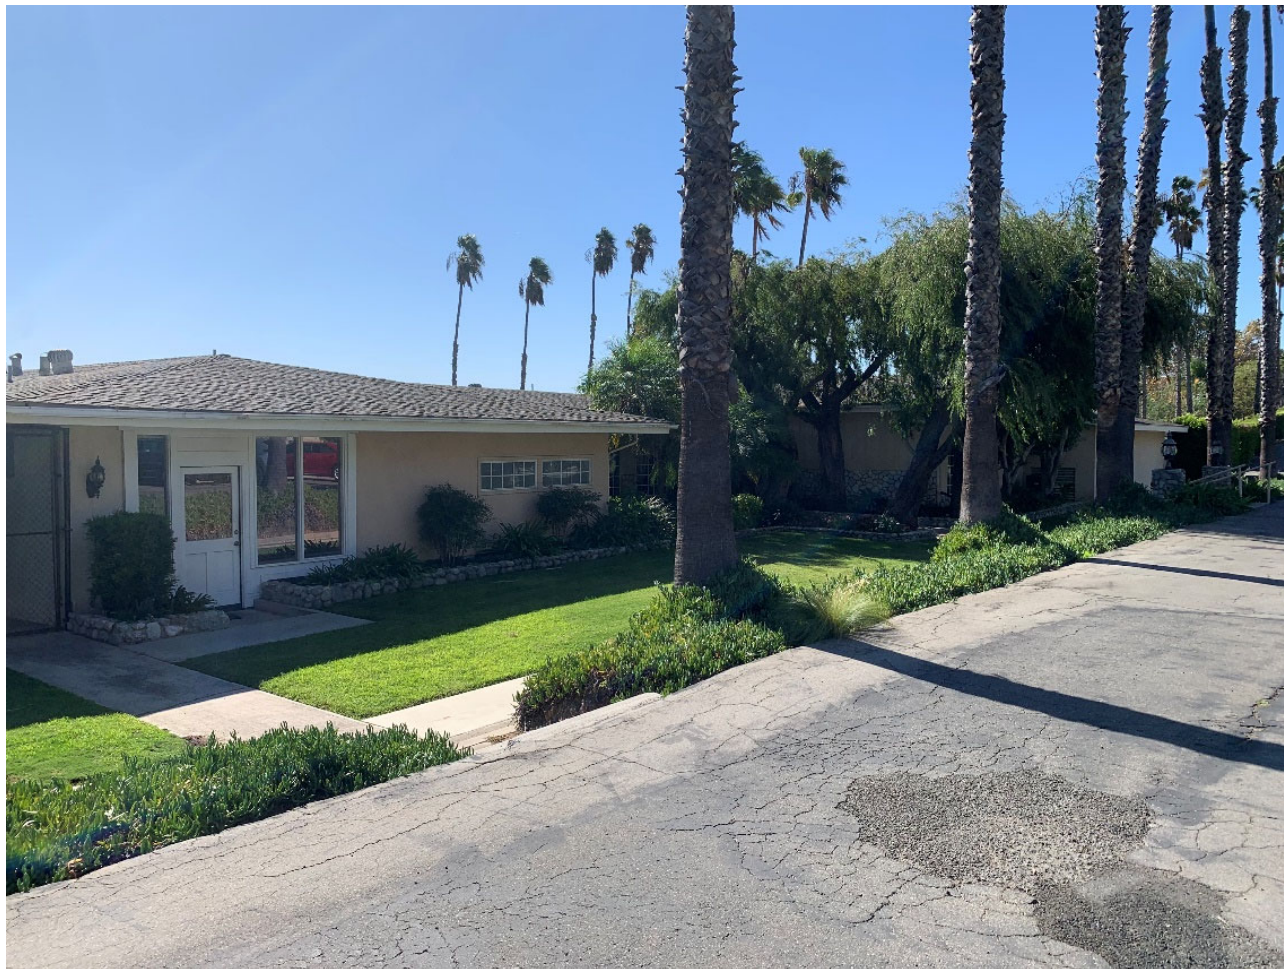
Clubhouse, northwest elevation, facing south

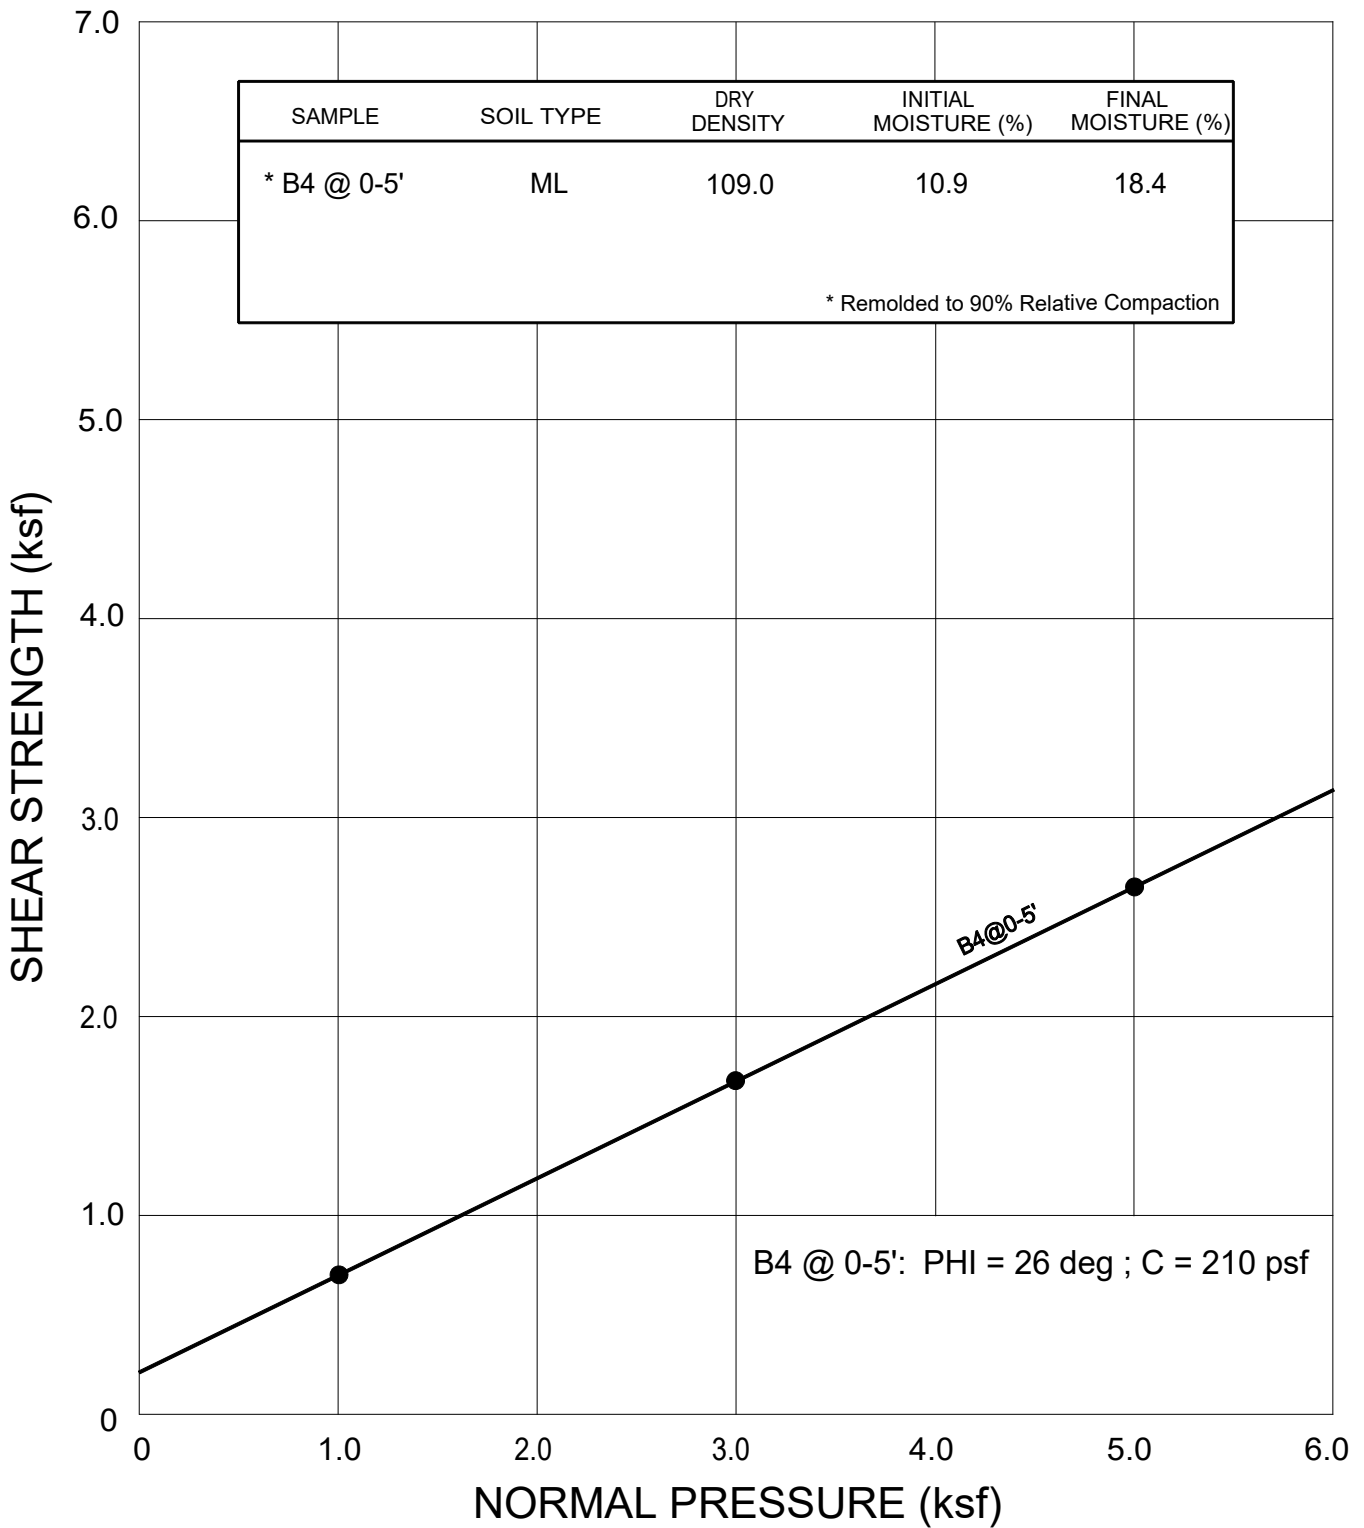
MAY 2017 PROJECT NO. A9568-88-02 FIG. B1

● DIRECT SHEAR, SATURATED

Laboratory tests were performed in accordance with generally accepted test methods of the “American Society for Testing and Materials (ASTM)”, or other suggested procedures. Selected samples were tested for direct shear strength, consolidation, gradation, and expansion characteristics, compaction, resistance value (R-value), corrosivity, and in-place dry density and moisture content. The results of the laboratory tests are summarized in Figures B1 through B6. The in-place dry density and moisture content of the samples tested are presented on the boring logs, Appendix A.

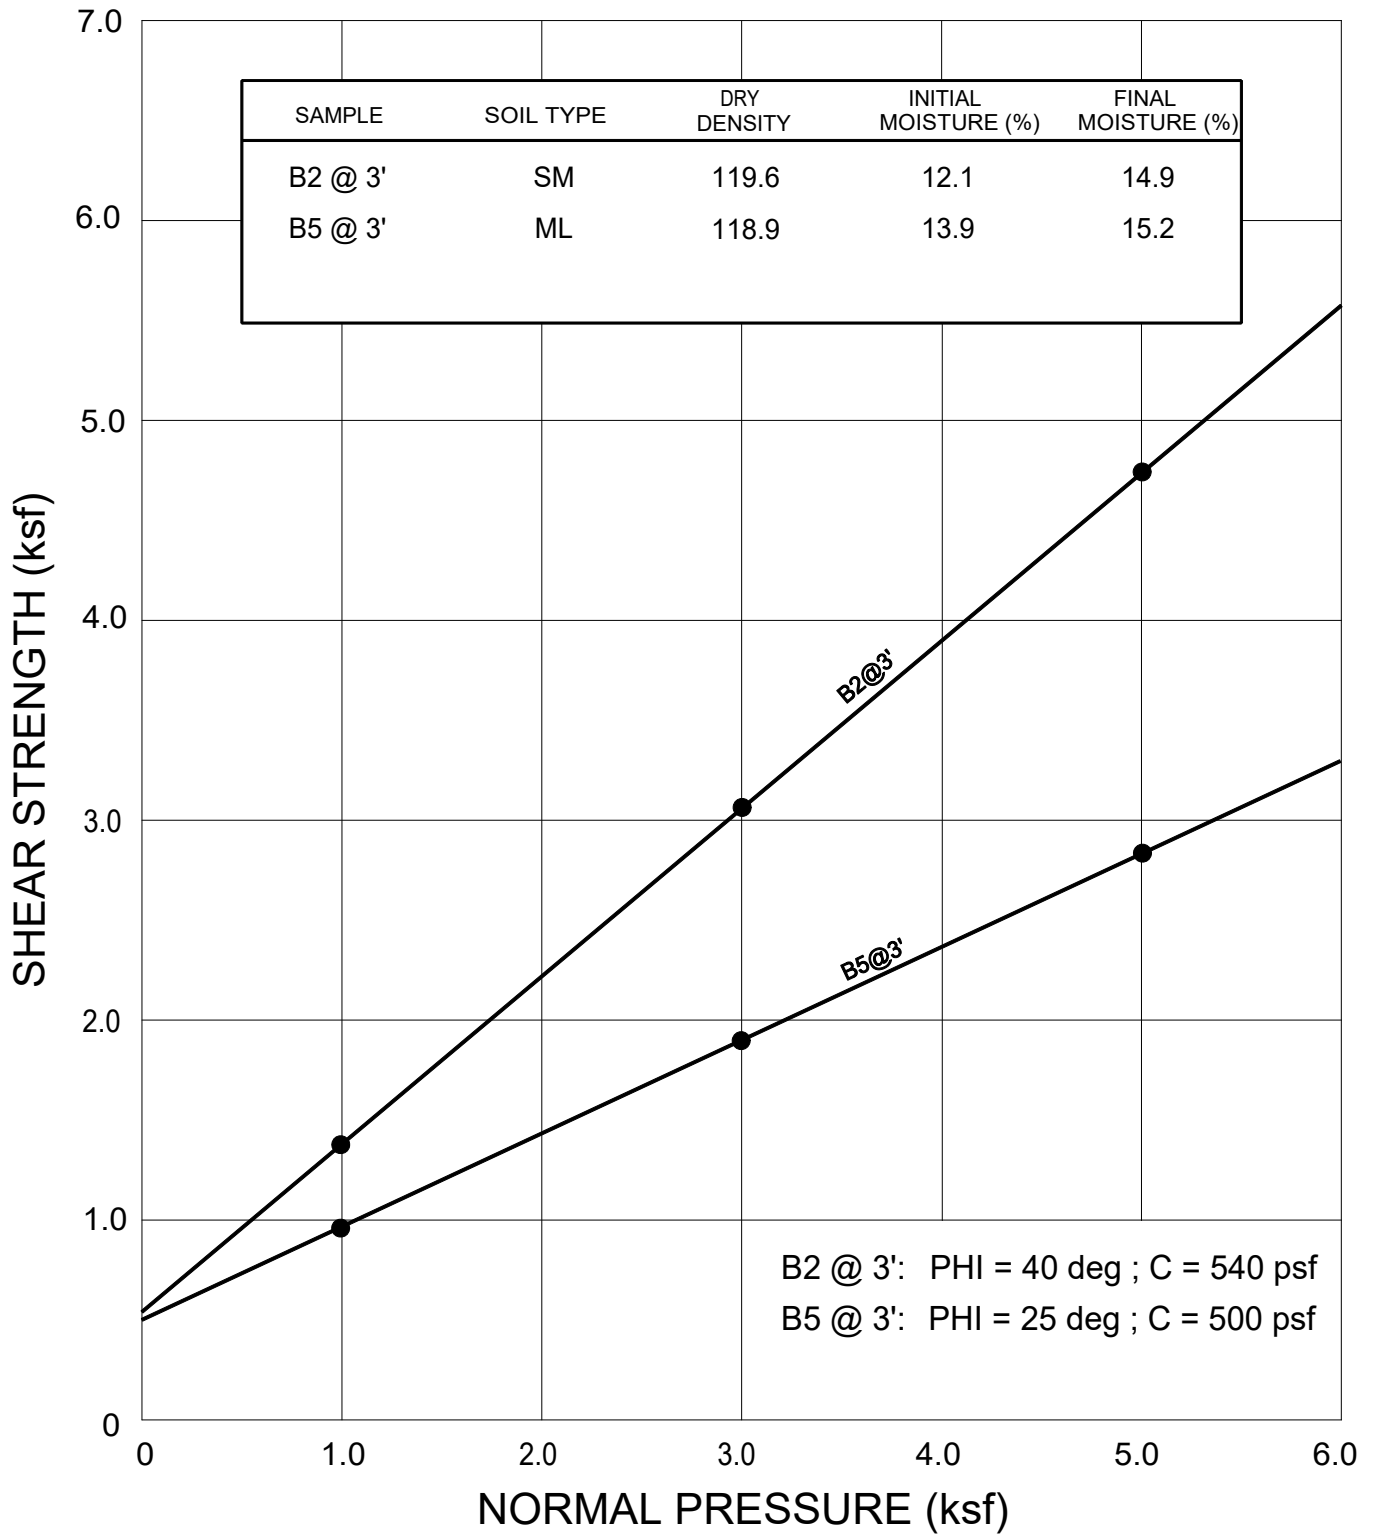
FIG. B2

● DIRECT SHEAR, SATURATED

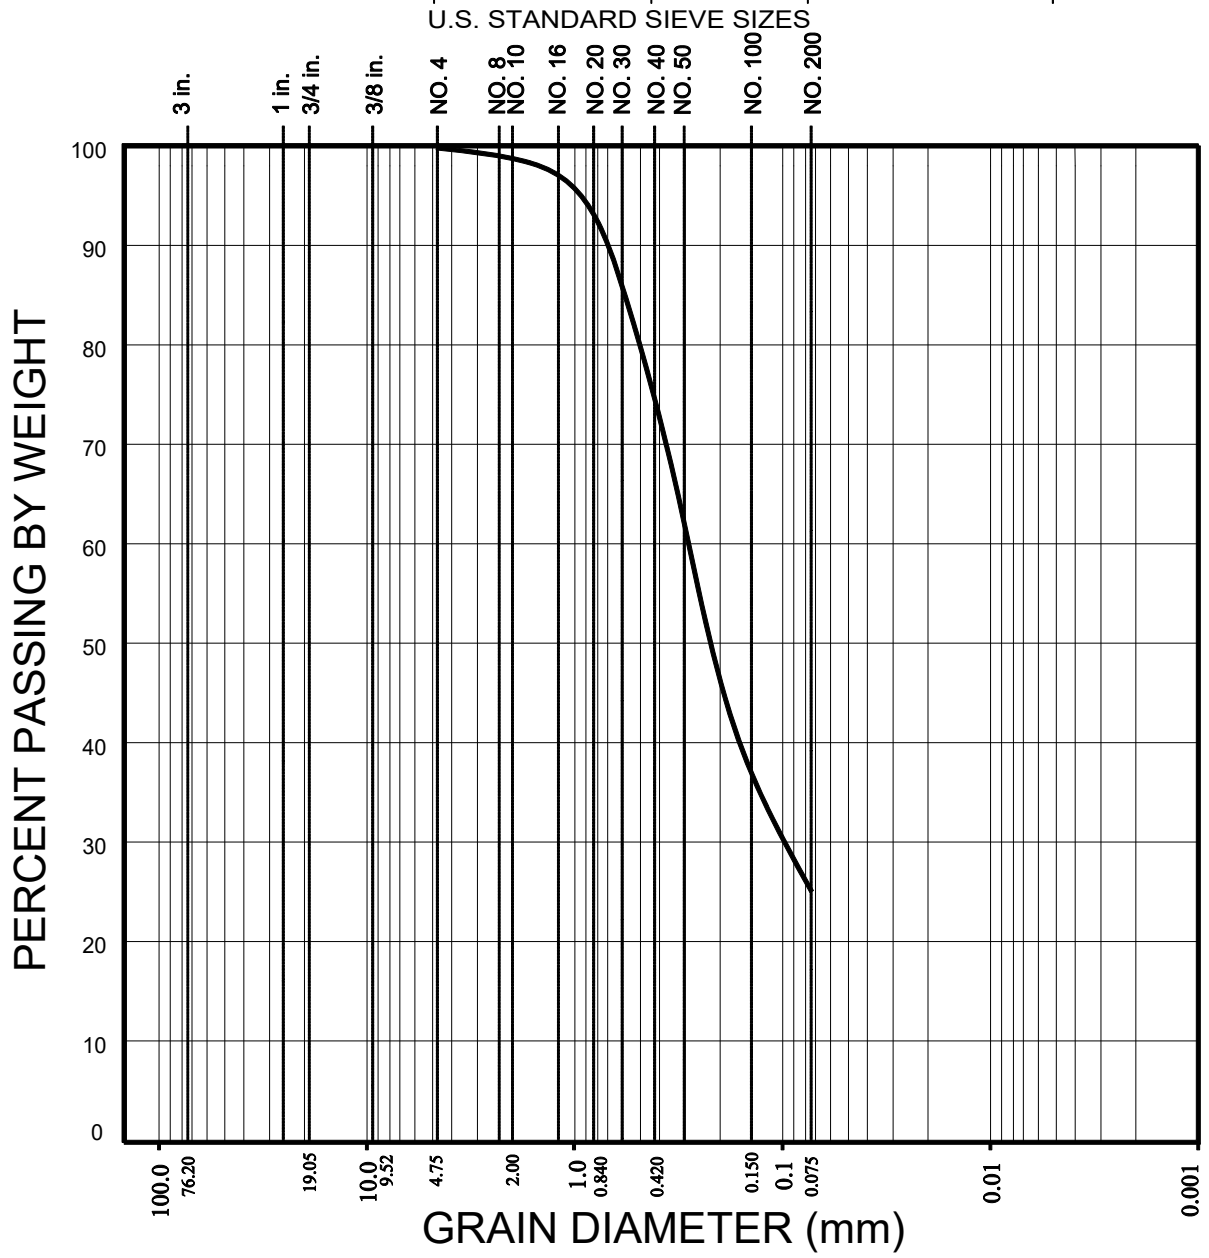
SAMPLE	UNIFIED SOIL CLASSIFICATION
— B3 @ 20-22'	SM

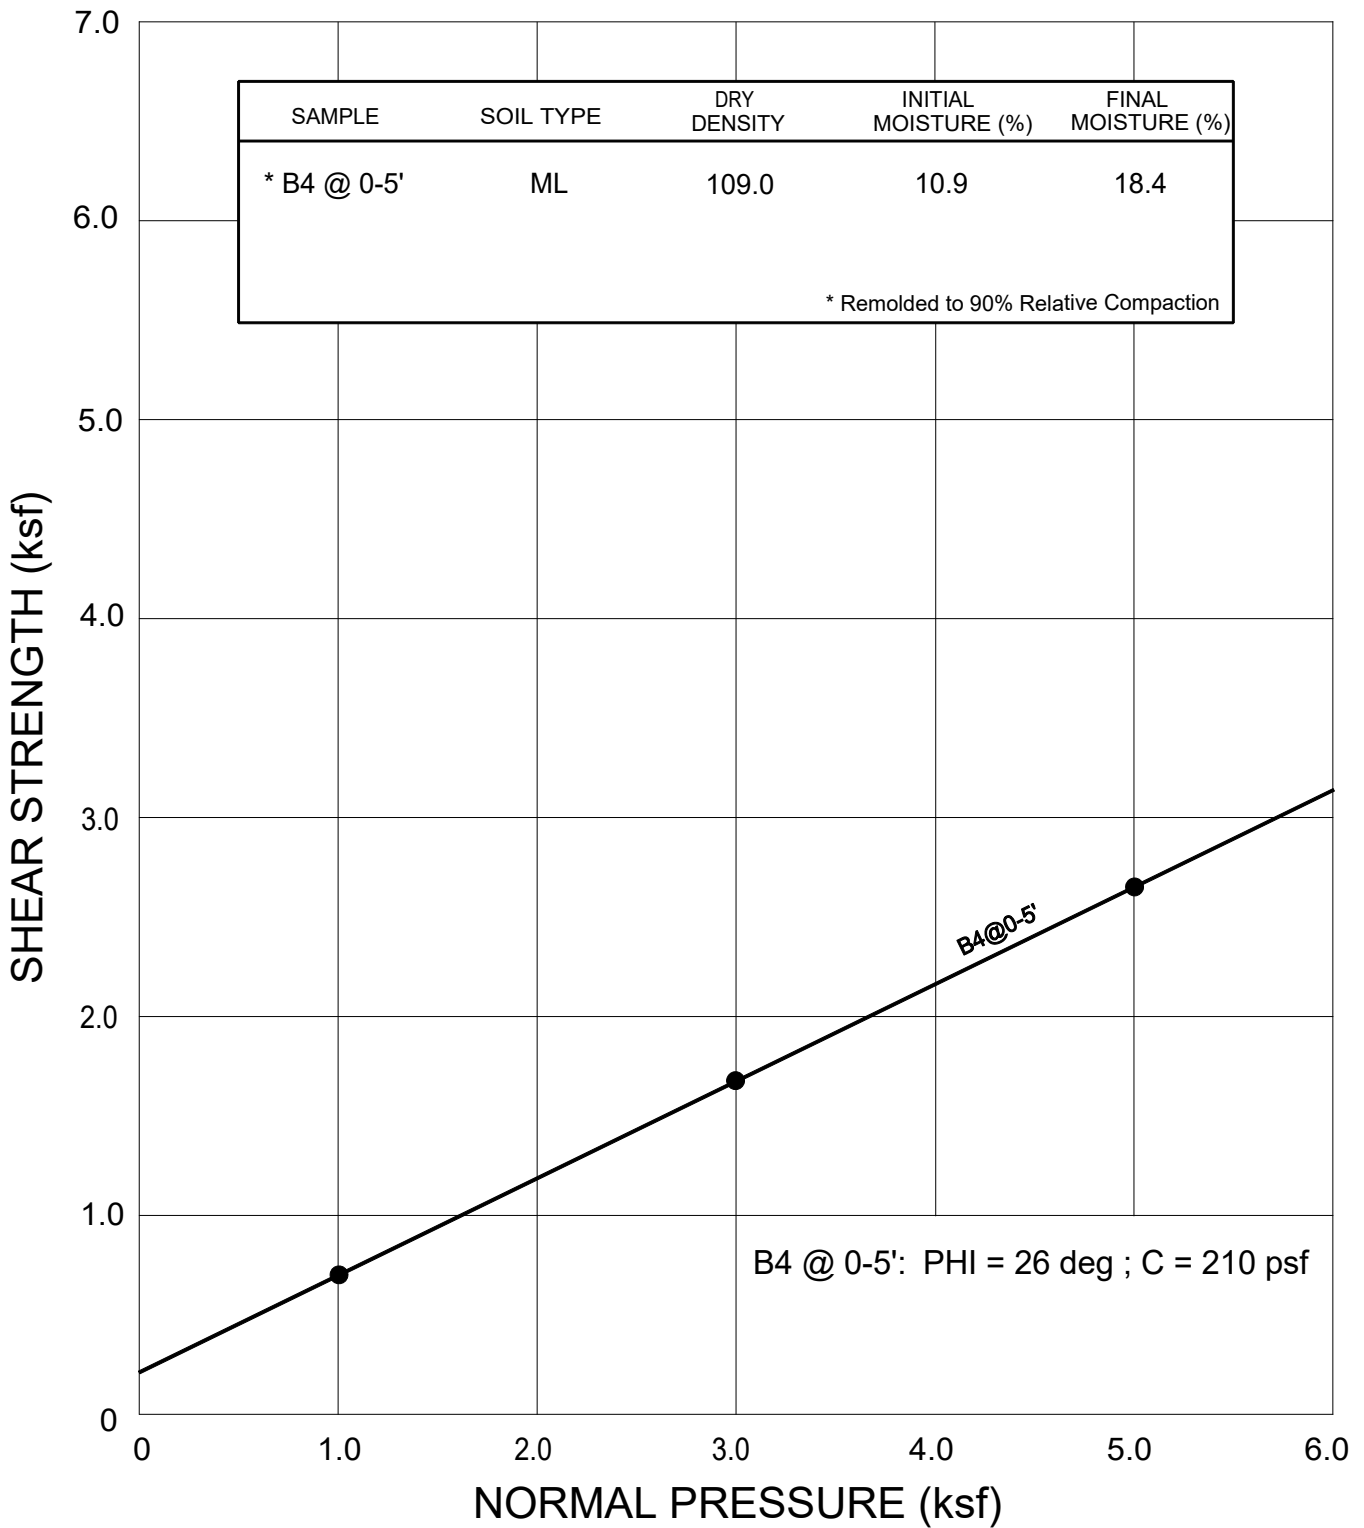
MAY 2017 PROJECT NO. A9568-88-02 FIG. B1

● DIRECT SHEAR, SATURATED

Laboratory tests were performed in accordance with generally accepted test methods of the “American Society for Testing and Materials (ASTM)”, or other suggested procedures. Selected samples were tested for direct shear strength, consolidation, gradation, and expansion characteristics, compaction, resistance value (R-value), corrosivity, and in-place dry density and moisture content. The results of the laboratory tests are summarized in Figures B1 through B6. The in-place dry density and moisture content of the samples tested are presented on the boring logs, Appendix A.

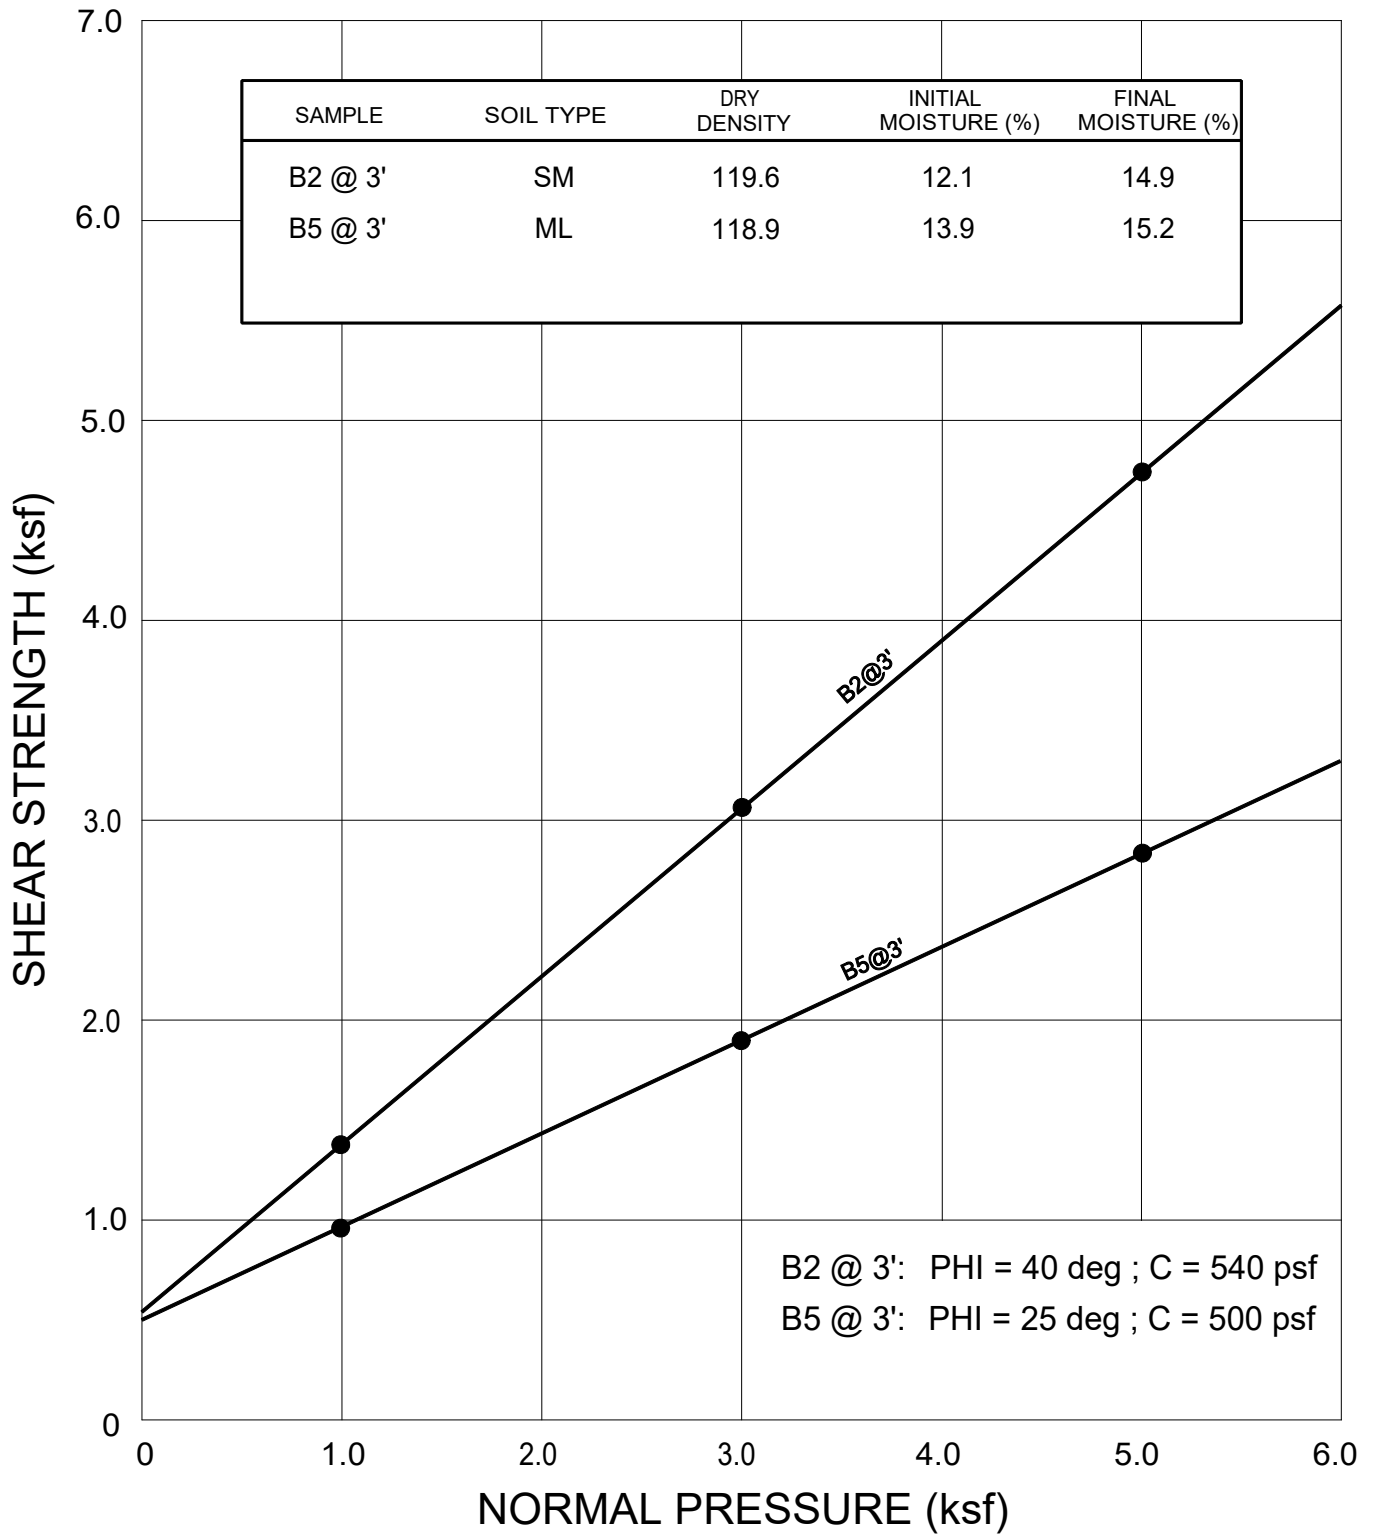
FIG. B2

● DIRECT SHEAR, SATURATED

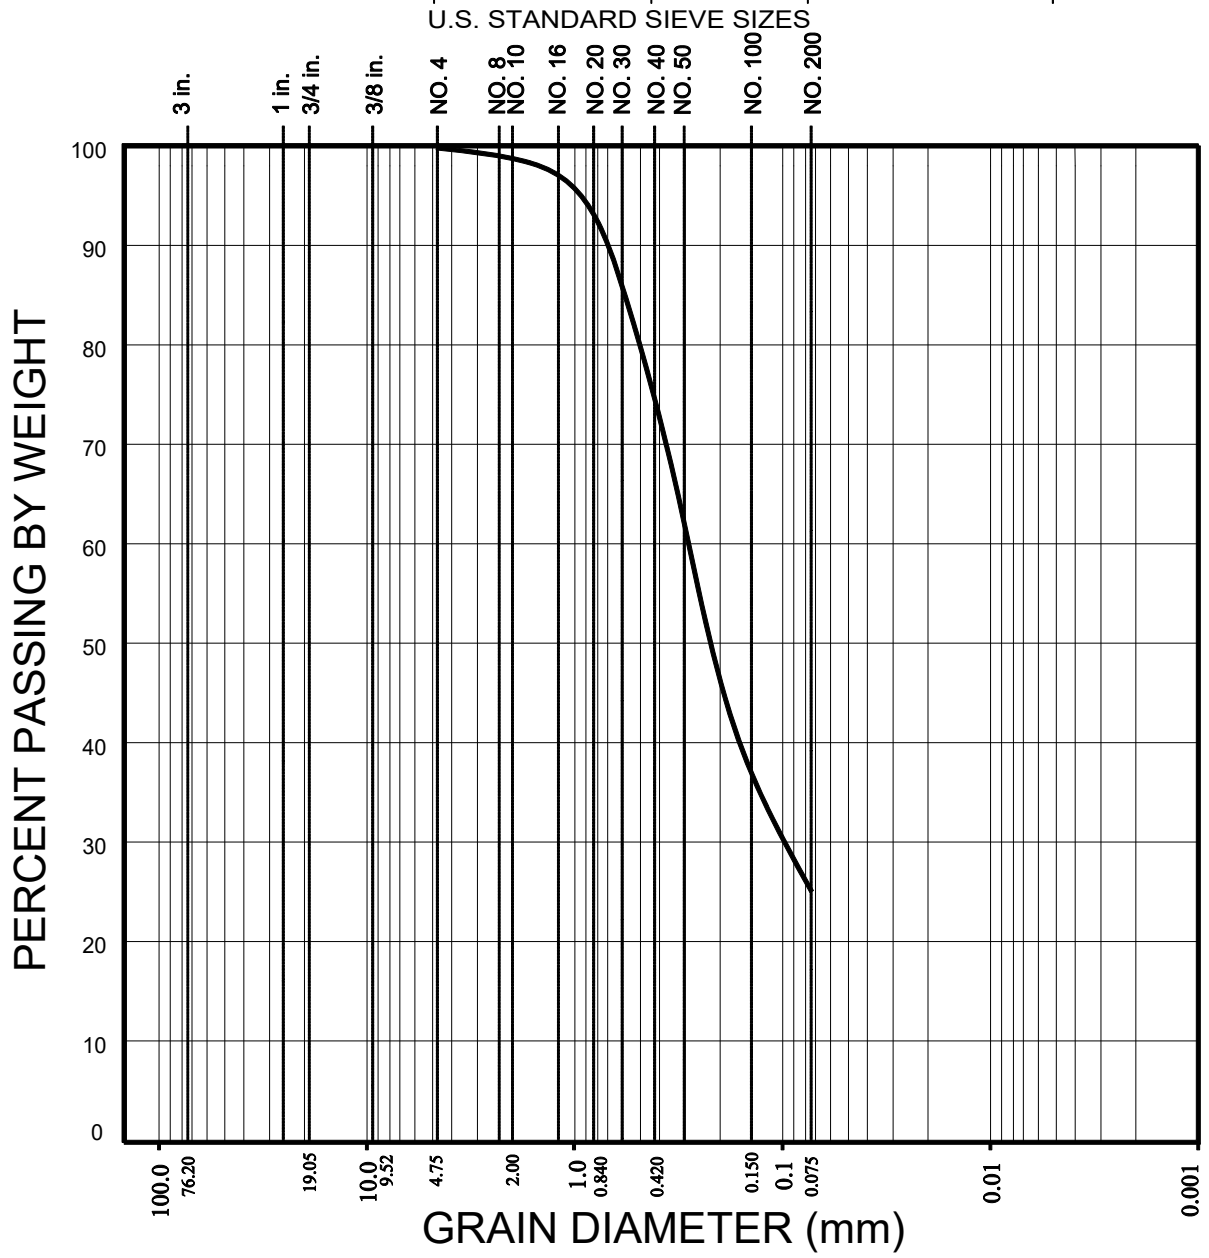
SAMPLE	UNIFIED SOIL CLASSIFICATION
— B3 @ 20-22'	SM
