KIRCHBERG RESIDENCE
 31329 HALFWAY ROAD
 SILVERADO, CALIFORNIA 92676

SITE PLAN & EXISTING FLOOR PLANS

SCALE:	1/4" = 1'-0"
DRAWN:	WMR
DATE:	10.25.22
JOB:	KIRCH-2213
SHEET:	A

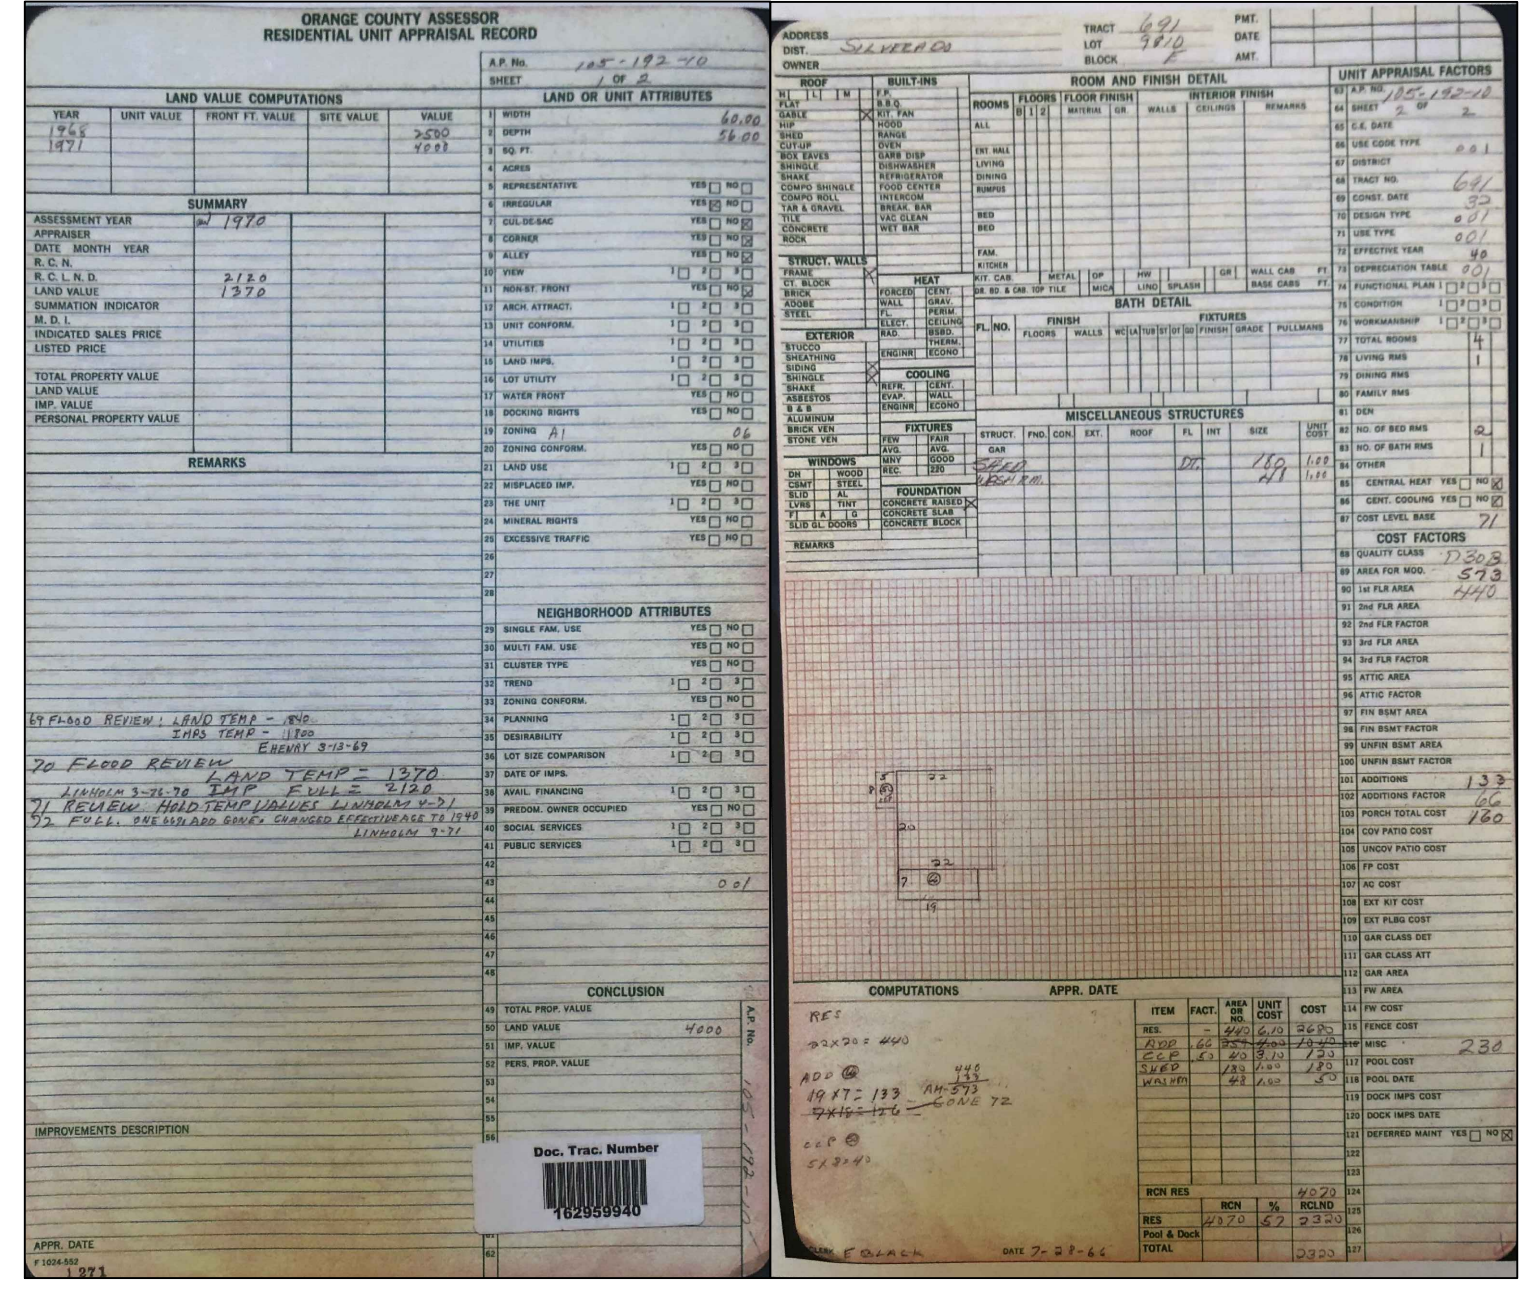
- RED LINE REPRESENTS THE PERMITTED STRUCTURE DRAWN ON THE RESIDENTIAL UNIT APPRAISAL RECORD.
 - MASTER BEDROOM ASSUMED TO BE UN-FERMITTED.
 - DECK ASSUMED TO BE UN-FERMITTED.

THE OCPW PLANNING DEPARTMENT IS USING A RESIDENTIAL UNIT APPRAISAL RECORD (DATED 1966-1972) OBTAINED FROM THE ASSESSORS OFFICE AS THE SCALE BASIS FOR ESTABLISHING PERMITTED/UN-FERMITTED STRUCTURES ON OUR PROPERTY. THE AREAS OUTLINED BY CROSS-HATCH ON THIS DOCUMENT REPRESENT THE SUPPOSED UN-FERMITTED STRUCTURES DUE TO NOT BEING DOCUMENTED ON SAID RESIDENTIAL UNIT APPRAISAL RECORD.

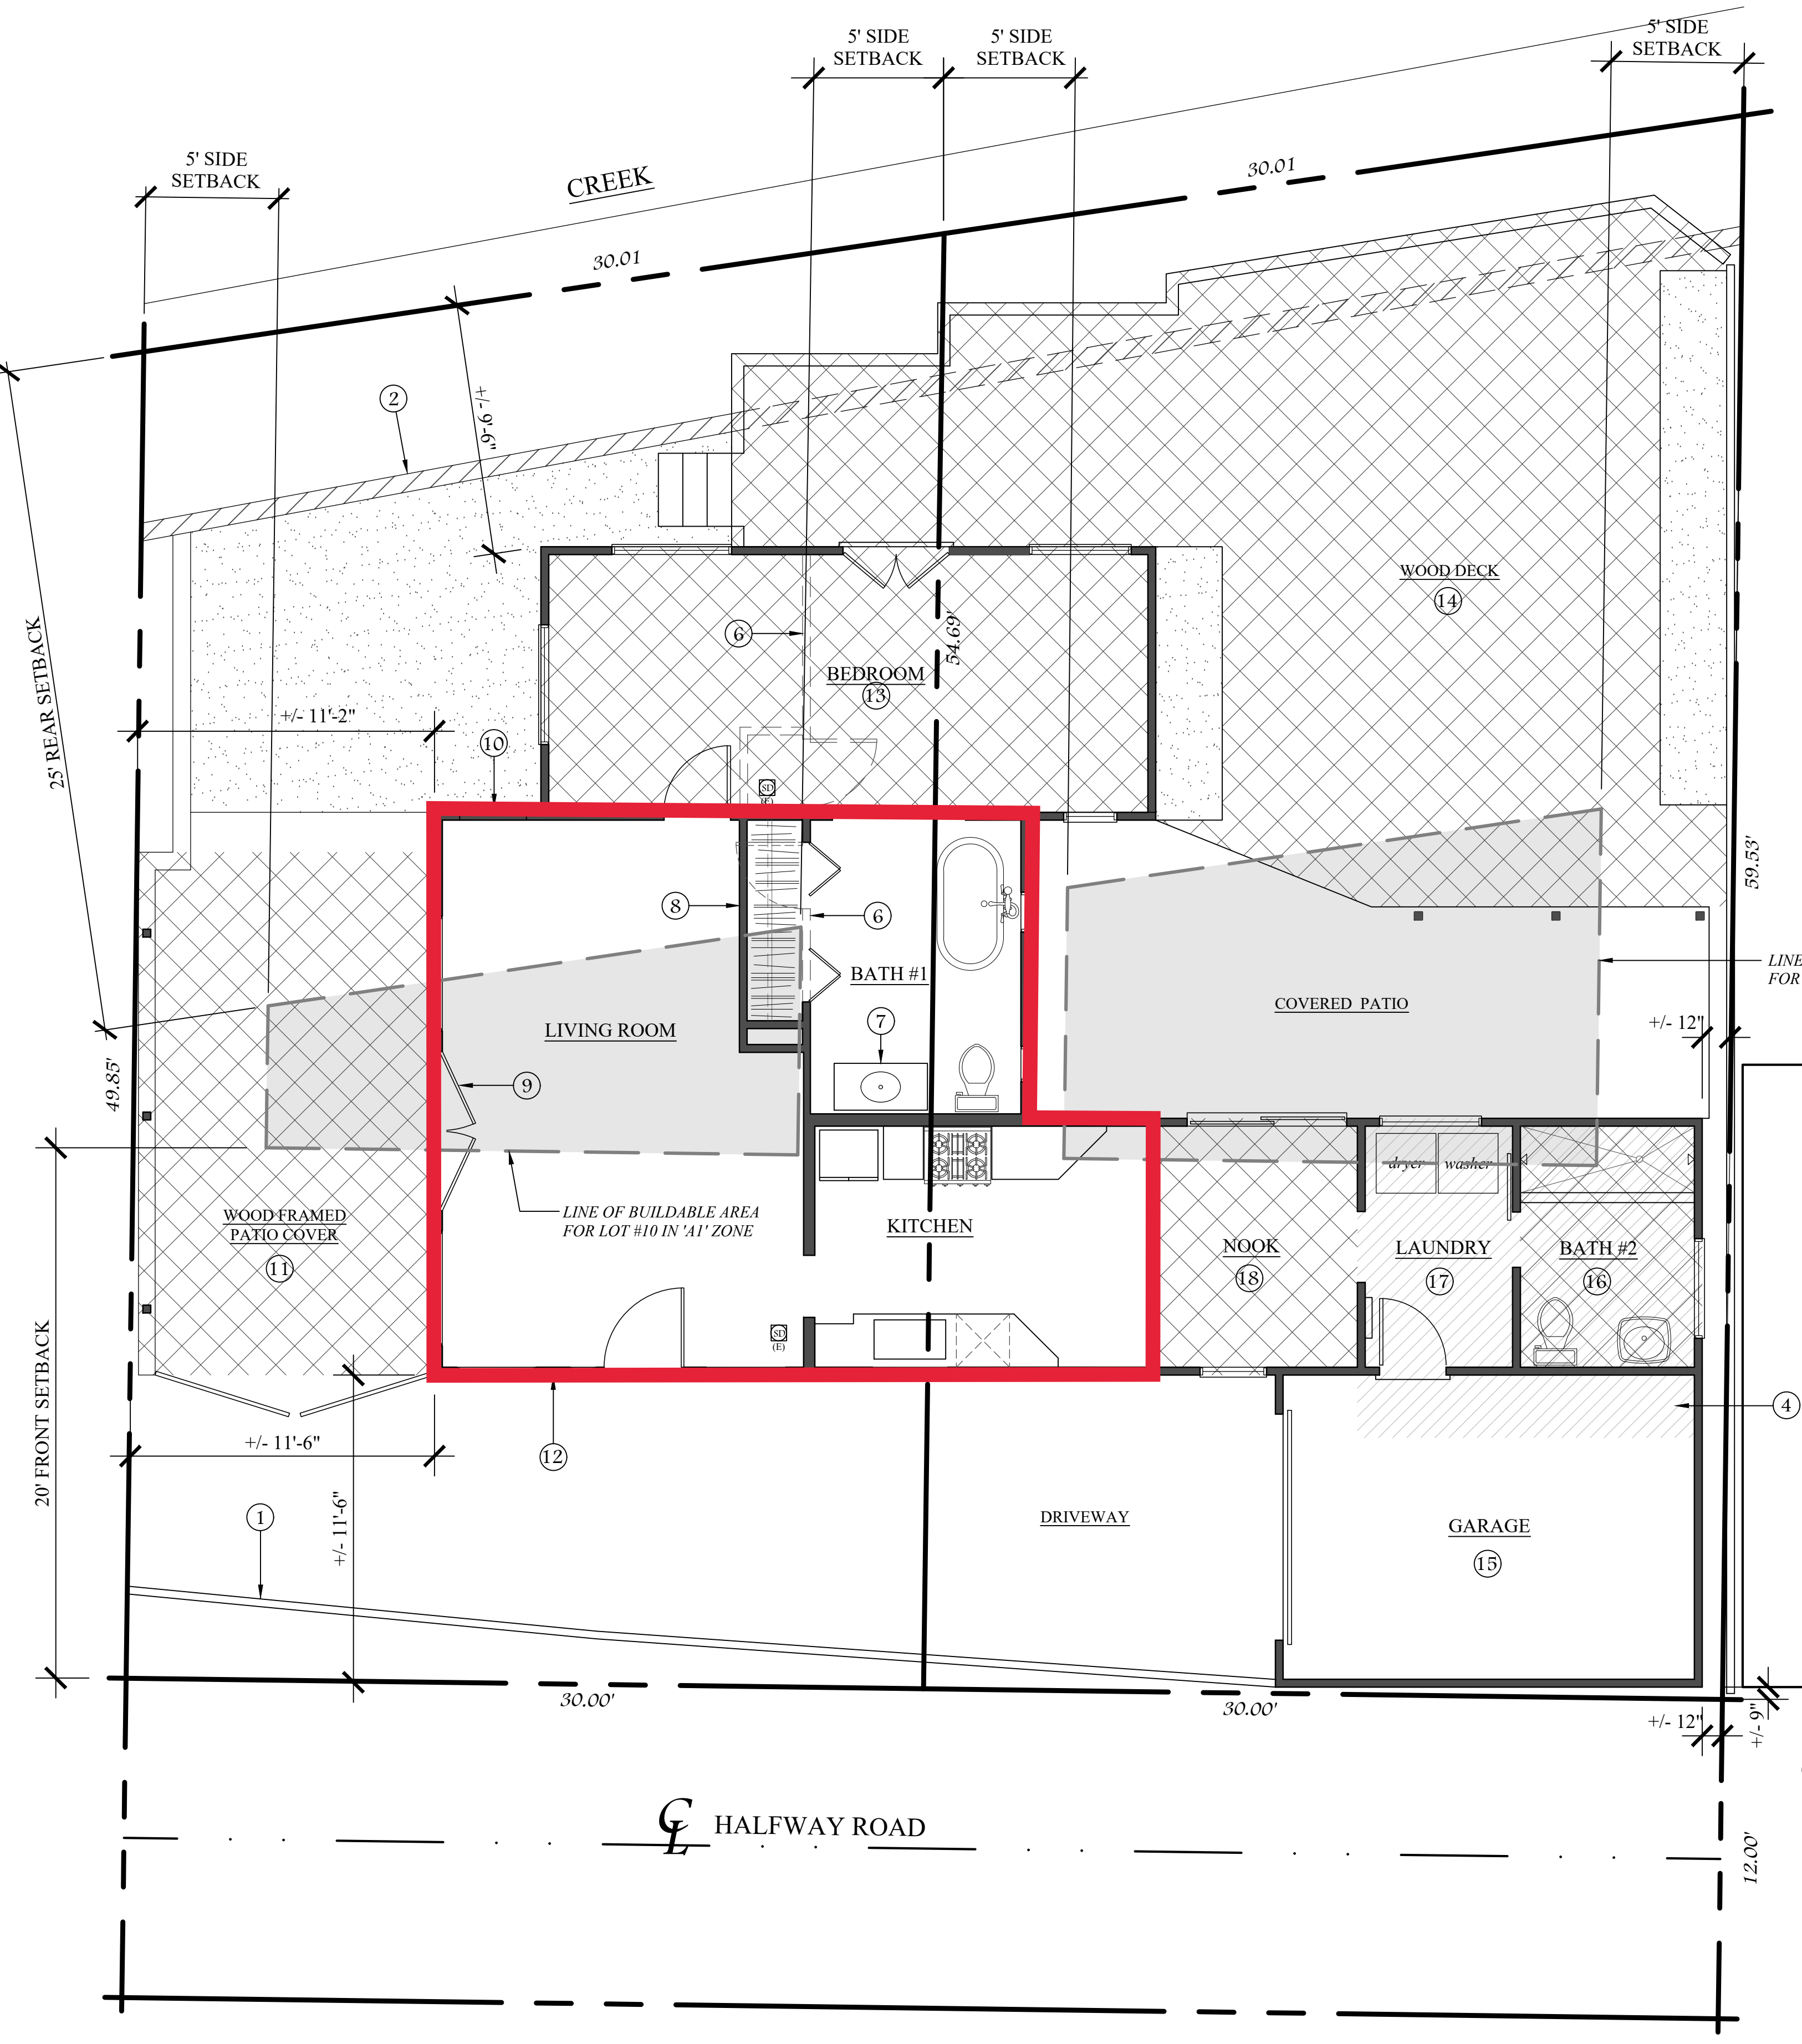
- SITE PLAN KEYED NOTES:**
- 6" TALL WOOD FENCE.
 - EXISTING CONCRETE RETAINING WALL.
 - FOOTPRINT OF ADJACENT PROPERTY. NO STRUCTURES ARE ADJACENT TO OTHER PROPERTY LINES.

- HATCHED AREA REPRESENTS STORAGE LOFT ABOVE.
 - LINE OF BUILDING FOOTPRINT BELOW.
 - NON-STRUCTURAL WALLS REMOVED (UN-FERMITTED).
 - VANITY REPLACED (UN-FERMITTED).

- CLOSET ADDED (UN-FERMITTED).
 - FRENCH (DNOR ADDED) (UN-FERMITTED).
 - WINDOW REMOVED (UN-FERMITTED).
 - WOOD FRAMED PATIO COVER (FORMERLY REFERRED TO A "CARPORT") ASSUMED TO BE UN-FERMITTED.

- GARAGE IS PERMITTED AS DESCRIBED ON THE RESIDENTIAL UNIT APPRAISAL RECORD (REFERRED TO AS "SHED", A TERM COMMONLY USED TO REFER TO A GARAGE, I.E.: "GARAGE SHED").

- BATH #2 IS ASSUMED TO BE UN-FERMITTED.
 - LAUNDRY ROOM IS PERMITTED AS DESCRIBED ON THE RESIDENTIAL UNIT APPRAISAL RECORD (REFERRED TO AS "WASH RM").

- PORTION OF THE NOOK ASSUMED TO BE UN-FERMITTED.

BUILDING SITING NOTE:
 THE FOOTPRINT OF THE BUILDING REPRESENTED HERE IS A RESULT OF AERIAL PHOTOS AND VISUAL OBSERVATION OF THE LOCATION OF HALFWAY ROAD WITH RESPECT TO EXISTING BUILDING ALONG THE STREET.

ALL KNOWN PERMITTED AND UNPERMITTED STRUCTURES ARE AND/OR HAVE BEEN IDENTIFIED BASED ON AVAILABLE RECORDS MAINTAINED BY THE COUNTY. SEE SITE PLAN KEYED NOTES NOS. 6 - 10. UNLESS OTHERWISE INDICATED, IT MUST BE PRESUMED THAT ALL STRUCTURES IDENTIFIED ARE EITHER PERMITTED, EXEMPTED, OR PART OF THE ORIGINAL CONSTRUCTION, AS COUNTY RECORDS—DESPITE ALL MATTERS OF DUE DILIGENCE AND REQUESTS—APPEAR TO BE INCOMPLETE, DESTROYED, OR NON-EXISTENT, AND ANY AND ALL CONSTRUCTION HISTORY PRIOR TO THE CURRENT OWNERSHIP IS CATEGORICALLY IMPOSSIBLE TO ASCERTAIN OR OBTAIN. MOREOVER, WHILE HISTORICAL/FORENSIC ARCHITECTURAL ANALYSIS MAY ADD SOME INSIGHTS INTO WHEN CERTAIN STRUCTURES WERE PERMITTED AND/OR OTHERWISE REQUIRE PERMITTING (SEE AGAIN E.G., SITE PLAN KEYED NOTES NOS. 6 - 10), THE LACK OF COUNTY RECORDS AND/OR HISTORICAL DATA RENDERS A COMPLETE DETERMINATION/FINDING IMPOSSIBLE. IN CLOSING, IT MUST BE REITERATED, THE CURRENT HOMEOWNERS PURCHASED THEIR RESIDENCE IN JUNE OF 2016 IN ITS PRESENT CONDITION AND POSSESS NO ADDITIONAL KNOWLEDGE TO THE AFOREMENTIONED OTHER THAN STATED ON THIS SHEET.
