THE RANCH PLAN PLANNED COMMUNITY
PLANNING AREAS 3 AND 4 RUNOFF MANAGEMENT PLAN

TECHNICAL APPENDIX O.3

Updated Lateral Erosion Analysis

Re: **RMV Ranch Plan Updated Assessment for Lateral Streambank Erosion Analyses for PA1 / PA2**

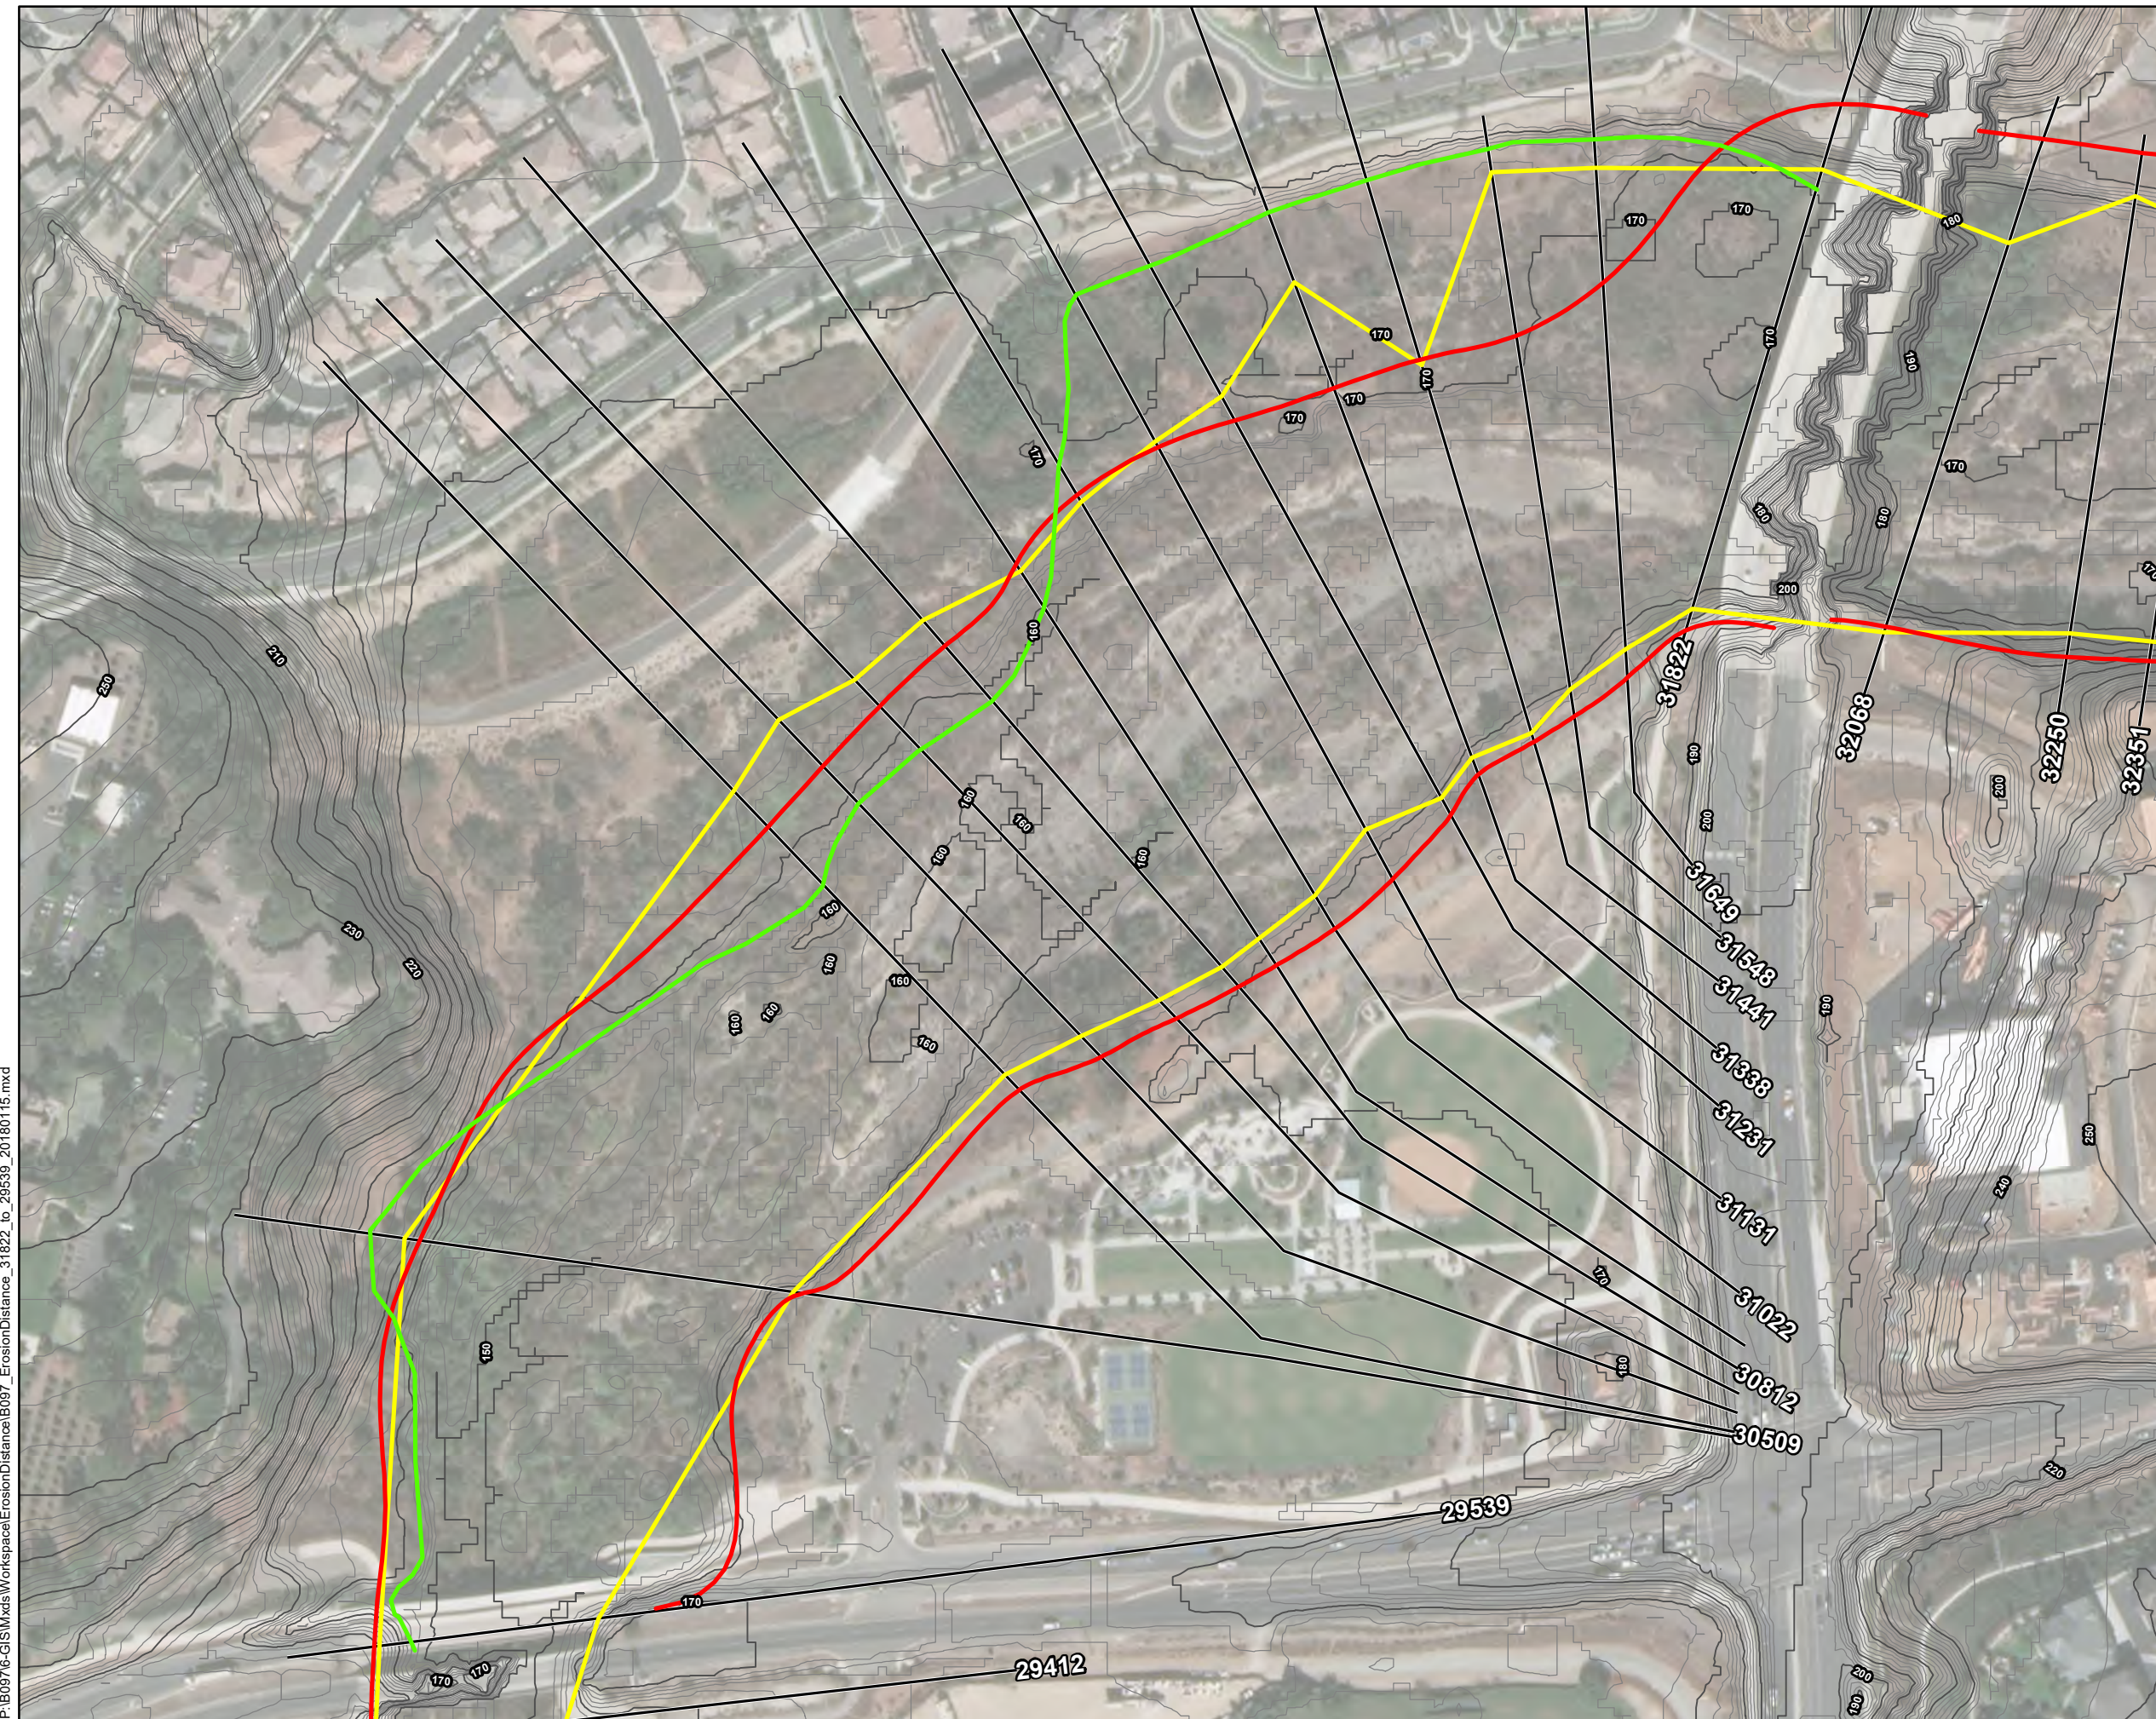
Figure No. 2
**COMPARISON OF
LONG TERM LATERAL
EROSION ESTIMATES
PA1 DEVELOPMENT AREA**

The County review process for the different previous lateral erosion studies had used independent peer review as well as their own internal staff review. The peer review had included the application of a separate sediment transport computer program, FLUVIAL-12, to model the long term lateral erosion along the study limits and compare the results with the two different PACE studies. The long-term time simulation in PACE modeling was different than the peer review modeling. PACE has computed from the HEC-6T modeling an annualized sediment erosion deficit at each cross section and multiplied this value by 60 in order to compute 60-years of erosion, plus adding a single 100-year storm erosion amount to compute the total lateral erosion. This is the procedure adopted from Maricopa County Flood Control District studies. The peer review modeling had used a sequence of storms over a 20-year period. The primary findings from the comparison with peer review computed erosion limits indicated that (1) the July 2017 PACE lateral erosion limits/hazard zones along the PA3/PA4 development areas were the same or provided larger erosion boundary limit than peer review FLUVIAL-12 model results (see *Figure No.3 – Comparison 2017 PACE Lateral Erosion Limits and Peer Review FLUVIAL-12 Model*), and (2) along the northern San Juan Creek bank adjacent to the PA1 development area there was a significant deviation between the PACE (September 2006) and the peer review model had computed much greater lateral erosion in this area (see *Figure No. 2 Comparison of Long Term Lateral Erosion Estimates PA1 Development Area*).

The results of this revised lateral erosion for the PA1 area are summarized on *Figure No. 2 – Comparison of Long Term Lateral Erosion Estimates PA1 Development Area* which compares the different analyses by PACE and Dr. Chang. The figure only illustrates the portion of the PA1 area where there was difference identified or additional erosion from the peer review modeling. The remainder of the erosion boundaries in the PA1/ PA2 area are adequate. The figure illustrates that **the revised PACE analysis generates lateral erosion distances that exceed the Dr. Chang model estimates, but does not extend into the development area** since the development was actually setback further using the floodplain limits. The detailed calculations that were performed for each individual cross section are provided in the *Technical Appendix*. Although improvements continue to be outside of the conservative limits of the erosion setback line, the County should continue to require evaluation and survey of the special monitoring monuments for this area. Site-specific erosion monitoring program and mitigation program was developed to specifically address lateral migration along a large river meander bend in this area. The monitoring composed of several different monitoring features/processes which also serve to identify level of risk. The results of the active monitoring program would potentially trigger different levels of corrective/preventative erosion mitigation measures depending on the severity of the measured erosion. This involves using three monuments which are four-inch buried steel pipes filled with concrete differentiated by either a (1) green – closest monument to the bank, (2) yellow – intermediate monument to bank and development, or (3) red – monument closest to the development edge. Each of the monuments have the colored metal tag identifier. The horizontal distance from the closest remaining monument to the active streambank edge is measured after each rainfall event of significance. The severity of lateral erosion associated with a storm event would be defined by the location of the erosion relative to the type of monument (green, yellow, or red). This specialized monitoring effort for this area provides an additional layer of safety to ensure the long protection of the development.

2. The lateral erosion limit near the PA1 development did change with the more detailed modeling procedure and the revised limits are shown for comparison on *Figure No.2*. This figure illustrates that **the revised PACE analysis generates lateral erosion distances that exceed the Dr. Chang model estimates, but does not extend into the development area** since the development was actually setback further using the floodplain limits. However, in this area a site-specific erosion monitoring program and mitigation program was developed to specifically address lateral migration along a large river meander bend. The monitoring composed of several different monitoring features/processes which also serve to identify level of risk. This specialized monitoring effort for this area provides an additional layer of safety to ensure the long protection of the development.
