MODJESKA GRADE ROAD IMPROVEMENTS PROJECT

UNINCORPORATED ORANGE COUNTY, CALIFORNIA

Biological Resources Assessment

December 2023
JN 189853

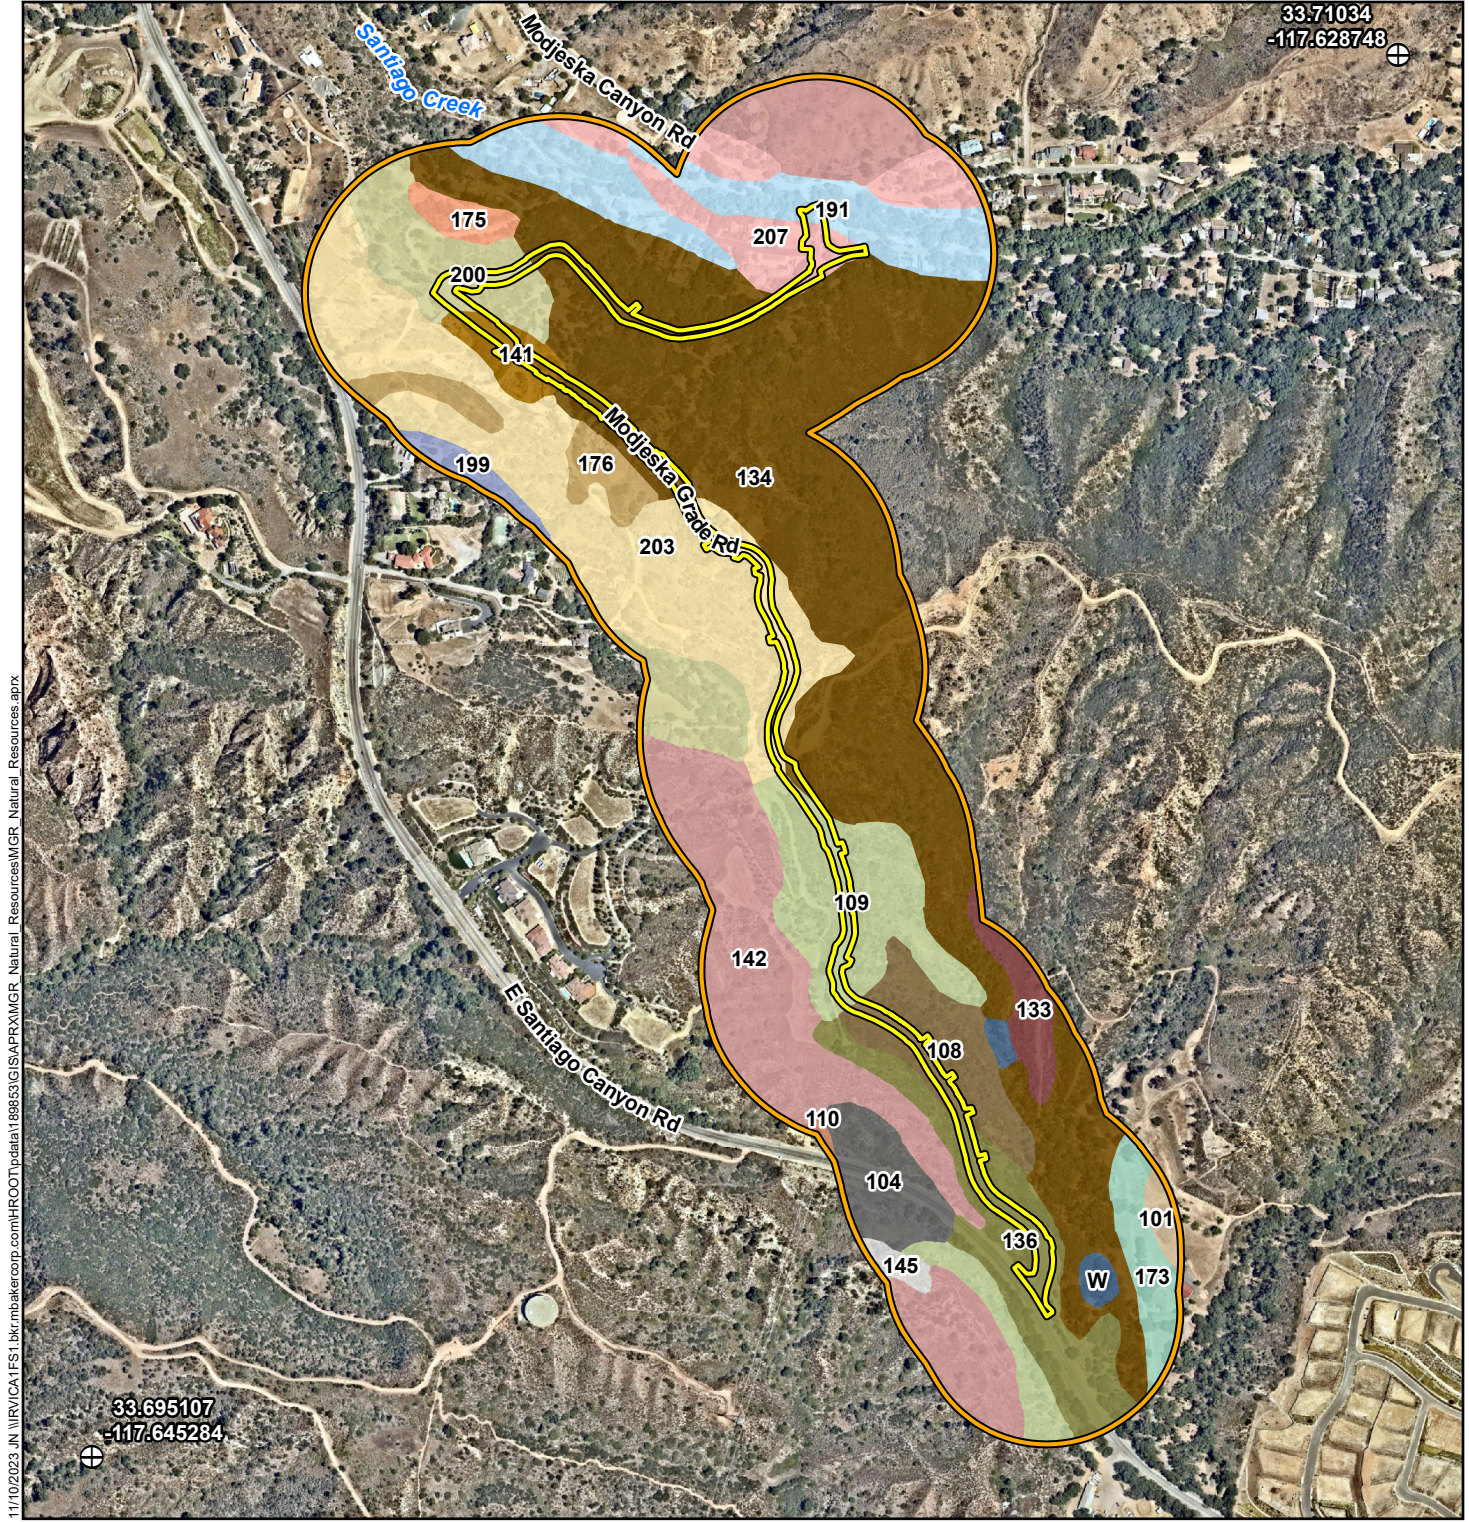
Legend			
	Project Site		101 Alo clay, 15 to 30 percent slopes, dry
	Survey Area (500-foot Buffer)		104 Alo variant clay, 15 to 30 percent slopes
	Reference Point		108 Anaheim clay loam, 15 to 30 percent slopes
			109 Anaheim clay loam, 30 to 50 percent slopes
			110 Anaheim clay loam, 50 to 75 percent slopes
			133 Botella clay loam, 9 to 15 percent slopes
			134 Calleguas clay loam, 50 to 75 percent slopes, eroded
			136 Capistrano sandy loam, 9 to 15 percent slopes
			141 Cieneba sandy loam, 15 to 30 percent slopes
			142 Cieneba sandy loam, 30 to 75 percent slopes, eroded
			145 Cieneba-Rock outcrop complex, 30 to 75 percent slopes
			173 Myford sandy loam, 15 to 30 percent slopes
			175 Myford sandy loam, 2 to 9 percent slopes
			176 Myford sandy loam, 9 to 15 percent slopes
			191 Riverwash
			203 Soper cobbly loam, 15 to 50 percent slopes
			199 Soper loam, 15 to 30 percent slopes
			200 Soper loam, 30 to 50 percent slopes

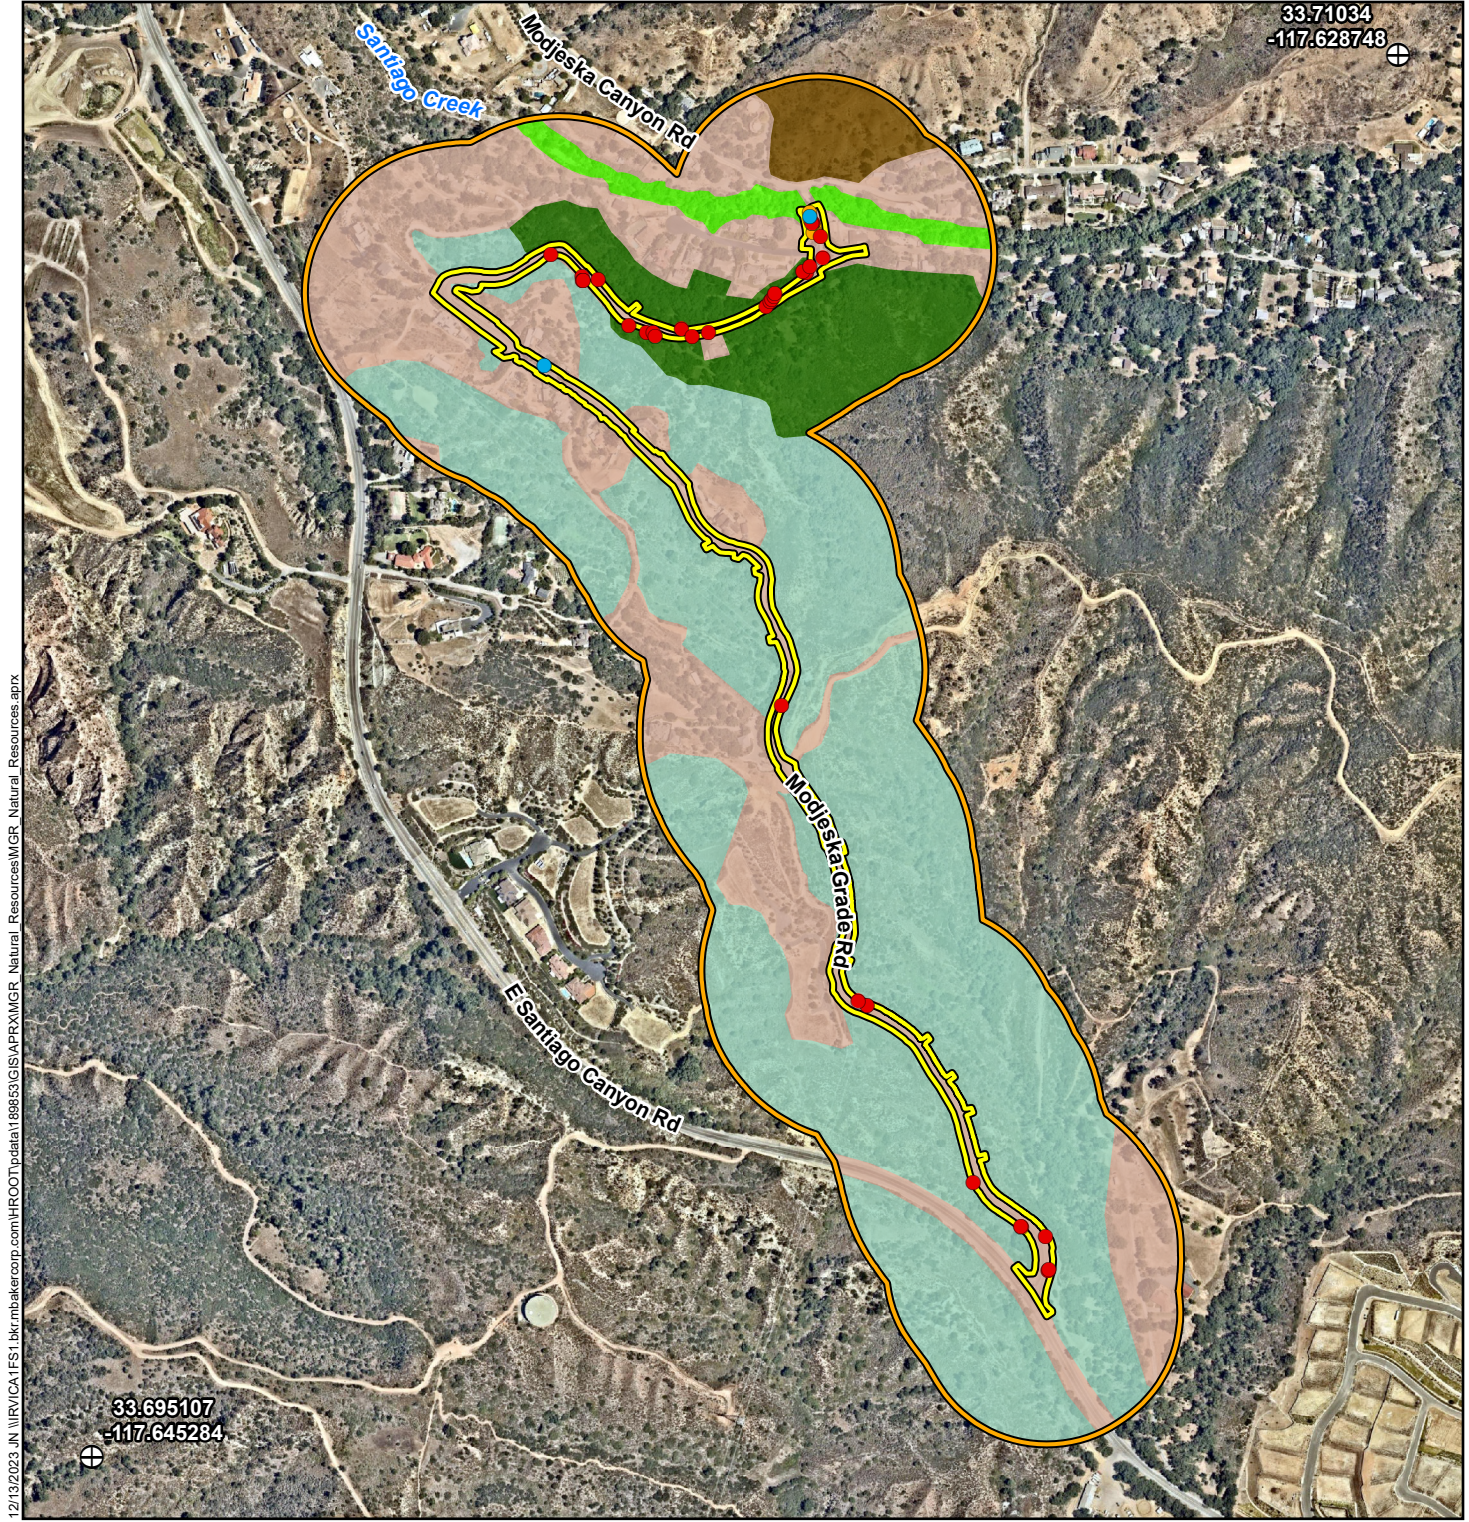
Legend			
	Project Site		California Sycamore - Coast Live Oak Riparian Woodlands (4.39 acres)
	Survey Area (500-foot Buffer)		Coast Live Oak Woodland and Forest (15.52 acres)
	Reference Point		Chamise-Sage Chaparral (93.01 acres)
			Disturbed Chamise-Sage Chaparral (4.73 acres)
			Disturbed/Developed (59.24 acres)
			California Sycamore
			Coast Live Oak
			Southern California Black Walnut

Five (5) vegetation communities and land cover types were identified on-site during the habitat assessment field surveys. Vegetation communities and land cover types mapped in the survey area are depicted on Figure 5, *Vegetation Communities and Other Land Uses*, and described in further detail below. Refer to Appendix B for a complete list of plant species that were observed within the survey area during the field survey. Refer to Table 2 below for a summary of vegetation communities and impacts within the project site:

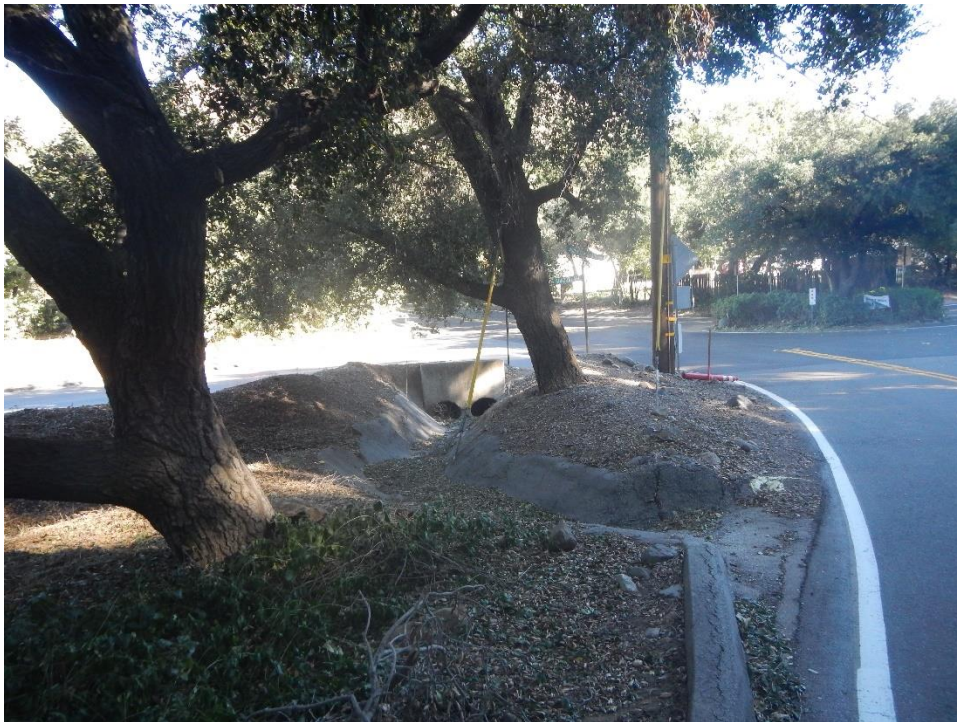
Photograph 6: Looking north towards Aquatic Feature 1 and some oak trees at the north end of the project site.

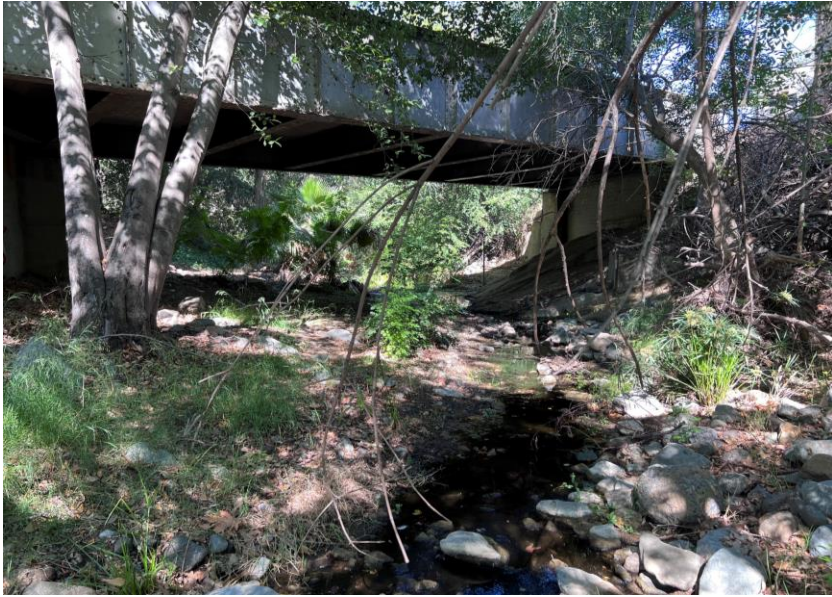
Photograph 1: View looking west at the Modjeska Grade Road Bridge spanning Santiago Creek. Latitude 33.708694°, Longitude -117.636086°.

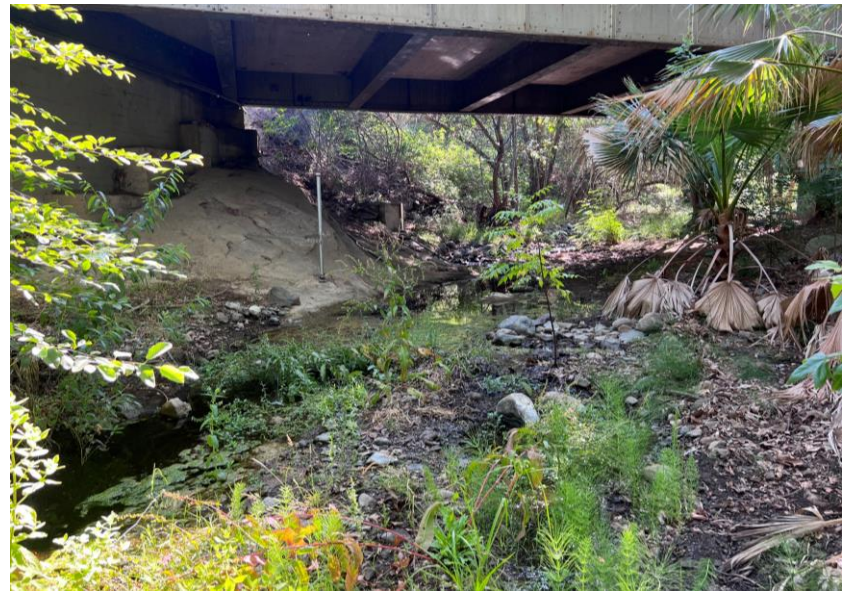
Photograph 2: View looking east at the Modjeska Grade Road Bridge spanning Santiago Creek. Latitude 33.708703°, Longitude -117.636444°.

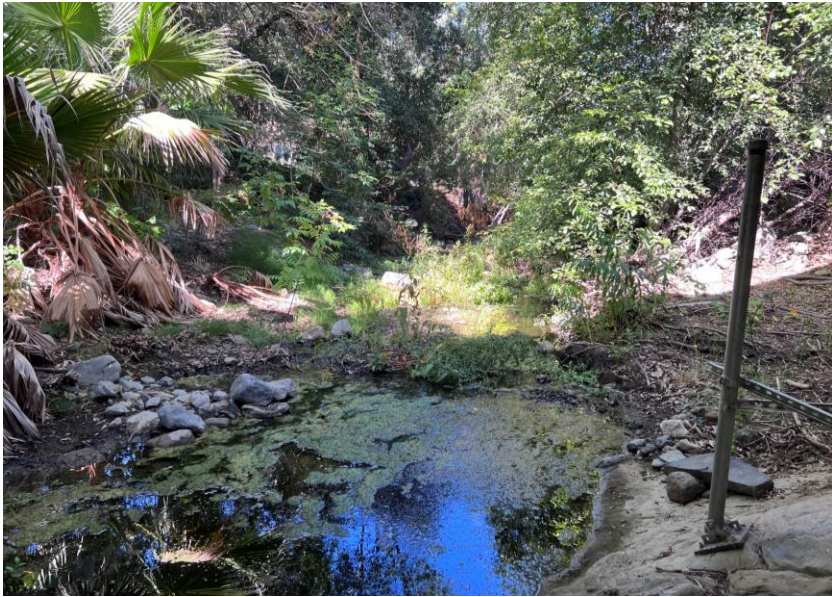
Photograph 3: View looking west at Santiago Creek underneath Modjeska Grade Road Bridge. Latitude 33.708747°, Longitude -117.636344°.

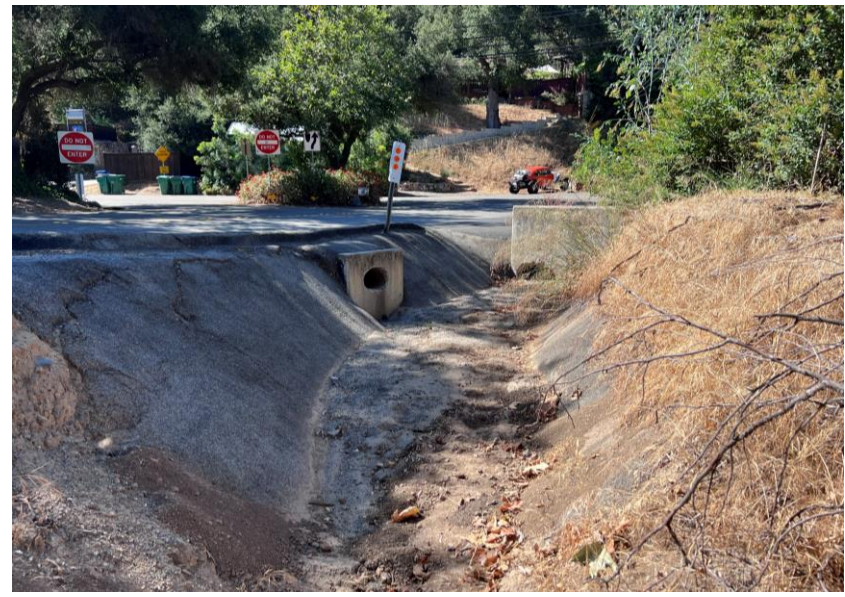
Photograph 6: View looking south at AF-1 towards Santiago Creek. Latitude 33.708478°, longitude -117.636361°.

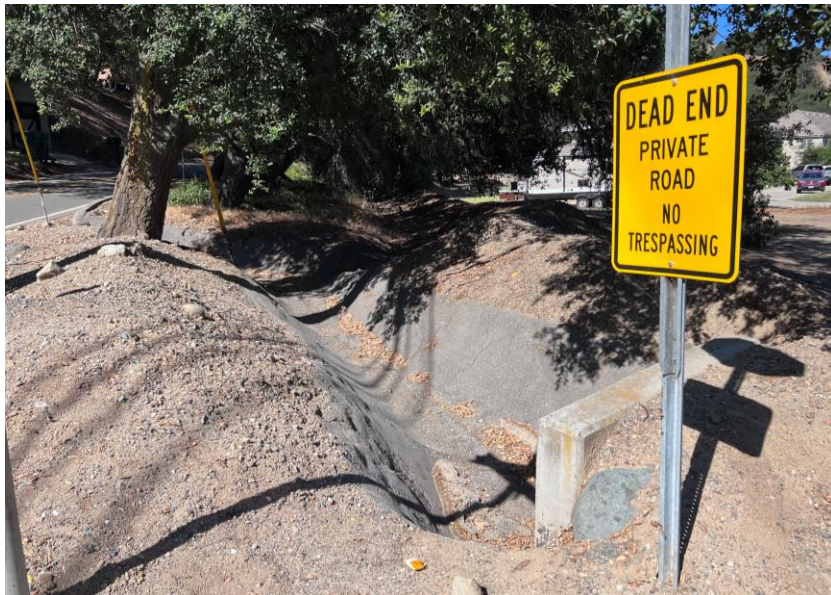
Photograph 7: View looking southwest at AF-1 before it undergrounds at Shadowland Circle. Latitude 33.708122°, longitude -117.636183°

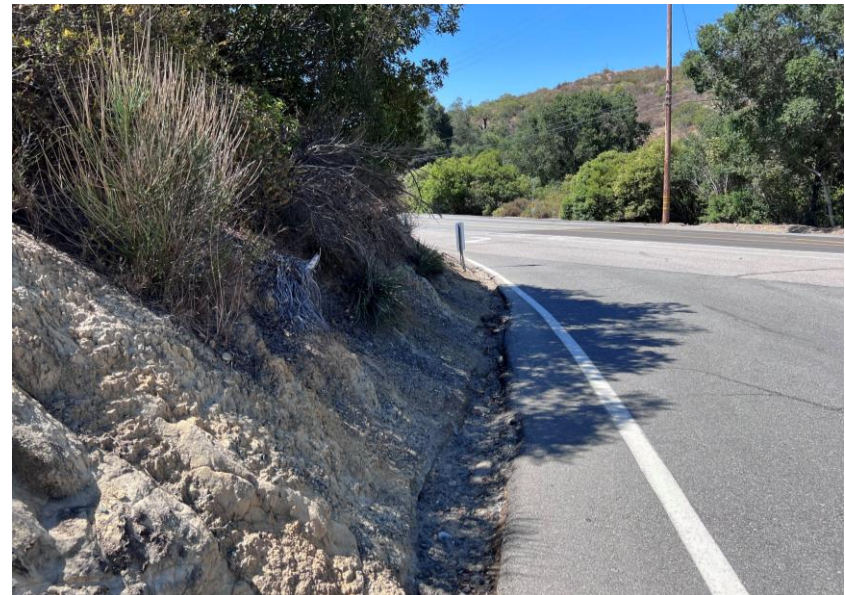
Photograph 8: View looking south at a non-jurisdictional erosional feature located within the southern portion of the project site. Latitude 33.697072°, Longitude -117.633111°.
