THE RANCH PLAN PLANNED COMMUNITY
PLANNING AREAS 3 AND 4 RUNOFF MANAGEMENT PLAN

TECHNICAL APPENDIX L

Amendment to Stream Monitoring Program

The Ranch Plan Planned Community Planning Areas 3 and 4 Runoff Management Plan Stream Monitoring Program

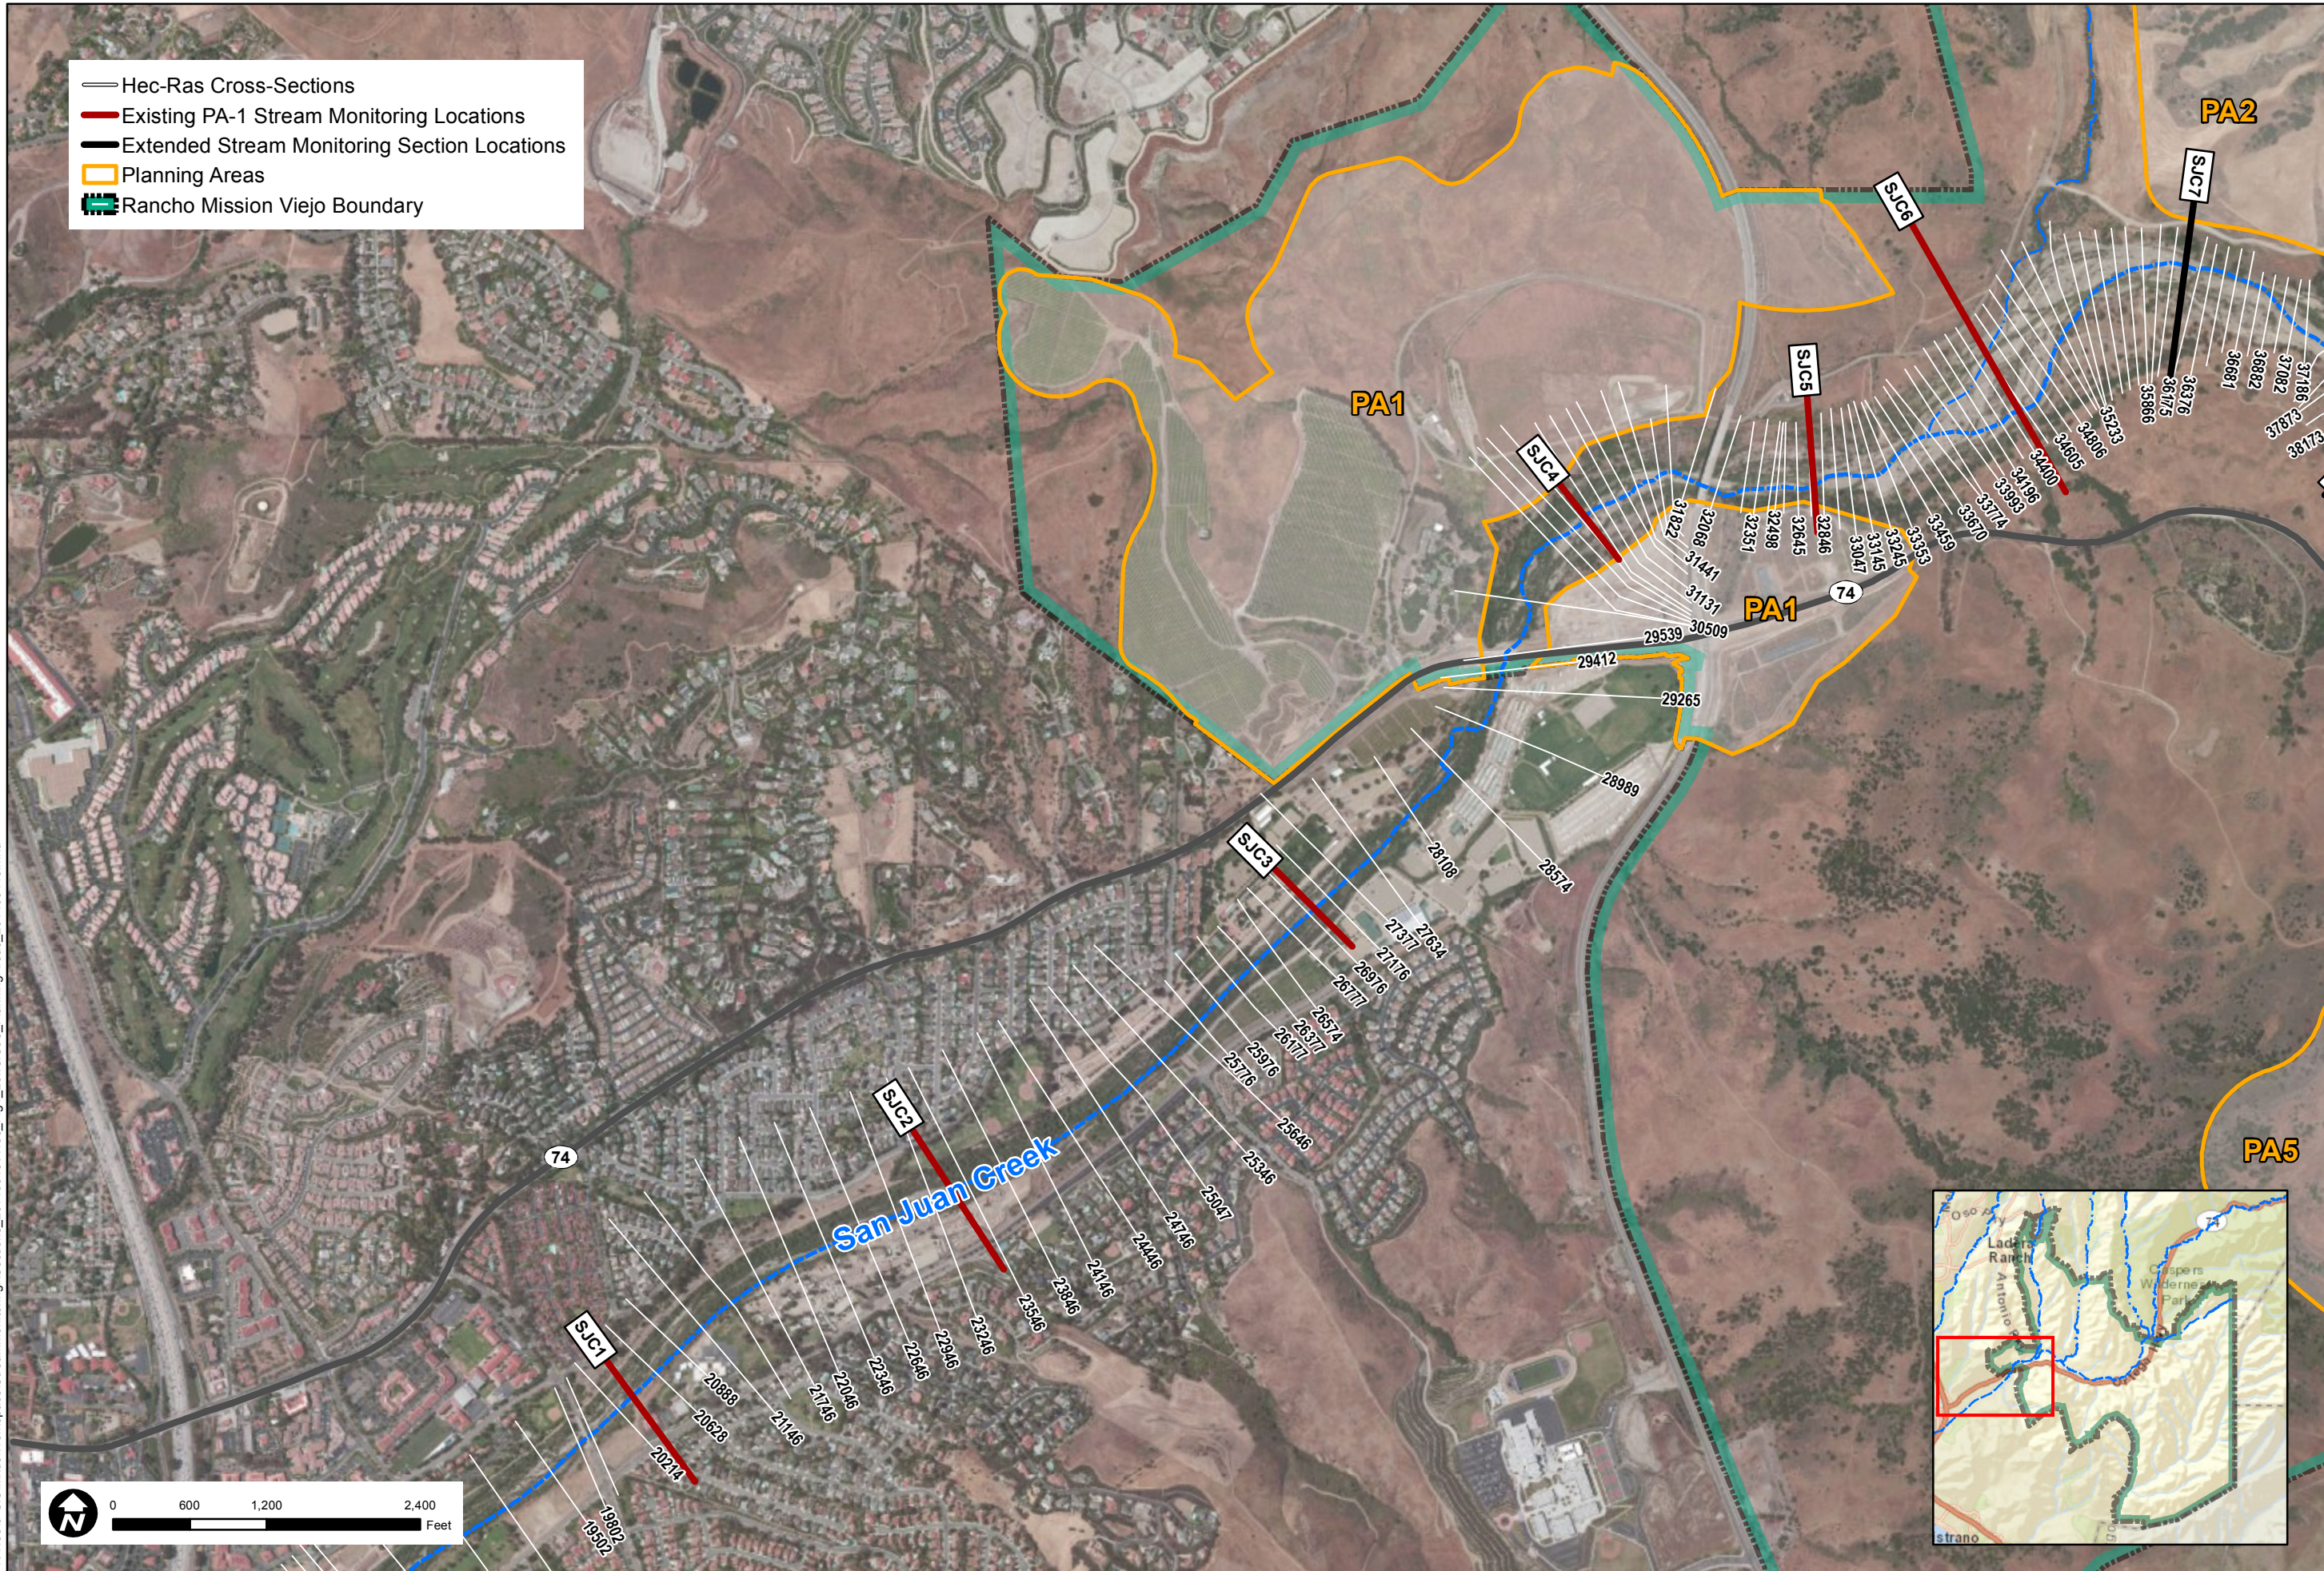
- Hec-Ras Cross-Sections
- Existing PA-1 Stream Monitoring Locations
- Extended Stream Monitoring Section Locations
- Planning Areas
- Rancho Mission Viejo Boundary

A total of six (6) new cross-sections are recommended along San Juan Creek for the implementation of the monitoring program upstream of the PA-1 monitoring limits which will encompass PA-2 through PA-5. The proposed cross-sections are illustrated in Exhibits 1 through 6. Note that these additional 6 cross sections are all located upstream of cross section No. 6 from the PA-1 Monitoring Program (also included in Exhibits 1 through 6 for completeness). In all cases, the cross-sections lie perpendicular to the direction of flow and can be considered to be representative of a particular reach of the channel based on the hydraulic and geologic properties. Similarly, a total of four (4) cross sections are recommended for implementation in Canada Chiquita along that portion of the channel extending from its confluence with San Juan Creek and PA-2 northwestern boundary. Finally, a total of four (4) cross sections are proposed for implementation along Gobernadora Creek, between its confluence with San Juan Creek and the proposed location of the Multipurpose Gobernadora Basin.
