THE RANCH PLAN PLANNED COMMUNITY
PLANNING AREAS 3 AND 4 RUNOFF MANAGEMENT PLAN

TECHNICAL APPENDIX O.1

ARM Study Memorandum for More Frequent Storm Events

DATE: February 20, 2018
TO: Khalid Bazmi, P.E., Assistant Director/County Engineer, OC Public Works
FROM: Robert McLean, P.E., Senior Civil Engineer, Infrastructure Programs
SUBJECT: RMV – Summary of ARM Study results and findings related to FEIR 589 MM 4.5-1 (G).

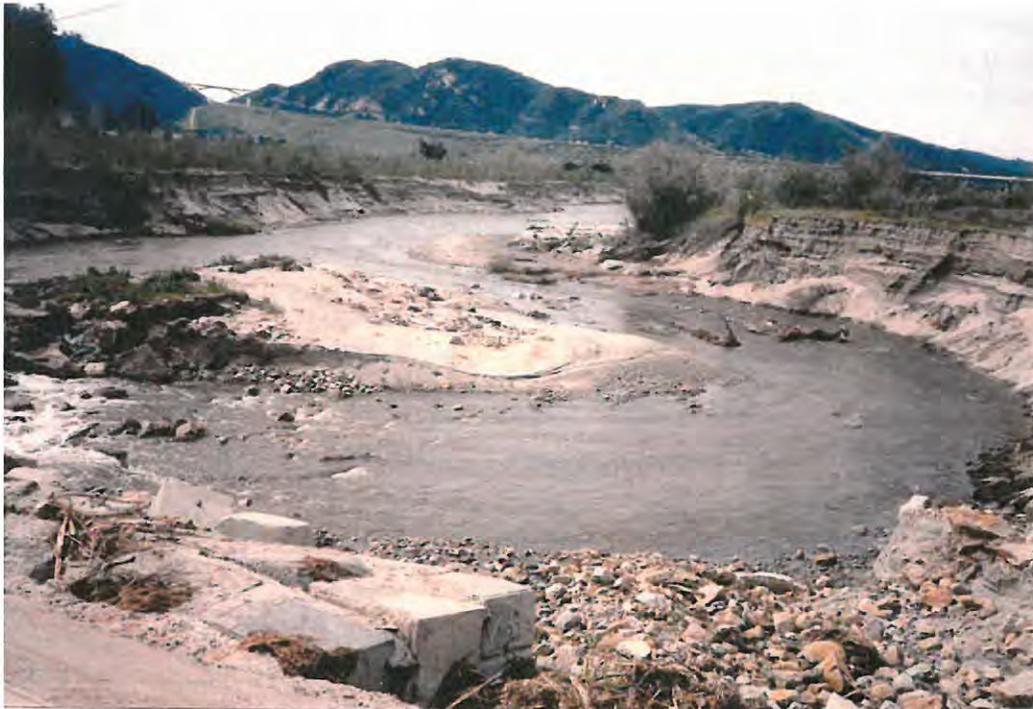
Figure 3. San Luis Rey River downstream of check dam at Shearer Crossing near Escondido, California. Channel responses to sediment deficit include degradation, development of more sinuous course, and coarsening of bed material

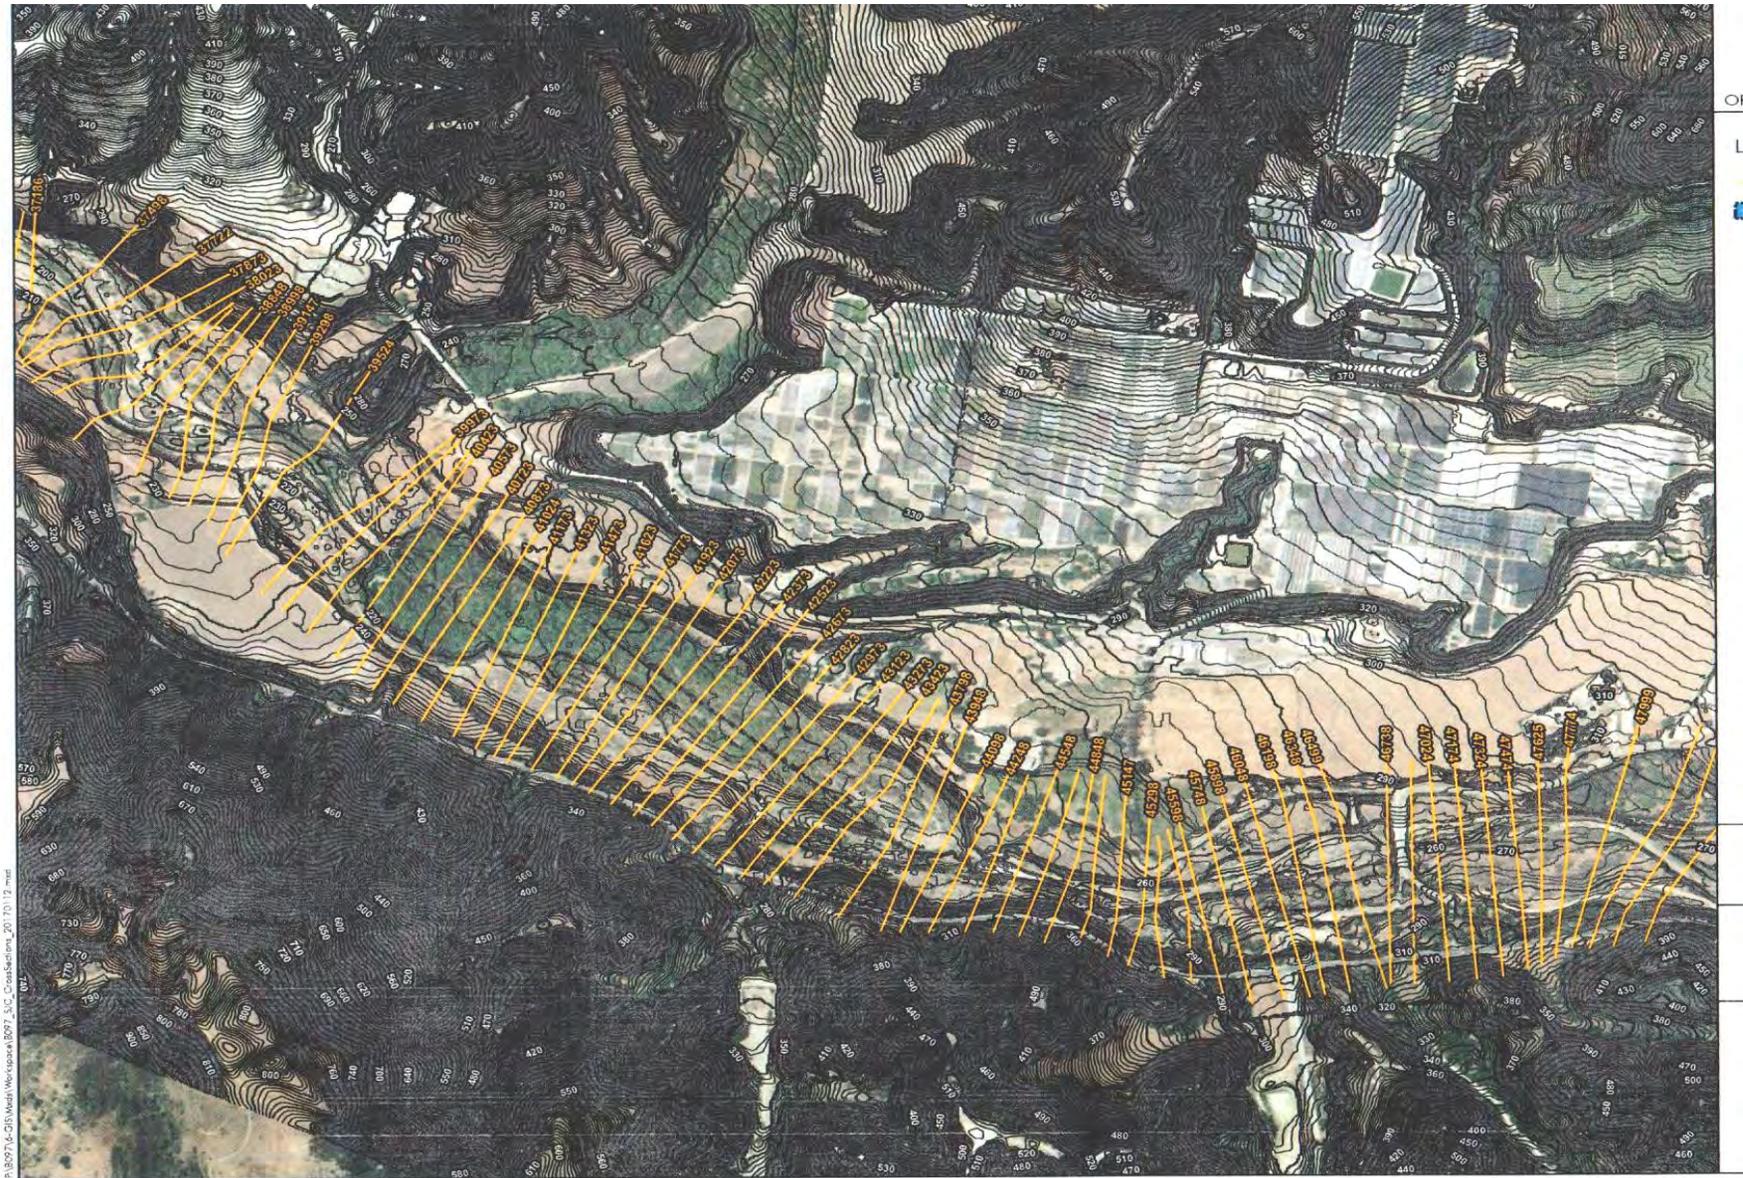
Figure 1(continued). Map of San Juan Creek with channel cross sections

growth and decay. In view of this morphological feature, it is useful to show the sinuous pattern by showing the thalweg in the stream channels. The sinuous pattern of the thalweg is useful to assess the effectiveness of the monitoring station. Those monitoring stations located near the apex of a sinuous curve provide the stream bank location vulnerable to stream bank erosion.

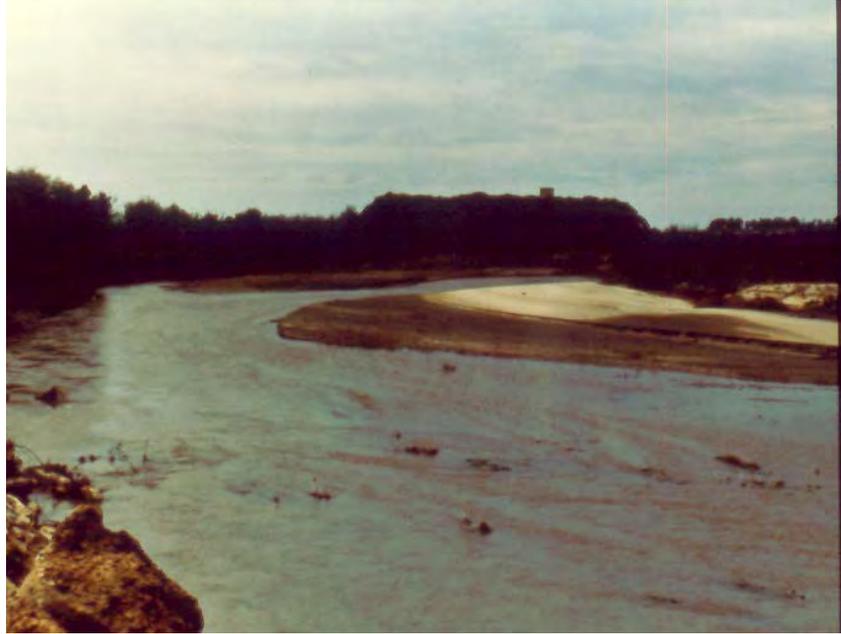
Figure 5. Sand bar formation along a curved channel

Sediment transport, in the presence of transverse flow, has a component in that direction. Sediment movement in the transverse direction contributes to the formation of transverse bed profile as exemplified by a sand bar formation along a river bend shown in Figure 5. In an unsteady flow, the transverse bed profile varies with time and is constantly adjusted toward equilibrium through scour and deposition.

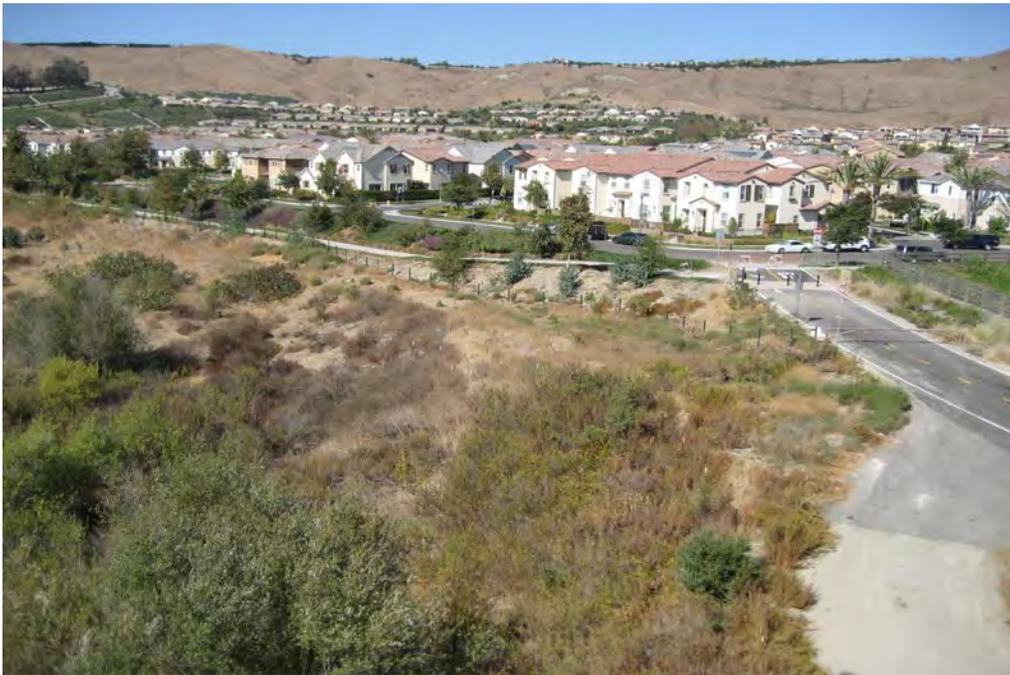
Figure 36. View of San Juan Creek toward downstream from Antonio Parkway Bridge

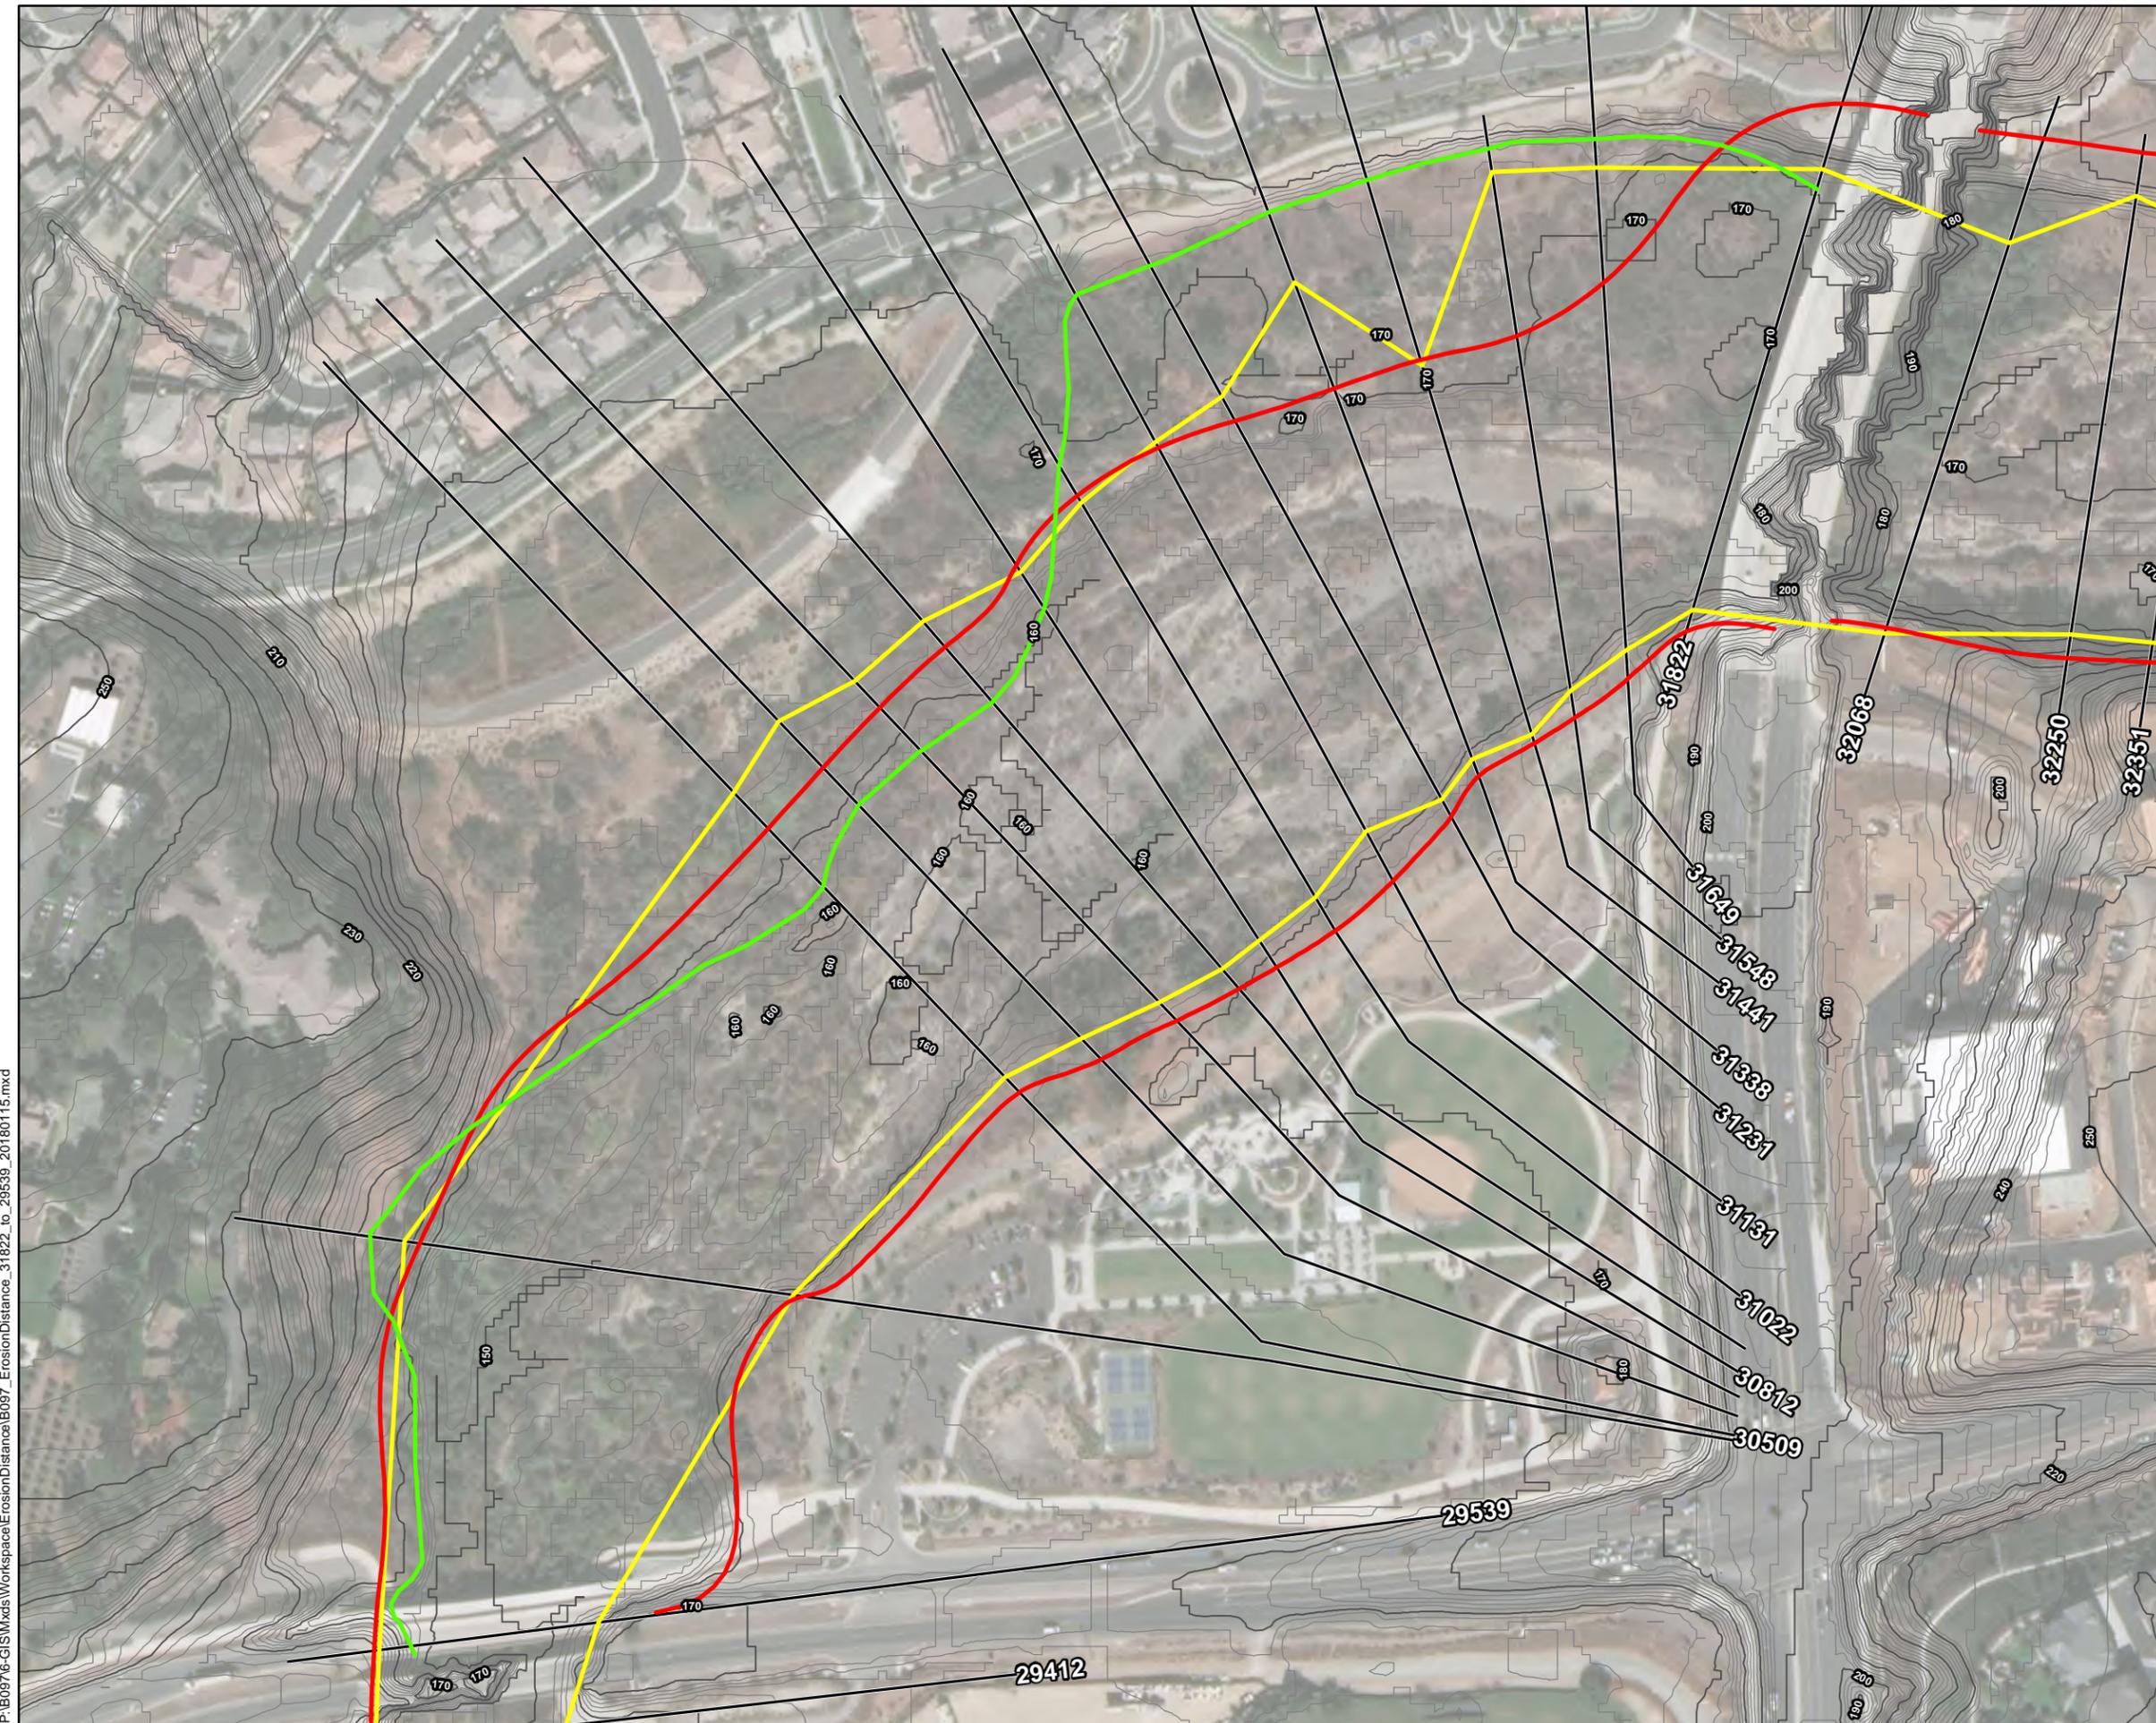
Figure No. 2
**COMPARISON OF
LONG TERM LATERAL
EROSION ESTIMATES
PA1 DEVELOPMENT AREA**

The results of this revised lateral erosion for the PA1 area are summarized on *Figure No. 2 – Comparison of Long Term Lateral Erosion Estimates PA1 Development Area* which compares the different analyses by PACE and Dr. Chang. The figure only illustrates the portion of the PA1 area where there was difference identified or additional erosion from the peer review modeling. The remainder of the erosion boundaries in the PA1/ PA2 area are adequate. The figure illustrates that **the revised PACE analysis generates lateral erosion distances that exceed the Dr. Chang model estimates, but does not extend into the development area** since the development was actually setback further using the floodplain limits. The detailed calculations that were performed for each individual cross section are provided in the *Technical Appendix*. Although improvements continue to be outside of the conservative limits of the erosion setback line, the County should continue to require evaluation and survey of the special monitoring monuments for this area. Site-specific erosion monitoring program and mitigation program was developed to specifically address lateral migration along a large river meander bend in this area. The monitoring composed of several different monitoring features/processes which also serve to identify level of risk. The results of the active monitoring program would potentially trigger different levels of corrective/preventative erosion mitigation measures depending on the severity of the measured erosion. This involves using three monuments which are four-inch buried steel pipes filled with concrete differentiated by either a (1) green – closest monument to the bank, (2) yellow – intermediate monument to bank and development, or (3) red – monument closest to the development edge. Each of the monuments have the colored metal tag identifier. The horizontal distance from the closest remaining monument to the active streambank edge is measured after each rainfall event of significance. The severity of lateral erosion associated with a storm event would be defined by the location of the erosion relative to the type of monument (green, yellow, or red). This specialized monitoring effort for this area provides an additional layer of safety to ensure the long protection of the development.

2. The lateral erosion limit near the PA1 development did change with the more detailed modeling procedure and the revised limits are shown for comparison on *Figure No.2*. This figure illustrates that **the revised PACE analysis generates lateral erosion distances that exceed the Dr. Chang model estimates, but does not extend into the development area** since the development was actually setback further using the floodplain limits. However, in this area a site-specific erosion monitoring program and mitigation program was developed to specifically address lateral migration along a large river meander bend. The monitoring composed of several different monitoring features/processes which also serve to identify level of risk. This specialized monitoring effort for this area provides an additional layer of safety to ensure the long protection of the development.
