Appendix G

HAZARDOUS MATERIALS ASSESSMENT

SITE ASSESSMENT REPORT SECTIONS 13 AND 19 T35 R8W AMOS TRAVIS AND REEVES-CARILLO LEASES ESPERANZA FIELD YORBA LINDA, CALIFORNIA

YORBA LINDA TRAVIS PROJECT APNS 351-031-04, -05, AND -17 YORBA LINDA, CALIFORNIA

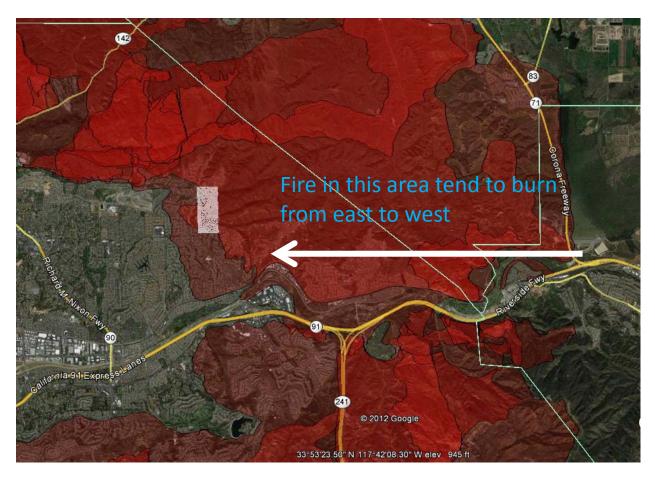
Fire Travel within the Historic Fire Corridors

Historical fire corridors exist to the north and south of the project site. The large majority of the fires with in the area in the CalFire database have burned from the east to the west under high wind conditions and normally in the fall. The graphic on the next page shows some of these fires and the ultimate fire perimeters when they were finally contained.

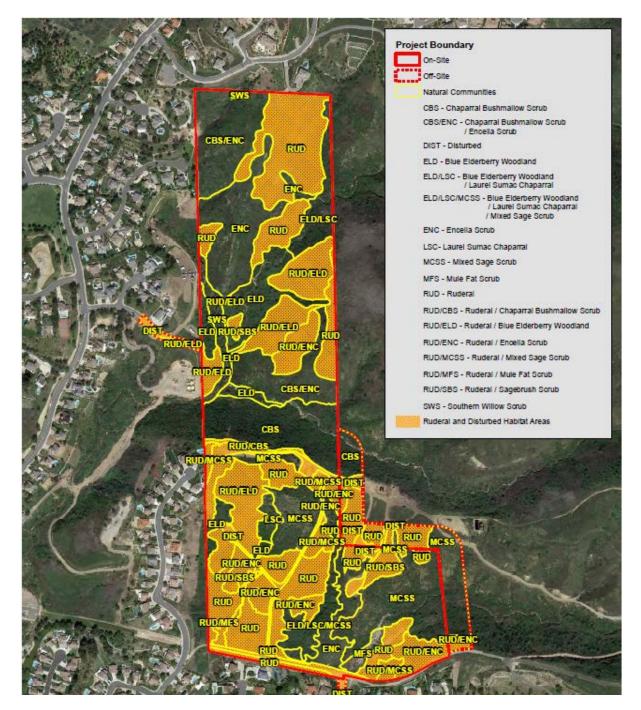
The map below shows the site overlaid on an aerial photo. Plant communities are shown in the legend. A larger copy is provided in the Appendix A

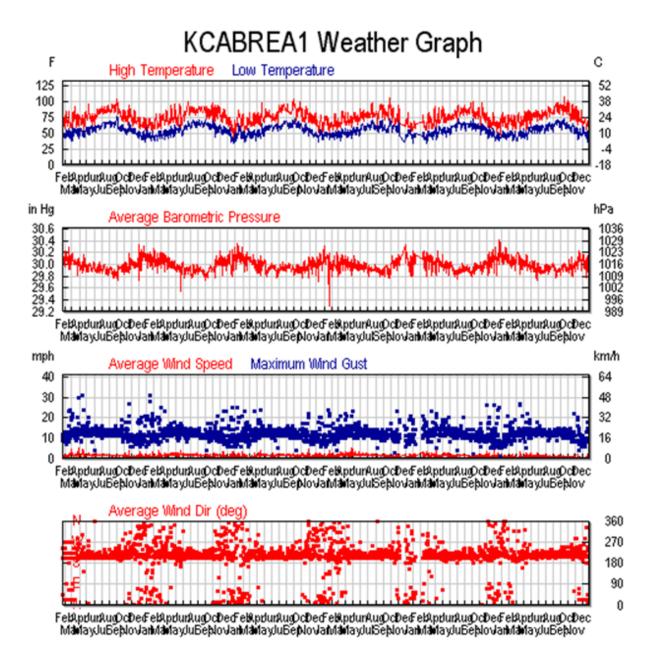
The graph above clearly shows the predominate wind direction is from the south to southwest. Storm come in from the northwest and the occasionally Santa Ana Wind event brings a east or northeast wind. The strongest wind gust measured 31 mph at this site.

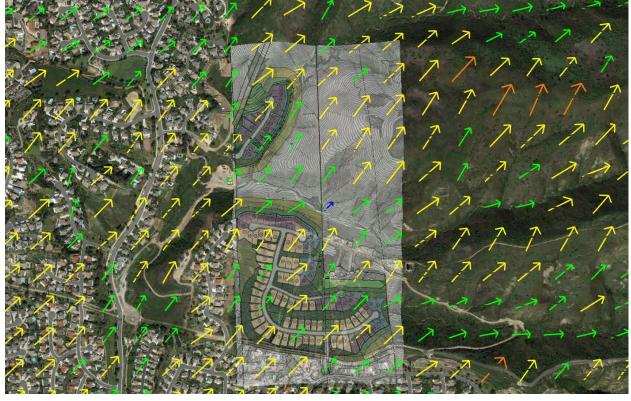
Southwest Wind

Using the Wind Ninja software, the wind and the relationship to the topography has been determined to NOT be a factor with this development. Limited wind channeling is achieved on any wind pattern at the project site. The changes in topography at the project site are simply too minor to overcome the wind in any scenario. The predominate wind (from the southwest) intersection the project boundaries from developed areas where no significant wildland fuel bed exist as shown below.

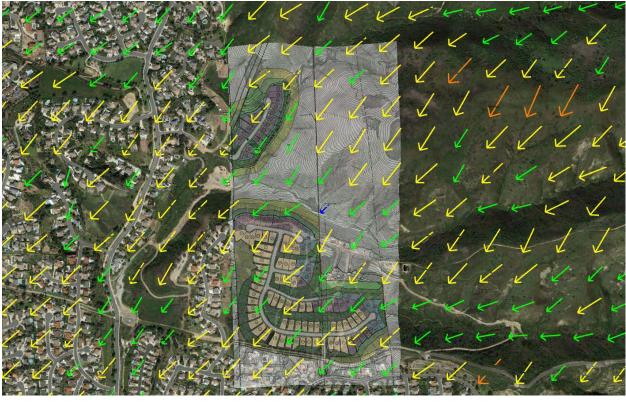
Northeast Wind

The graphics on the next page show a northeast wind (top) and an east wind (bottom). More wind channeling occurs with the NE wind than the E wind as the E wind runs parallel with the canyons thereby creating very little resistance to change the direction. Some ridgeline acceleration (orange arrows) occurs away from the development site and above the project site elevation. Some minor wind sheltering (green and blue arrows) occurs in the deeper drainages between the two development sites. Yellow arrows are average wind speed and the modeling showed no extreme acceleration (red arrows) near the project site.

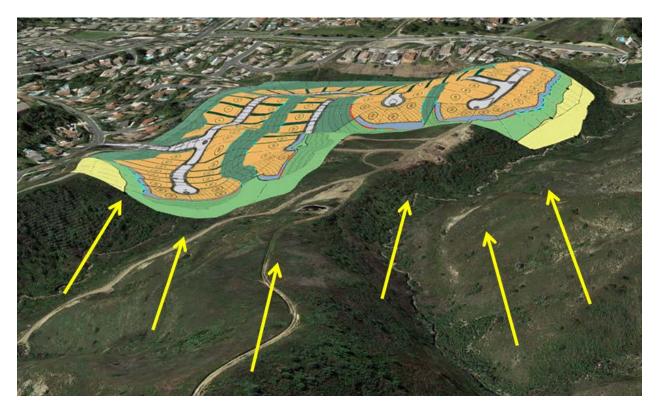
Wind from the east will travel down the two canyons east of the project site as shown above. Any fire within these canyons will be influenced by the wind and by the topography of the canyon. Once again the difference in fuel load on the north and south aspects is clearly visible and it should also be noted that the slope of the northern aspects is also significantly greater.

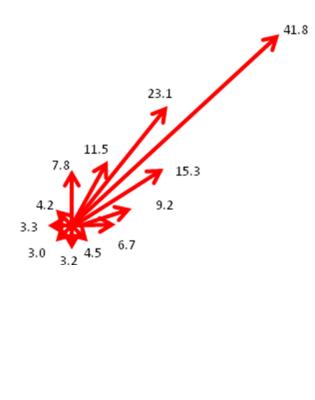
The Behave outputs are attached in the appendixes but have been summarized here for discussion purposes. The fire that has been modeled here is a fast running wind driven fire that burns in an elliptical pattern shown below by the red arrows. To the right are the calculated flame lengths for each of the directions of spread for the worst case scenarios modeled. We find that a maximum flame length for SCAL18 of 41.8 feet is possible at the head of the fire, when the fire is running across the slope with a continuous fuel bed that is consistent enough to produce a self-sustaining, self propagating fire. It is important to note that flames only 15 degrees out of the perfect alignment of all the factors are about one-half the size if the flaming point of the fire. Another 15 degrees drops the flame lengths to less than 1/3 of the flaming point. Fire to the flanks and backing fire are small enough to extinguished using hand tools.

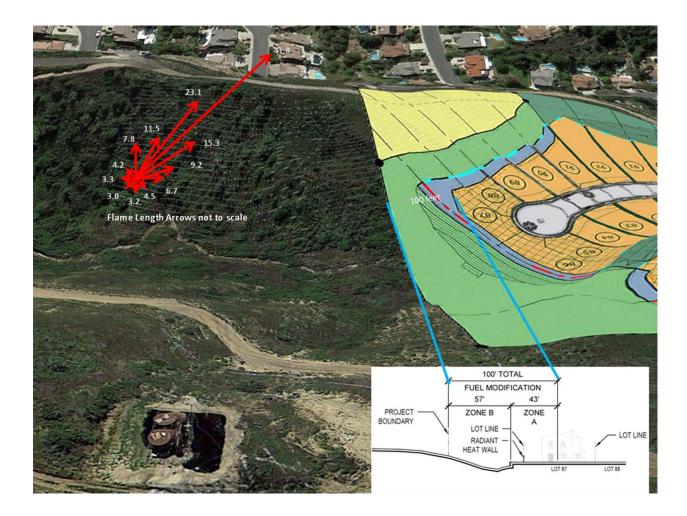
The fire behavior relative to the topography and structures within the project is an important factor in the development of the fire protection system for this development. Shown below, the north aspect due east of the southerly portion of the project site has significant fuels but is not in a location that will create an expose to the project site. The red arrows (not to scale) show that an east wind carrying fire down this canyon would be influenced by the slope and fuel to have the largest flame length be upslope away from the project site structures. Flames coming at the project site would be significantly less. The vegetation in the bottom of the canyon and on the south aspect, simply do not have enough fuel to produce the large flame lengths of the north aspect. The largest flame length impacting the fuel modification zone would be less than 25 feet and well within the 2:1 ratio needed for protecting the structures. In fact, the ration would be more in line with the 4:1 ratio required for a "safety zone" where personnel and equipment would be safe without the use of radiant heat shelters.

While the modeling indicates that flame lengths of just under 50 feet are possible under perfect conditions, this is unlikely due to predominate winds that drive wildland fires and arrangment of the slopes and fuel relative to the structures. The fuels are not aligned with the slope and wind and fuels are not continueous enough to drive fire behavior to the level of the equilibrium spread rates used in the modeling in most of the areas adjacent to the fuel modification zones. Flanking fire of six to eight feet maximum is expected at the property line of the lots within the development or at the base of the fuel modification zones or radiant heat walls. In all areas, the 2:1 safety ratio is achieved and in most areas the ratio is 4:1 or more.

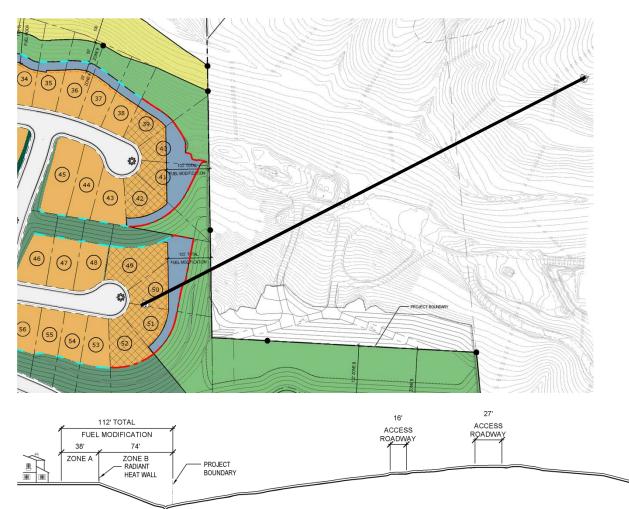
Two areas within the project site will not be capable of providing a typical 170 foot fuel modification zone. These areas would be protected in an equal but alternative method by increasing the irrigated zone(s) to 100 feet and providing a six foot high radiant heat wall at the bottom of the fuel modification zone (indicated by dotted red line).

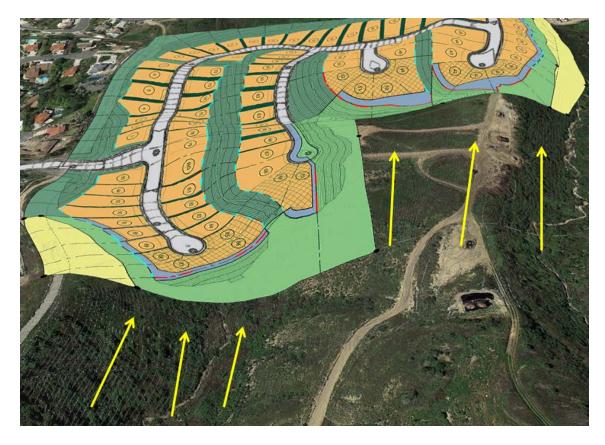
The radiant heat walls are perpendicular to the wind but parallel with the slope. This is shown on the graphic on the following page where the radiant heat wall locations are in red and the east wind shown in yellow. The radiant heat walls are at the property line and will be constructed on what is essentially the native slope that is shown in the graphic.

As indicated in the defensible space design, a block wall/radiant heat wall will be constructed when a fuel modification zone is not possible without offsite improvements. In all cases, the wall has been placed where the fuels below the structure is not of a continuous nature, not in alignment with the slope and Santa Ana winds or the predominate wind (S). In most cases, the radiant heat wall is at the base of the irrigated zone and down slope from the native vegetation

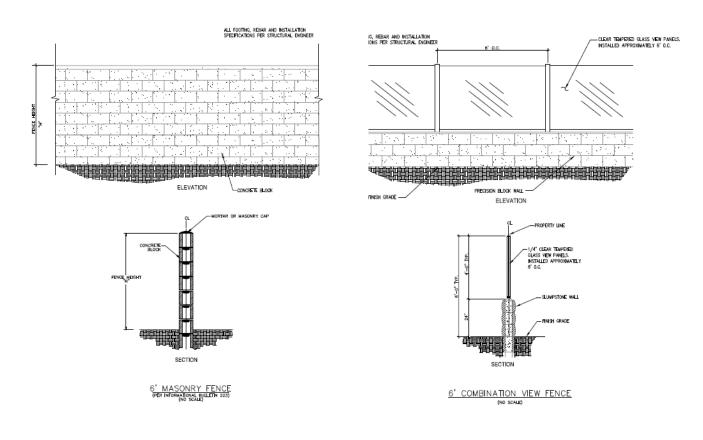
These walls will be either block or tempered glass over block similar to those shown below.

These types of walls are extremely effective when used at the top of the slope in light to moderate fuels. The extreme fire behavior that can be produced by high winds also bends the fire over making it travel more parallel to the ground. The harder the wind, the more the flame angle will be and the more effective the radiant heat wall will become.

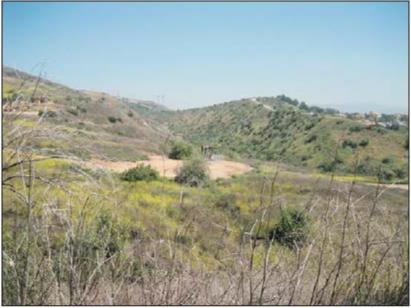
Photograph 5: Easterly view of existing on-site oil well located within central portion of Planning Area 1.

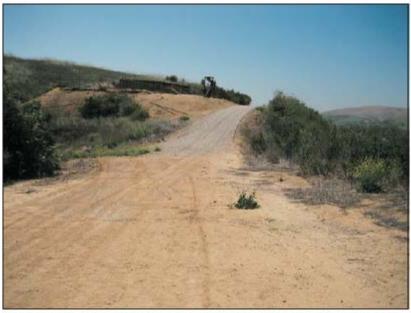
Photograph 6: Westerly view of existing on-site oil well located within northern portion of Planning Area 1.
