Appendix E –
Jurisdictional Delineation for Esperanza Hills Specific Plan Area
Prepared by Glen Lukos Associates, Inc. dated March 18, 2013
(revised May 9, 2013 and July 15, 2013)

March 18, 2013 [Revised May 9, 2013] [Revised July 15, 2013]

SUBJECT: Jurisdictional Delineation for Esperanza Hills Specific Plan Area,
Unincorporated Orange County, California.

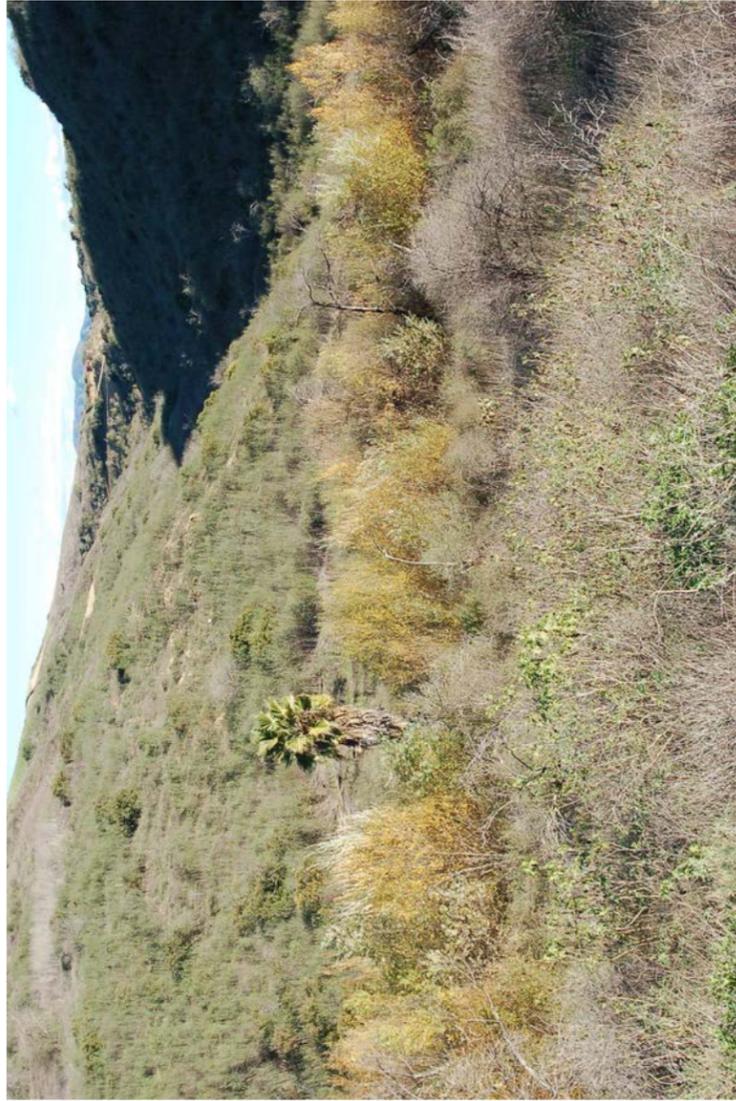
Photograph 3: View of Drainage D, immediately below confluence with Drainage G, offsite.

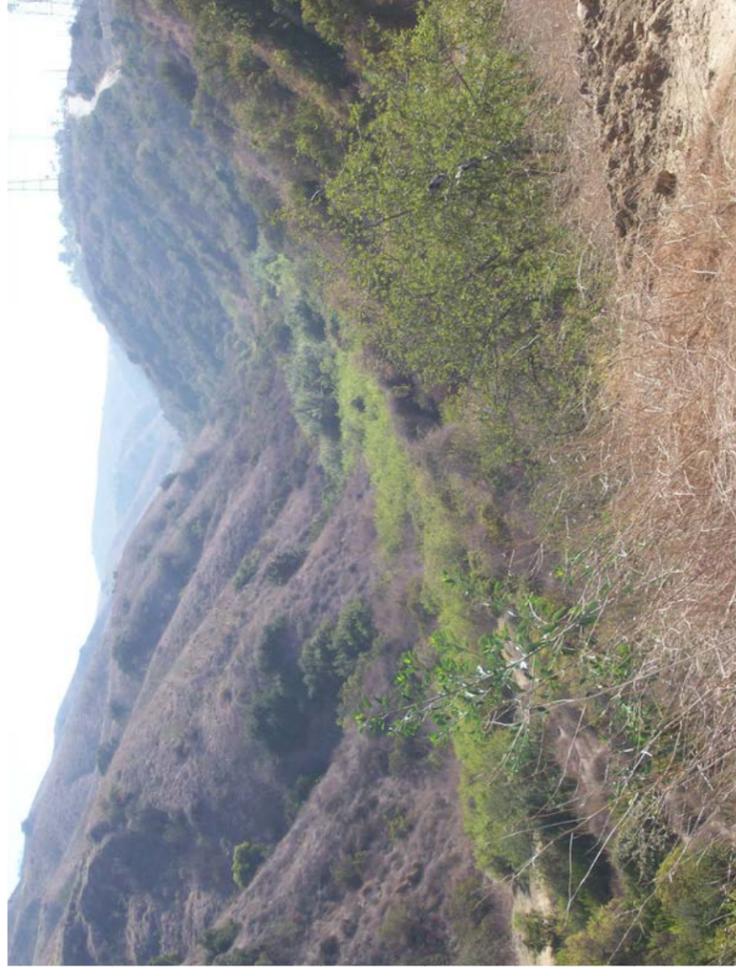
Photograph 4: View of Blue Mud Canyon Drainage looking east before Freeway Complex Fire.
