**Preliminary Geotechnical Investigation Report for Entitlement/EIR,
Proposed Legacy Club,
California Grand Villages,
Coto de Caza, County of Orange, California**

**Prepared For
CGV Coto, LLC.**

January 7, 2020

GMU Project No. 18-213-00

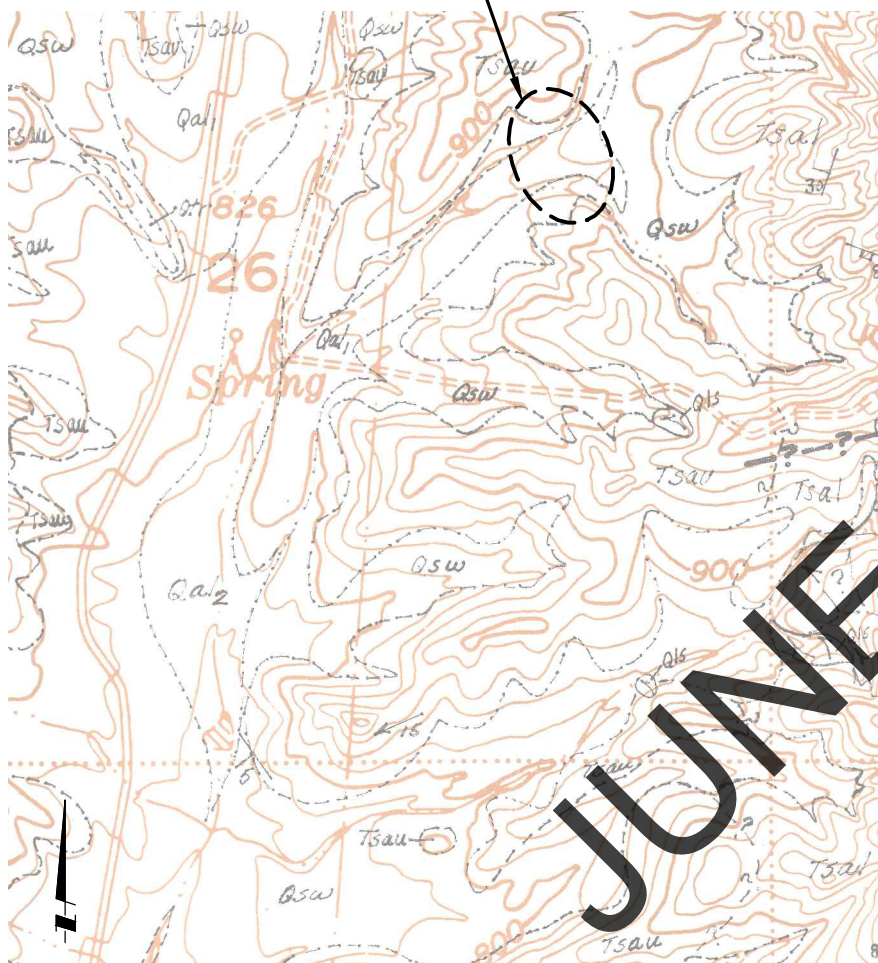
NW 1/4 Canada Gobernadora Quadrangle

- Qal** ALLUVIUM
- Qsw** SLOPEWASH
- Tsau** SANTIAGO FORMATION, UPPER MEMBER

within the upper portion of a tributary canyon which feeds into Gobernadora Canyon which ultimately drains south to the San Juan Creek watershed; see Plate 4 – Regional Geologic Maps.

Regional geologic structure near the site is characterized by a mostly homoclinal sequence of moderately dipping strata in a generally westerly direction. The Santiago Formation is mostly massive, with localized and poorly defined bedding planes. Because the bedding is most often poorly defined, non-fissile, and discontinuous, slope stability is generally good as compared to other Tertiary sedimentary formations in the area. A regional geologic map showing the site location is included on the attached Plate 4 – Regional Geology.
