5.5 Geology and Soils

This section analyzes the geology, soils, and seismicity of the Project Site, identifies the on-site soil conditions that have the potential to impact the Proposed Project and recommends mitigation measures to reduce the significance of such impacts to an acceptable level. This section summarizes the findings of the “Geotechnical Review of Conceptual Design Plans”(Geotechnical Review) prepared by American Geotechnical, Inc. dated August 2013 (Appendix G) and on the “Fault Hazard Assessment Report” (Fault Hazard Report) prepared by American Geotechnical, Inc. dated November 2012 (Appendix G) and approved by the County of Orange in March 2013, and the “Phase I Environmental Site Assessment Report” (Phase I ESA) prepared by American Geotechnical dated July 2012 (Appendix I).

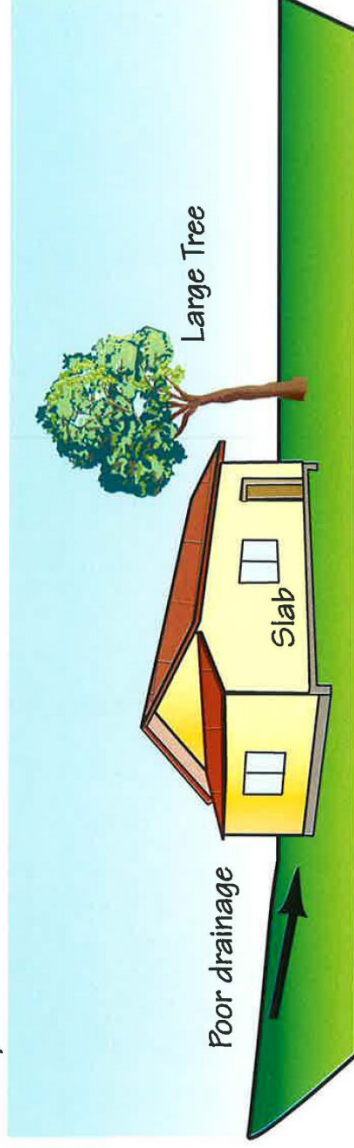
Exhibit 5-62 – Potential Expansive Soil Impacts

Potential Expansive Soil Impacts

a) NEWLY CONSTRUCTED

b) EXPANSIVE SOIL MOVEMENT

Expansive soil materials typically occur as part of engineered fill mixture derived from areas of bedrock cut. Impacts associated with expansive clay soil and heaving bedrock related to the adverse effects these materials can have on the structural integrity of foundations and other improvements.
