**Appendix G –
Geotechnical Report
Prepared by American Geotechnical, Inc. dated August 2013**

EXECUTIVE SUMMARY

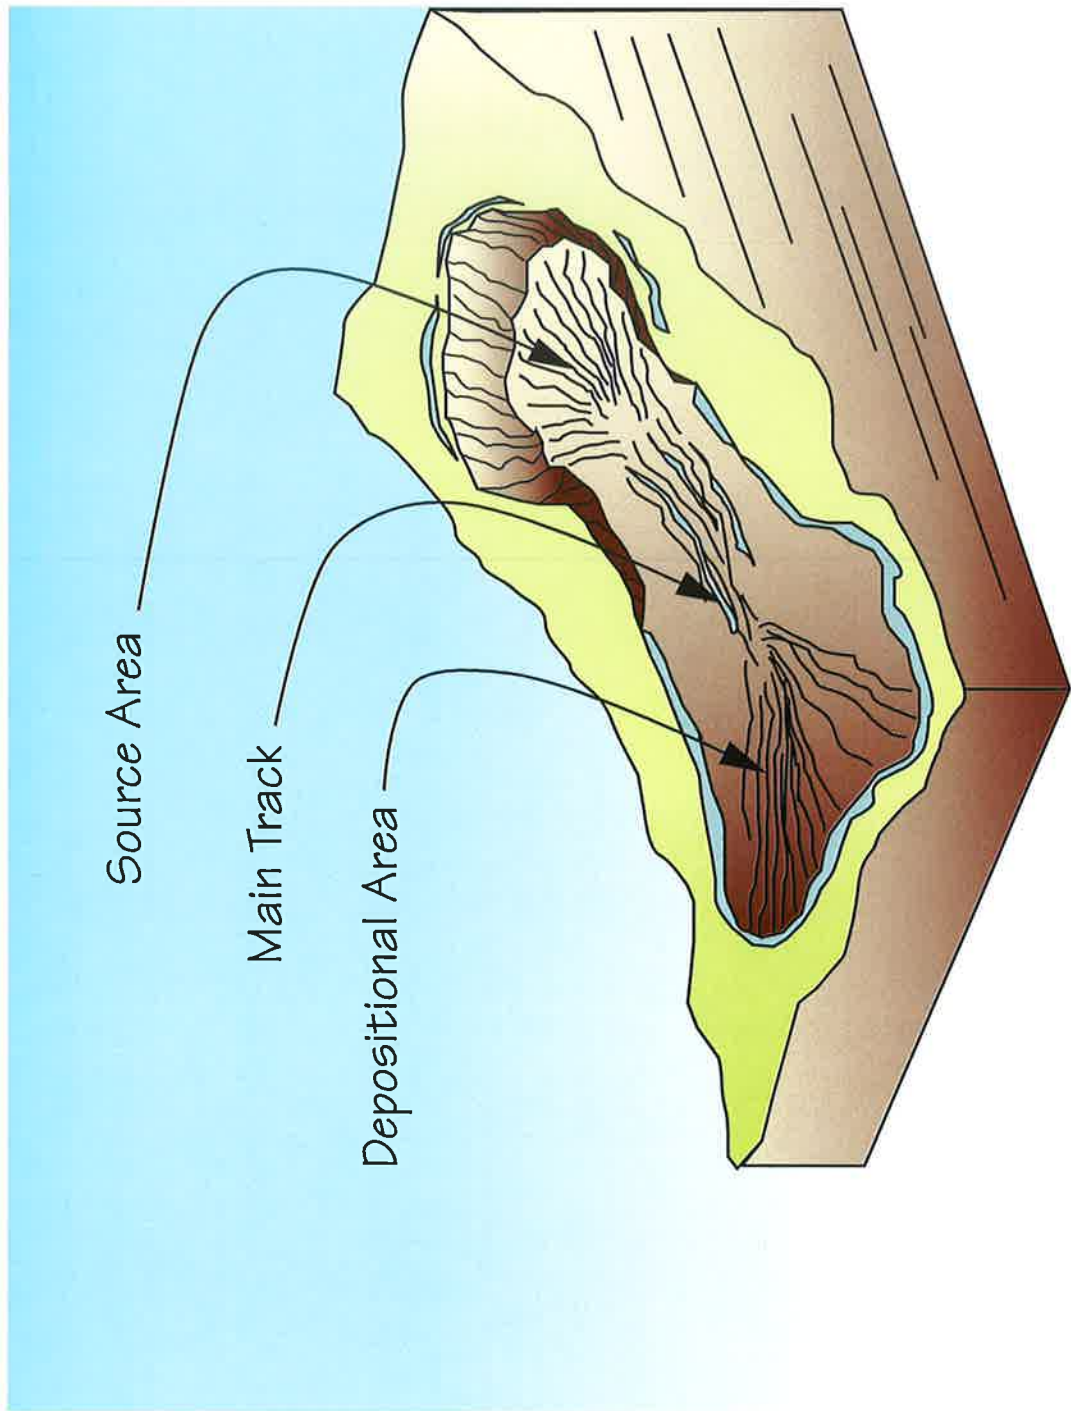
Typical Mud-Debris Flow

include debris flows, earthflows and slumps. Examples of typical surficial slump and mud-debris flow failures are depicted on Figures 10 and 11. Failures involving bedrock include wedge or block-rock falls where planar geologic structures (bedding, joints, faults, etc.) intersect, or shallow landslides involving zones of weathered bedrock.

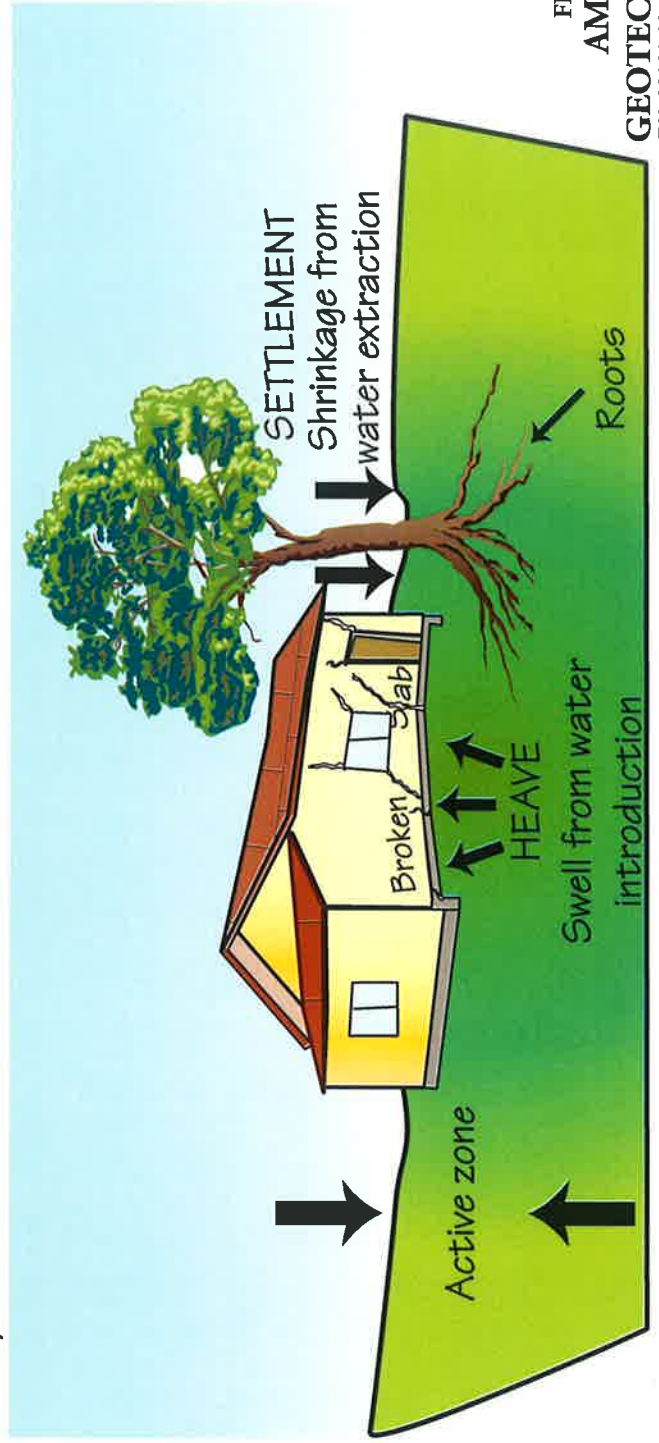
Potential Expansive Soil Impacts

a) NEWLY CONSTRUCTED

b) EXPANSIVE SOIL MOVEMENT

- Figure 14a: Settlement Types
- Figure 14b: Potential Fill Settlement Impacts
- Figure 15: Potential Transition Lot Impacts
- Figure 16: Potential Expansive Soil Impacts
