FAULT HAZARD ASSESSMENT REPORT
“WHITTIER FAULT ZONE”
ADDRESSING A PORTION OF THE PROPOSED
ESPERANZA HILLS RESIDENTIAL DEVELOPMENT PROJECT IN THE
SOUTHEASTERN PUENTE HILLS
UNICORPORATED ORANGE COUNTY, SOUTHERN CALIFORNIA

Subject: **FAULT HAZARD ASSESSMENT REPORT**
"Whittier Fault Zone"

Addressing a Portion of Proposed Esperanza Hills Residential Development in the Southeastern Puente Hills, Unincorporated County of Orange, Southern California

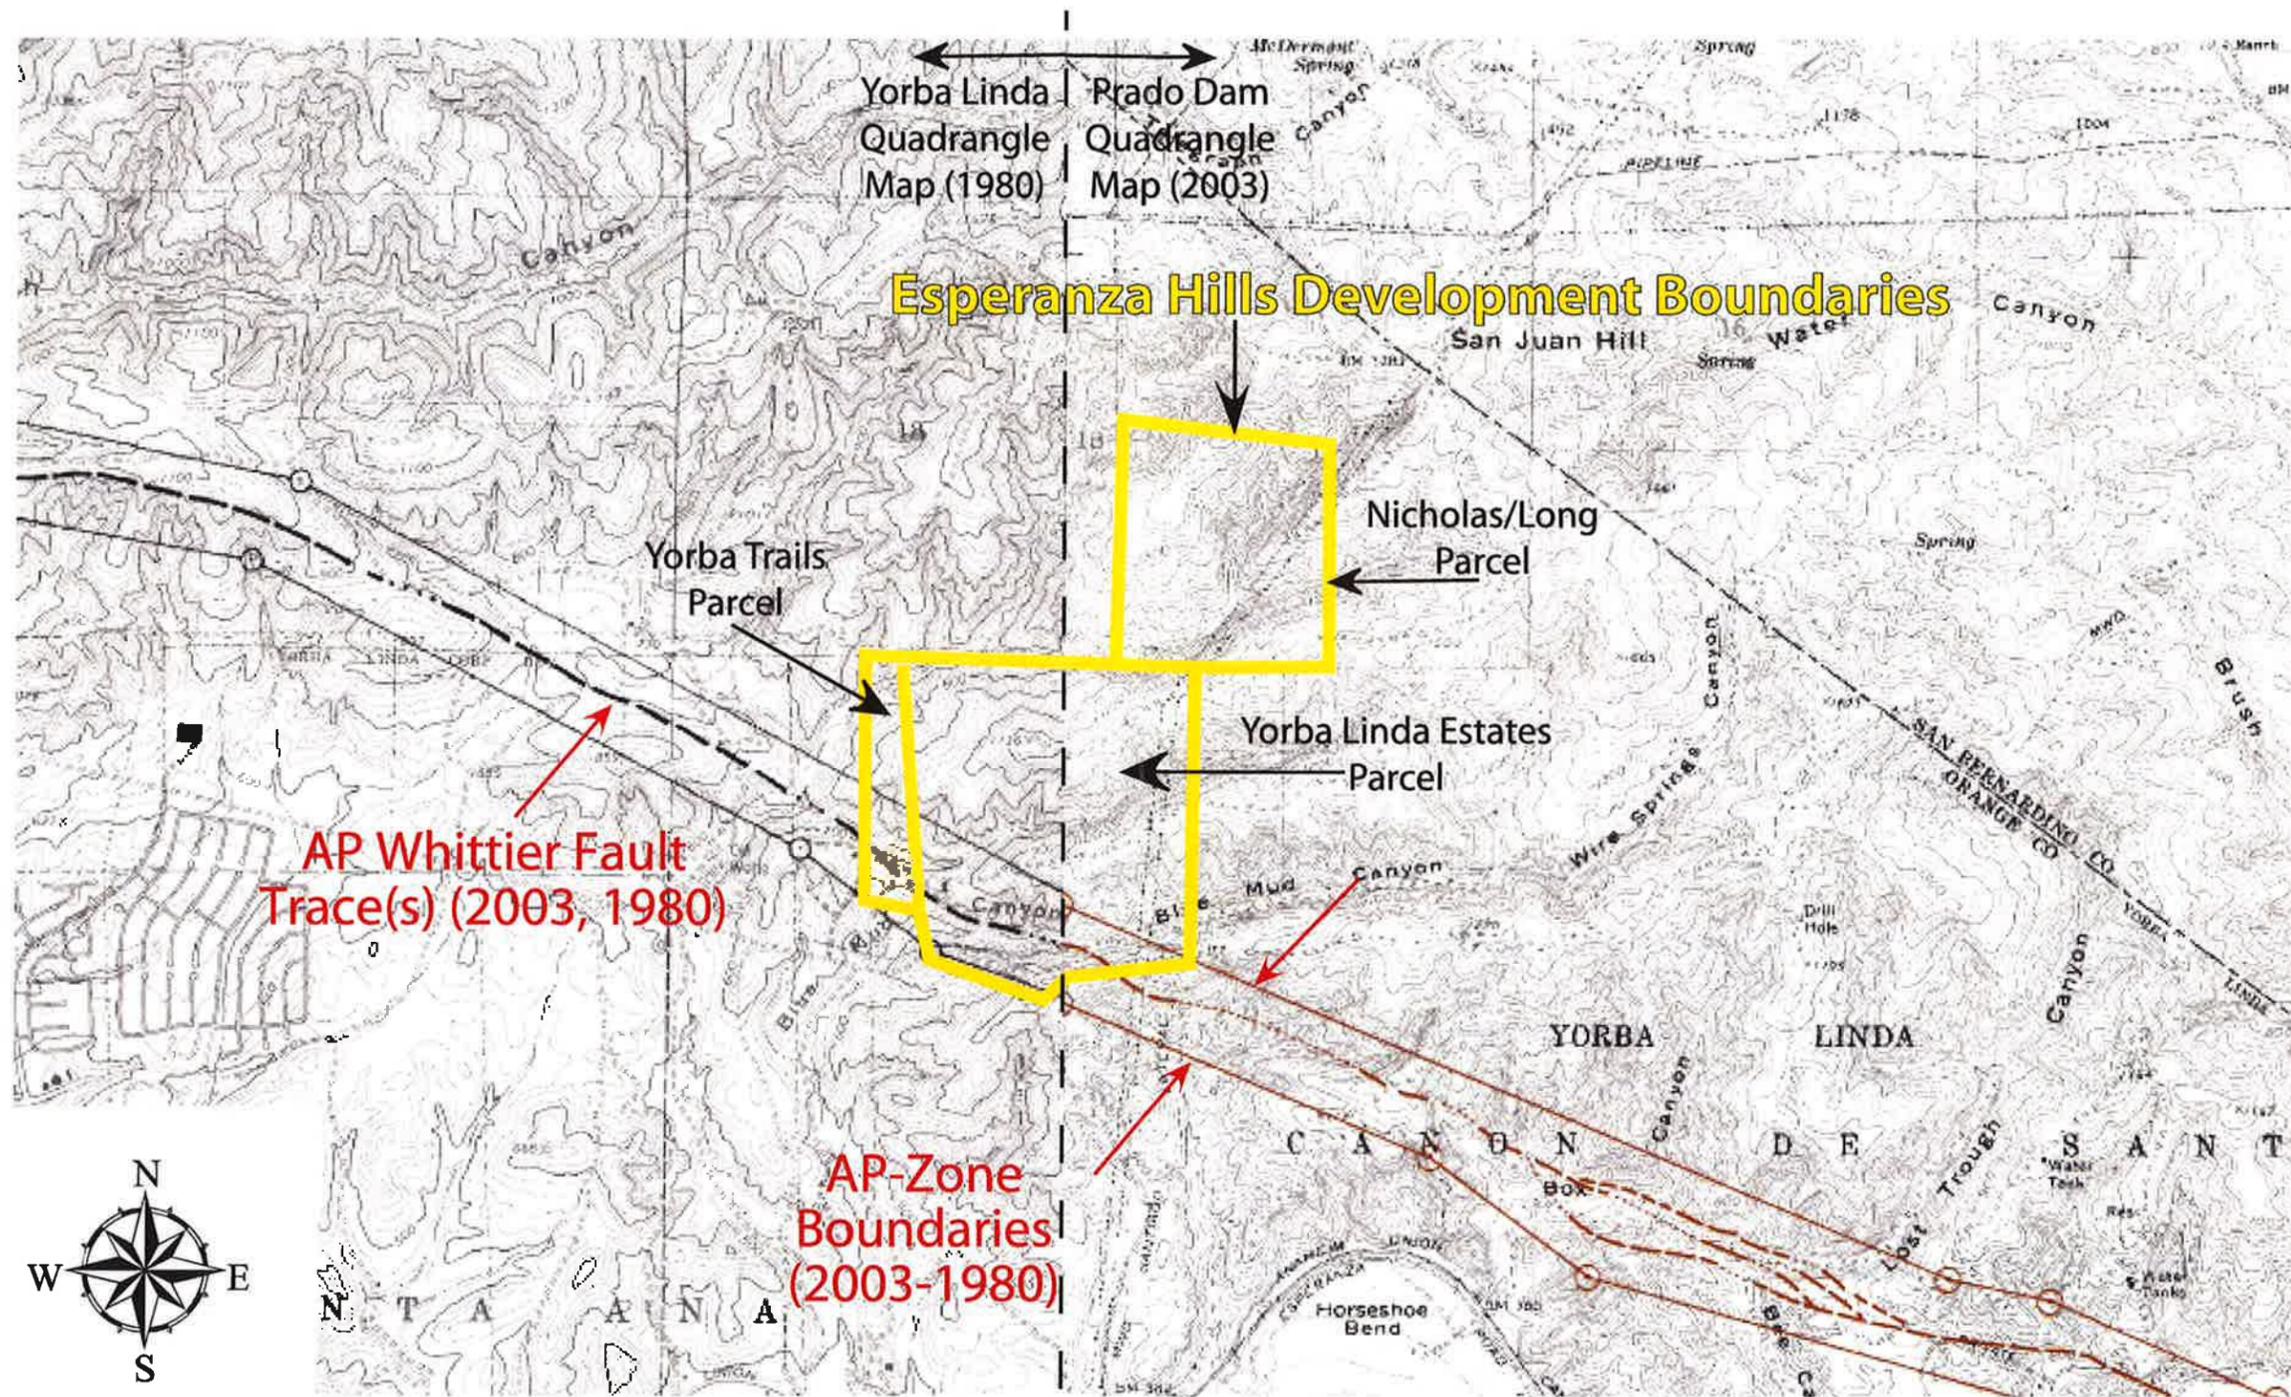
Figure 1

From: Alquist-Priolo (AP) Earthquake Fault Zone Maps
 Yorba Linda Quadrangle (1980)
 Prado Dam Quadrangle (2003)

Regional Topographic Location Map

The overall Esperanza Hills Development property lies along the southeastern flank of the Puente Hills within the northern Peninsular Ranges Geomorphic Province of California (Figure 1). Property boundaries straddle both the Yorba Linda and Prado Dam 7.5-Minute Topographic Quadrangle Maps. Approximately 469 acres are bounded by an irregular-linear shaped borders. Except for local access roads and cut pads associated with oil/gas production and Southern California Edison (SCE) transmission towers, the property largely retains its original natural configuration (Figure 2).

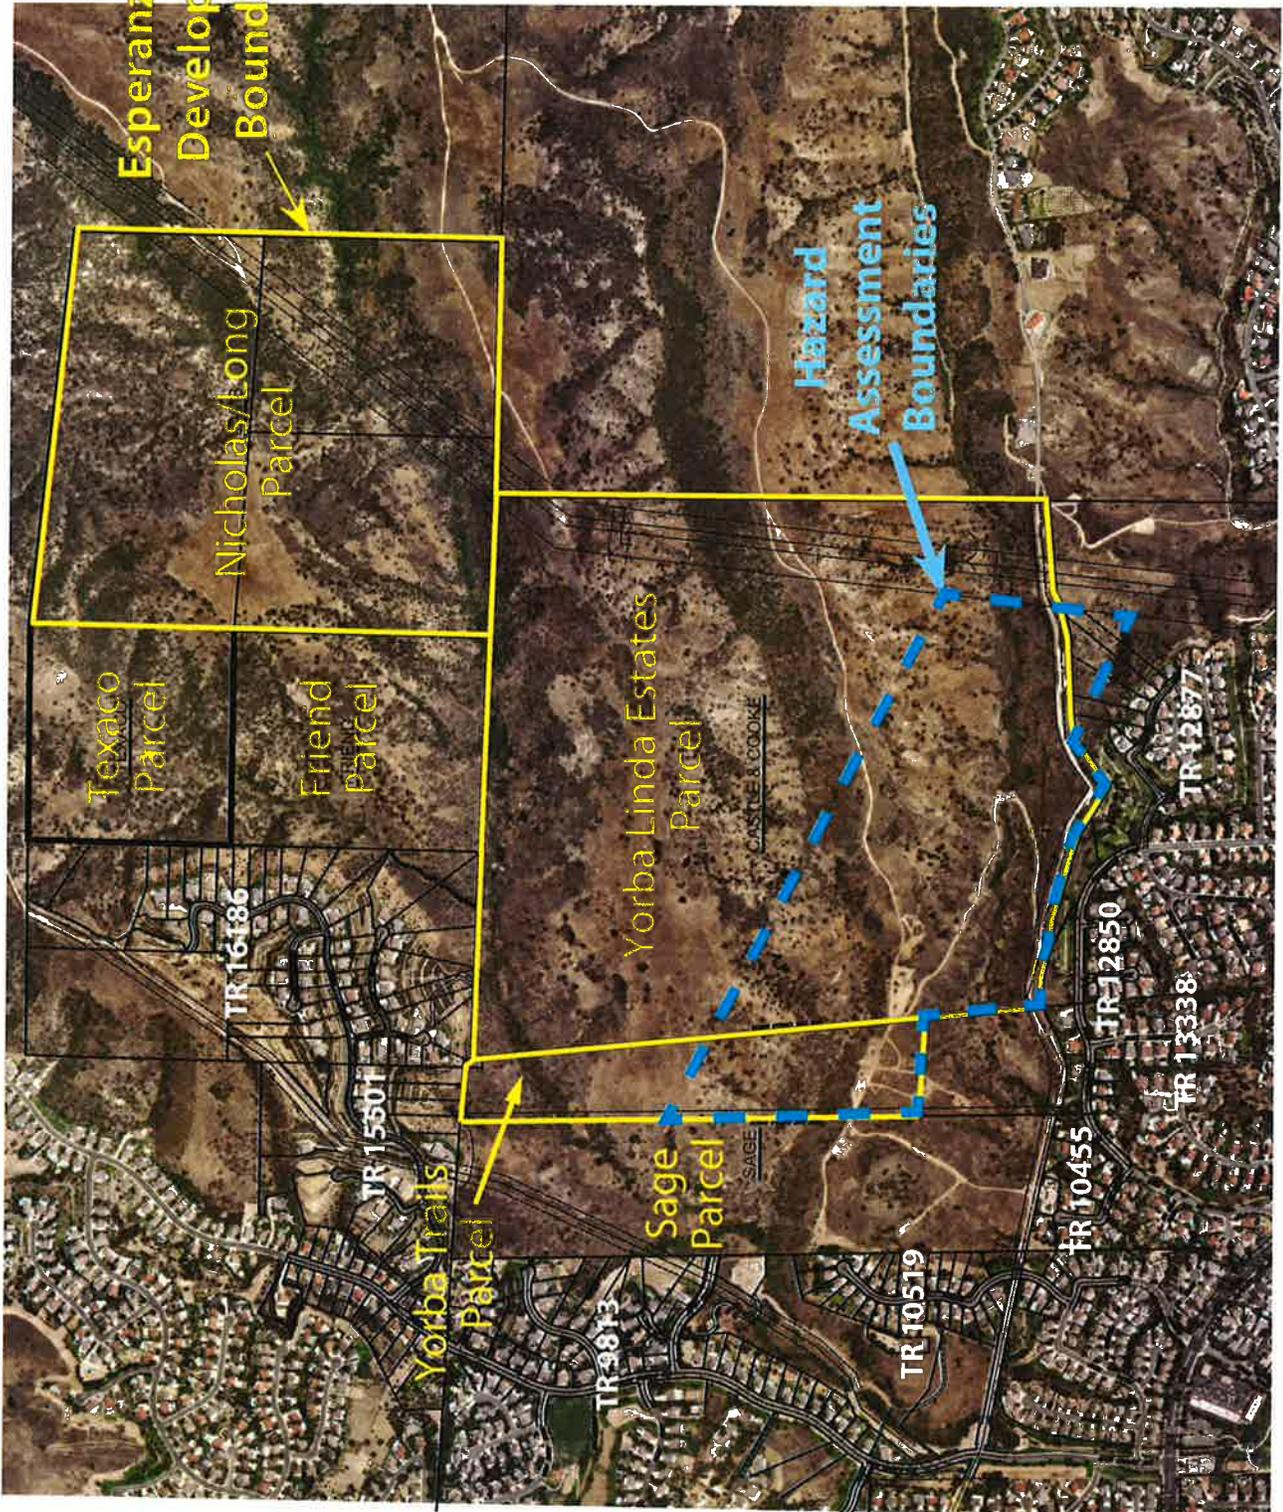
Ref - KWC Engineers (2008)

Orthophoto Map

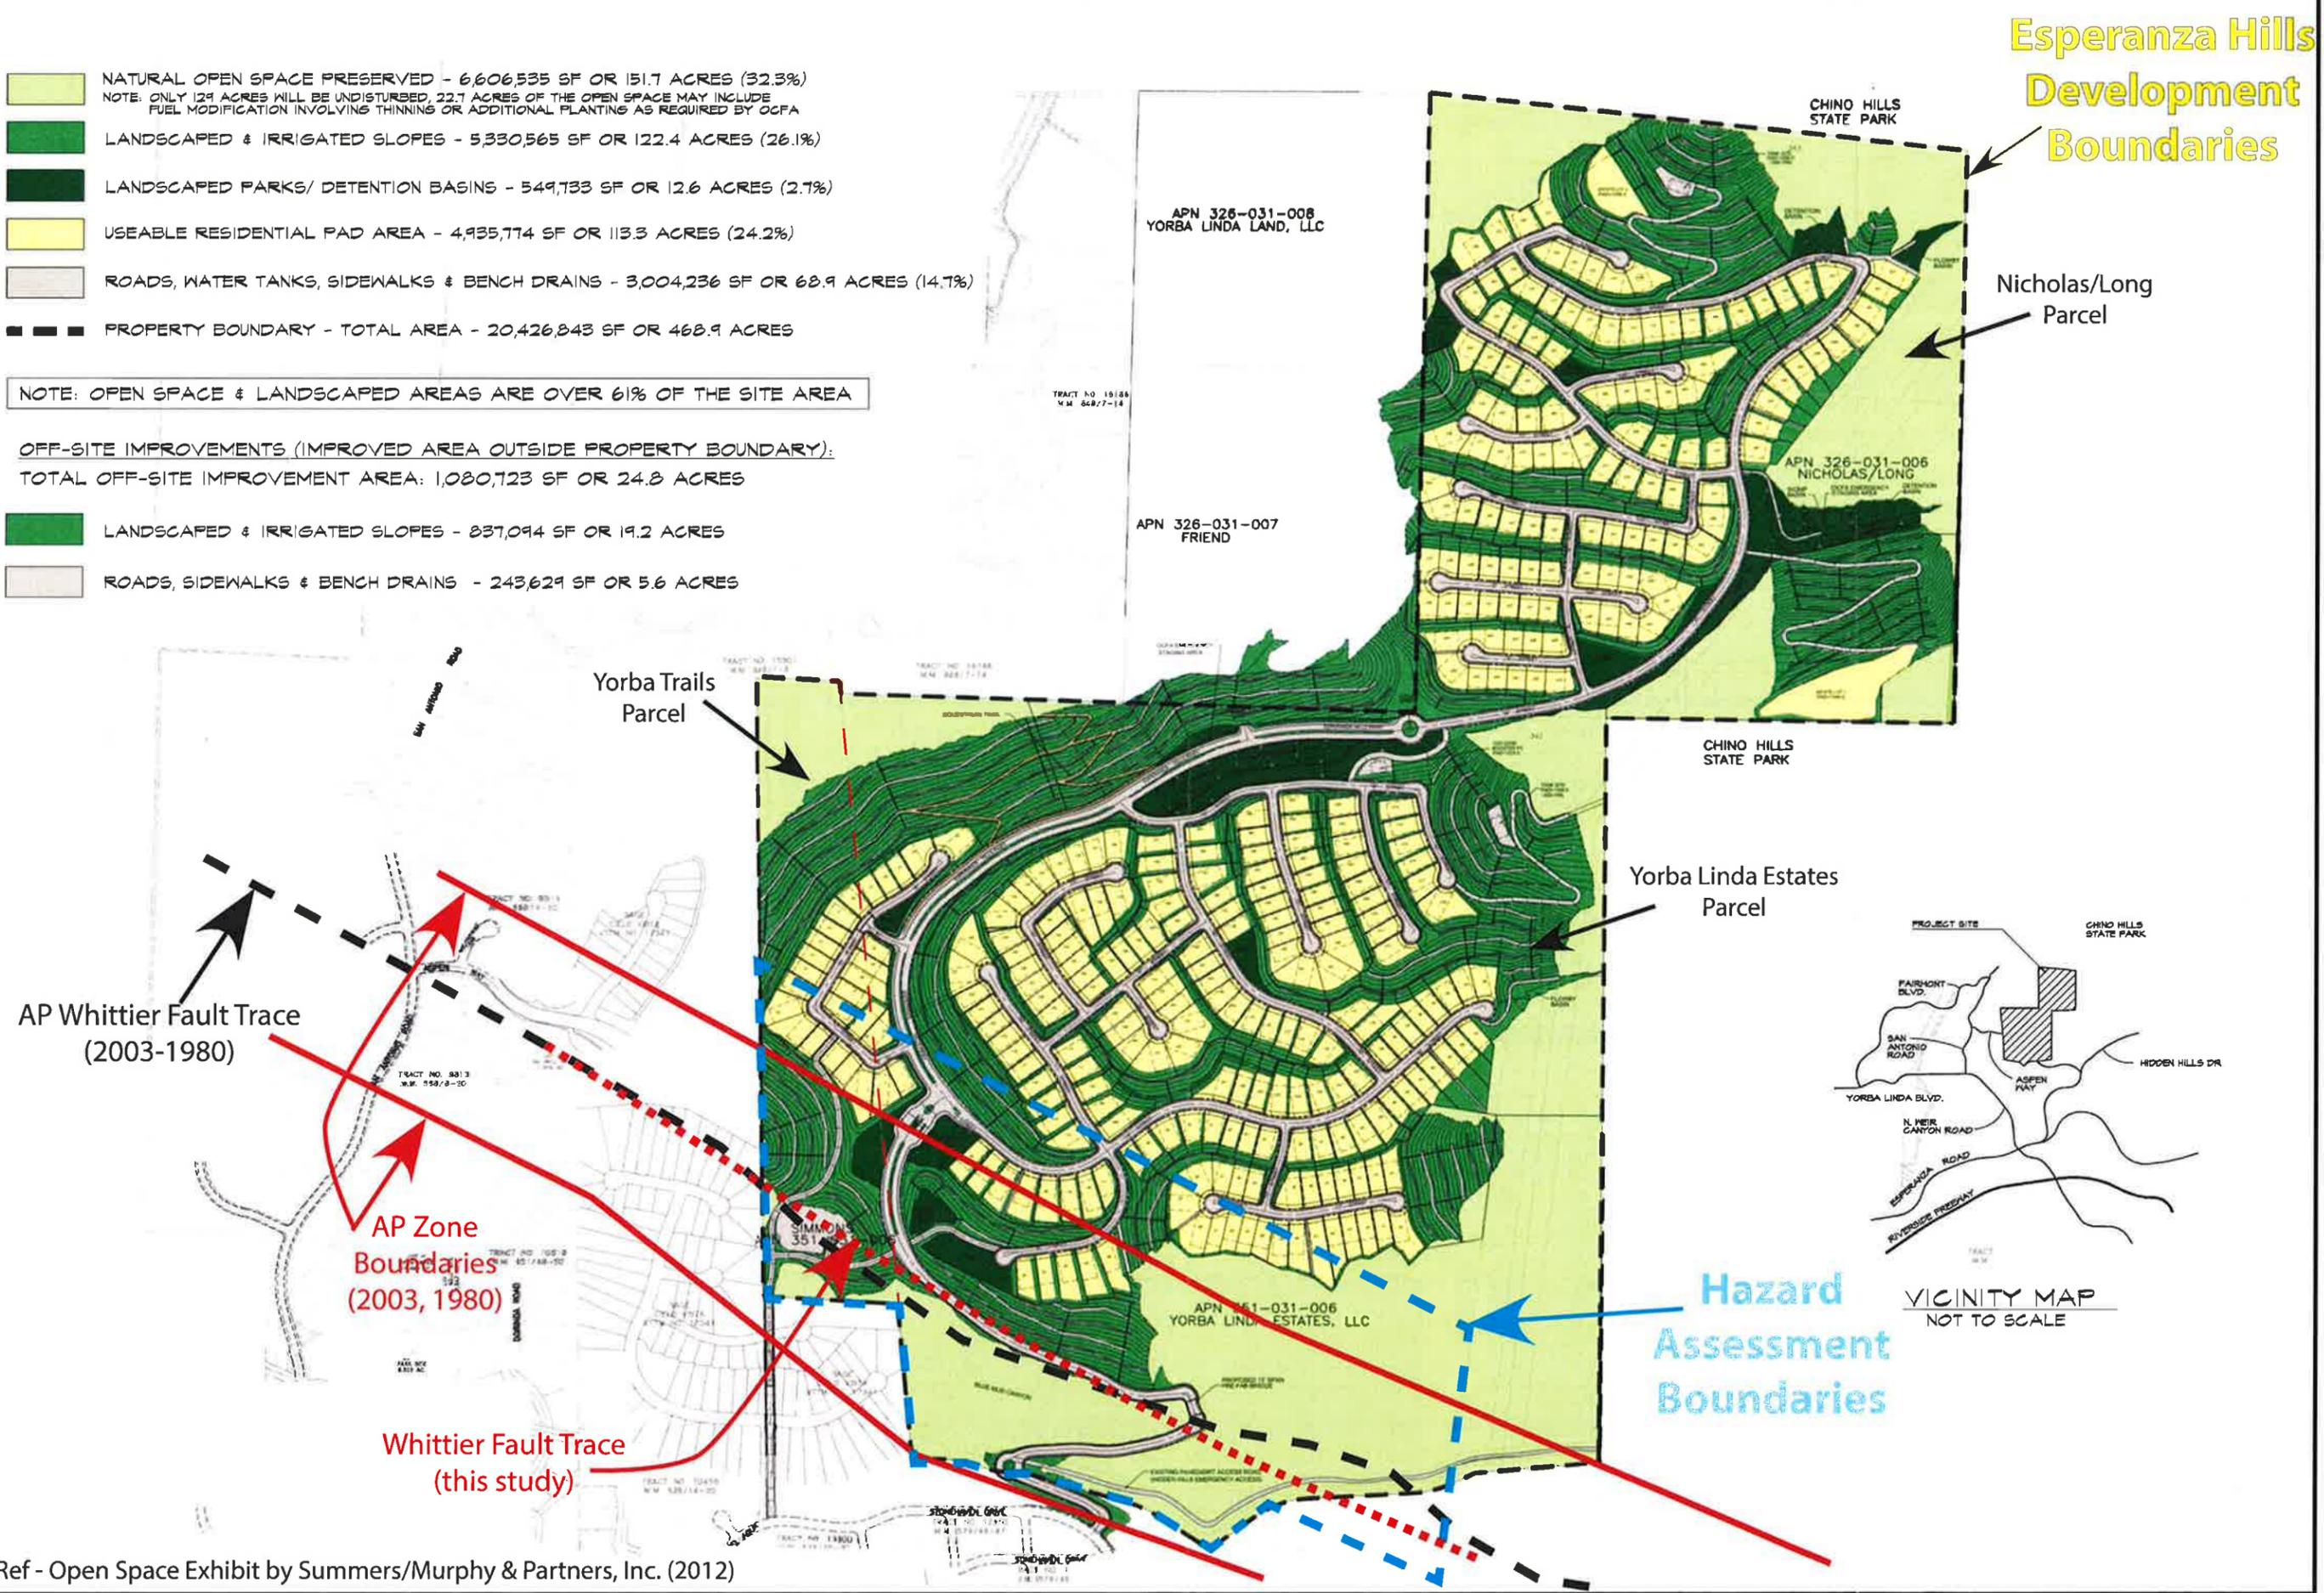
**Esperanza Hills
Development
Boundaries**

Nicholas/Long
Parcel

Yorba Linda Estates
Parcel

**Hazard
Assessment
Boundaries**

Boundaries of the subject Fault Hazard Assessment area (HA-Site) generally span the southern portion of the Simmons and YLE parcels (Figures 3a/3b, Plates 1a/1b). The north boundary of the HA-Site extends beyond the northern AP Zone boundary and runs parallel to it. The southern limits of the proposed conceptual design plan occur within the boundaries of the AP Zone. Fault trenching was conducted in the northern portion of the HA-Site in areas generally coincident with proposed design grading improvements (Plate 1a/1b).

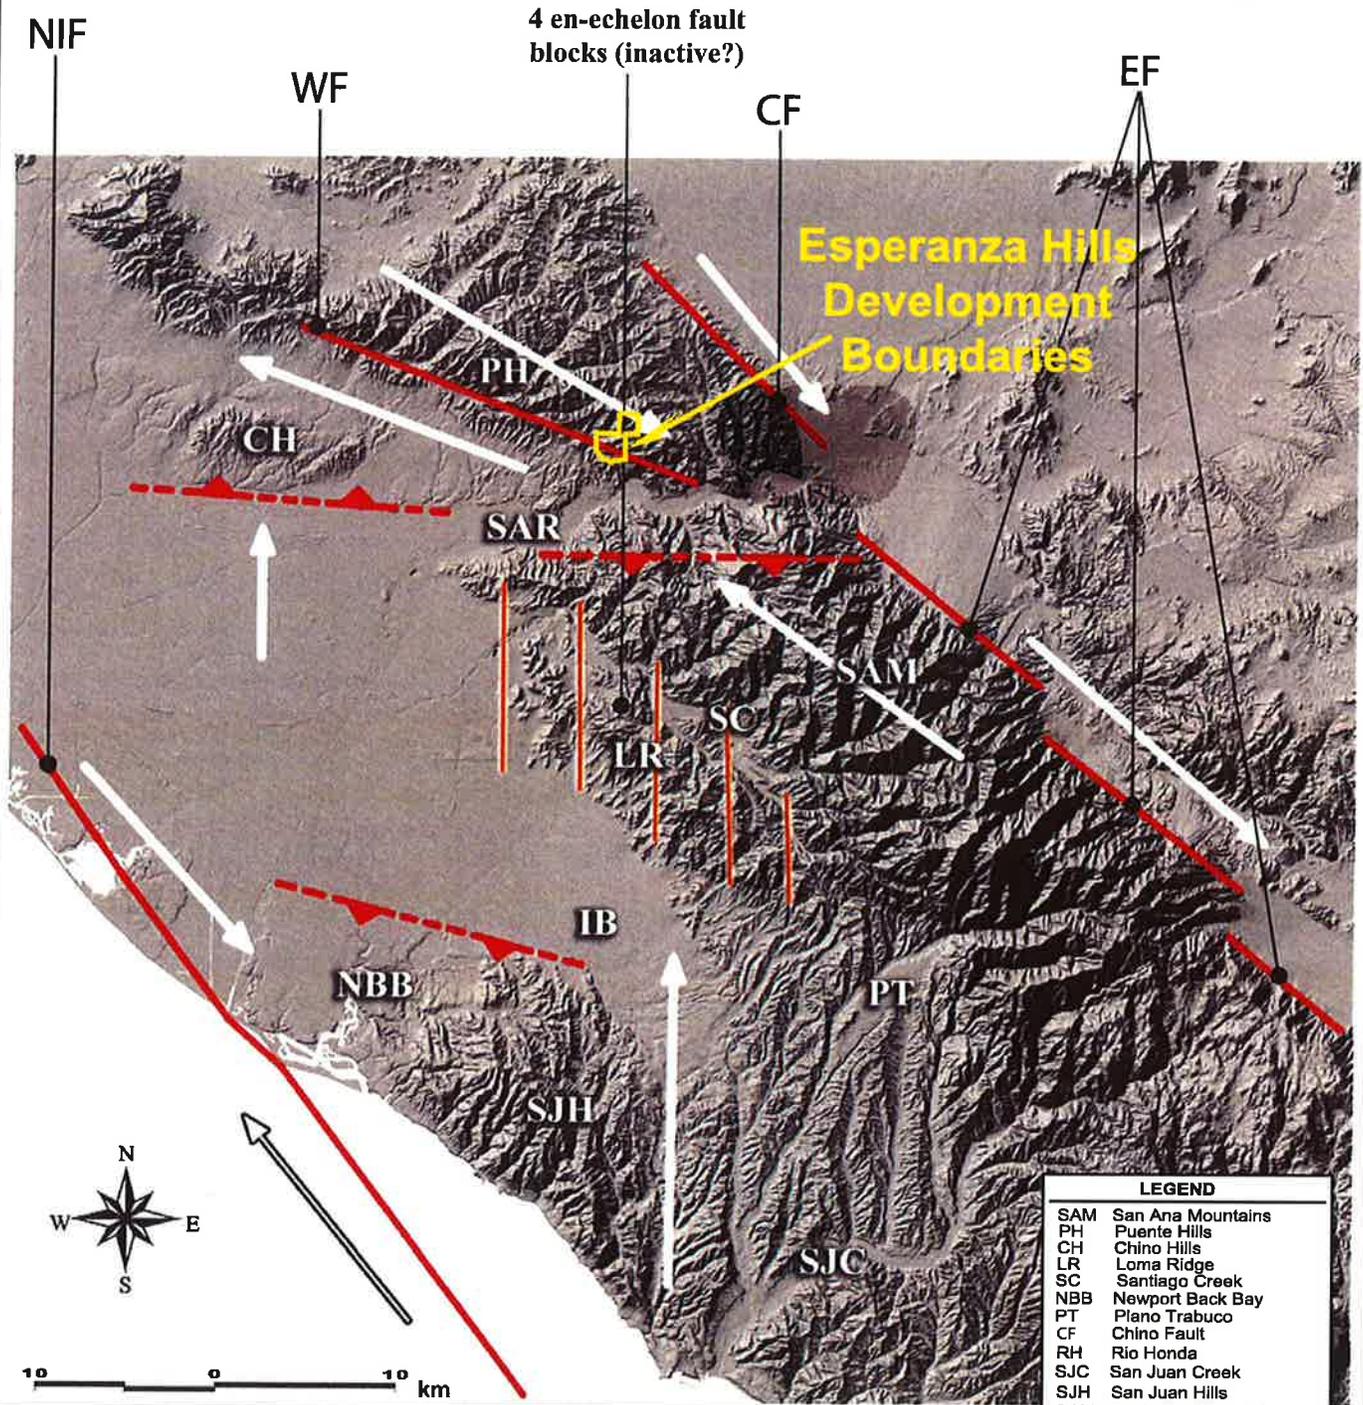
LEGEND	
SAM	San Ana Mountains
PH	Puente Hills
CH	Chino Hills
LR	Loma Ridge
SC	Santiago Creek
NBB	Newport Back Bay
PT	Plano Trabuco
CF	Chino Fault
RH	Rio Honda
SJC	San Juan Creek
SJH	San Juan Hills
SAM	Santa Ana Mountains
SAR	Santa Ana River
IB	Irvine Basin
WHF	Whittier Heights Fault
EF	Elsinore Fault
WF	Whittier Fault
NIF	Newport-Inglewood Fault

Reference - Grant, L., and Gath, E., "Active Deformation and Earthquake Potential of the Southern Los Angeles Basin, Orange County, California", 04HQGR0078, USGS.

Emergence of the hills is thought to have begun approximately 600 to 700 thousand years (ka) ago (Gath, 2007). Since late Pleistocene time motion along the fault has been transformed from mostly vertical reverse motion into what is presently almost purely dextral right-lateral strike-slip motion (Gath, 1992). The waning of vertical uplift has apparently allowed rates of erosion to outpace uplift, a condition interpreted from the mature pattern of surface erosion in the hills. Surface erosion is even more advanced southwest of the Whittier fault where the juxtaposition of more youthful and erodible bedrock units exists (Figure 4a/4b).

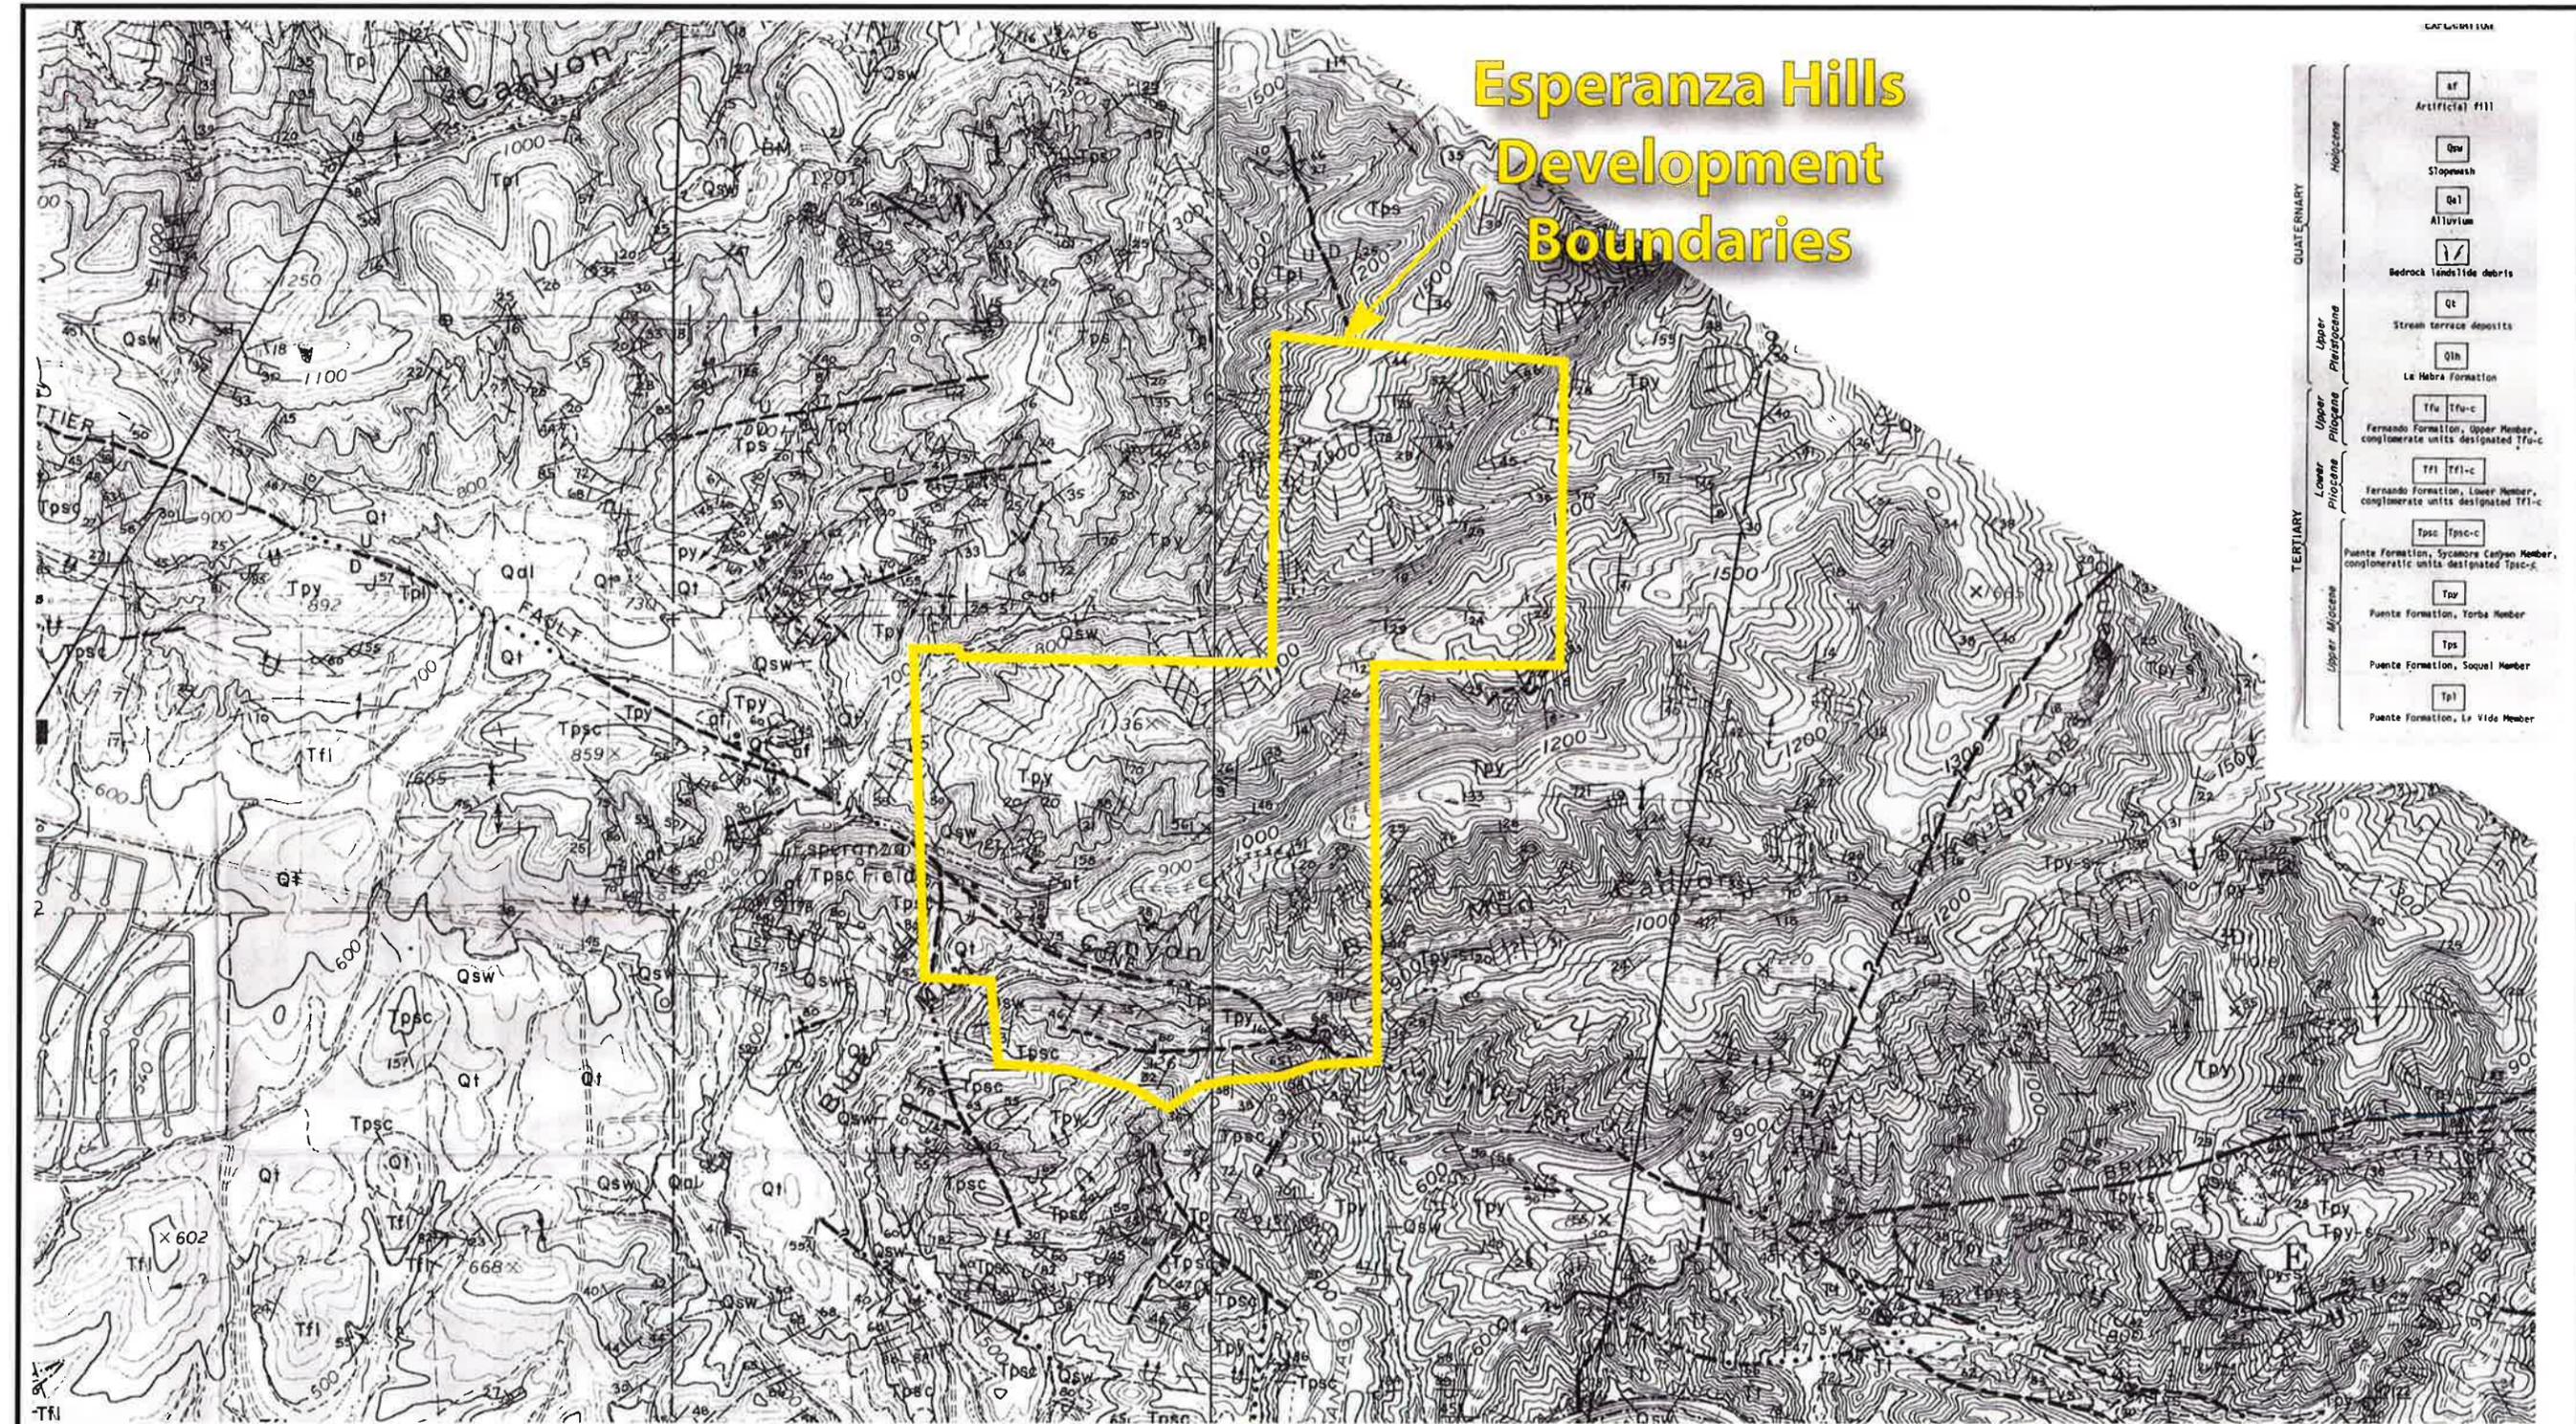
**Esperanza Hills
Development
Boundaries**

QUATERNARY	
af	Artificial fill
Qsw	Stonewash
Qel	Alluvium
Ql	Bedrock landslide debris
Qt	Stream terrace deposits
Qlh	La Habra Formation
Tfu-c	Fernando Formation, Upper Member, conglomerate units designated Tfu-c
Tfl-c	Fernando Formation, Lower Member, conglomerate units designated Tfl-c
Tps-c	Puente Formation, Sycamore Canyon Member, conglomeratic units designated Tps-c
Tpy	Puente Formation, Yorba Member
Tps	Puente Formation, Soquel Member
Tpl	Puente Formation, Le Vids Member

Although there is general agreement on the age and environment of this formation, different names are used to describe the rocks within the literature. For instance Dibblee (2001) groups them as part of the Monterey Formation while Tan, et.al. (1984) and assigns them by name to the Puente Formation. Regional geologic mapping and literature published by Dibblee and Tan, et.al. depict generally similar geologic contacts, structure and faulting relationships. The Dibblee map presents a more detailed depiction of regional geologic structure and the Tan map offers a more recognized use of stratigraphic nomenclature. For the purposes of this report we refer to the Tan publication for definitions of geologic stratigraphy, nomenclature and distribution of geologic contacts (Figure 5a).

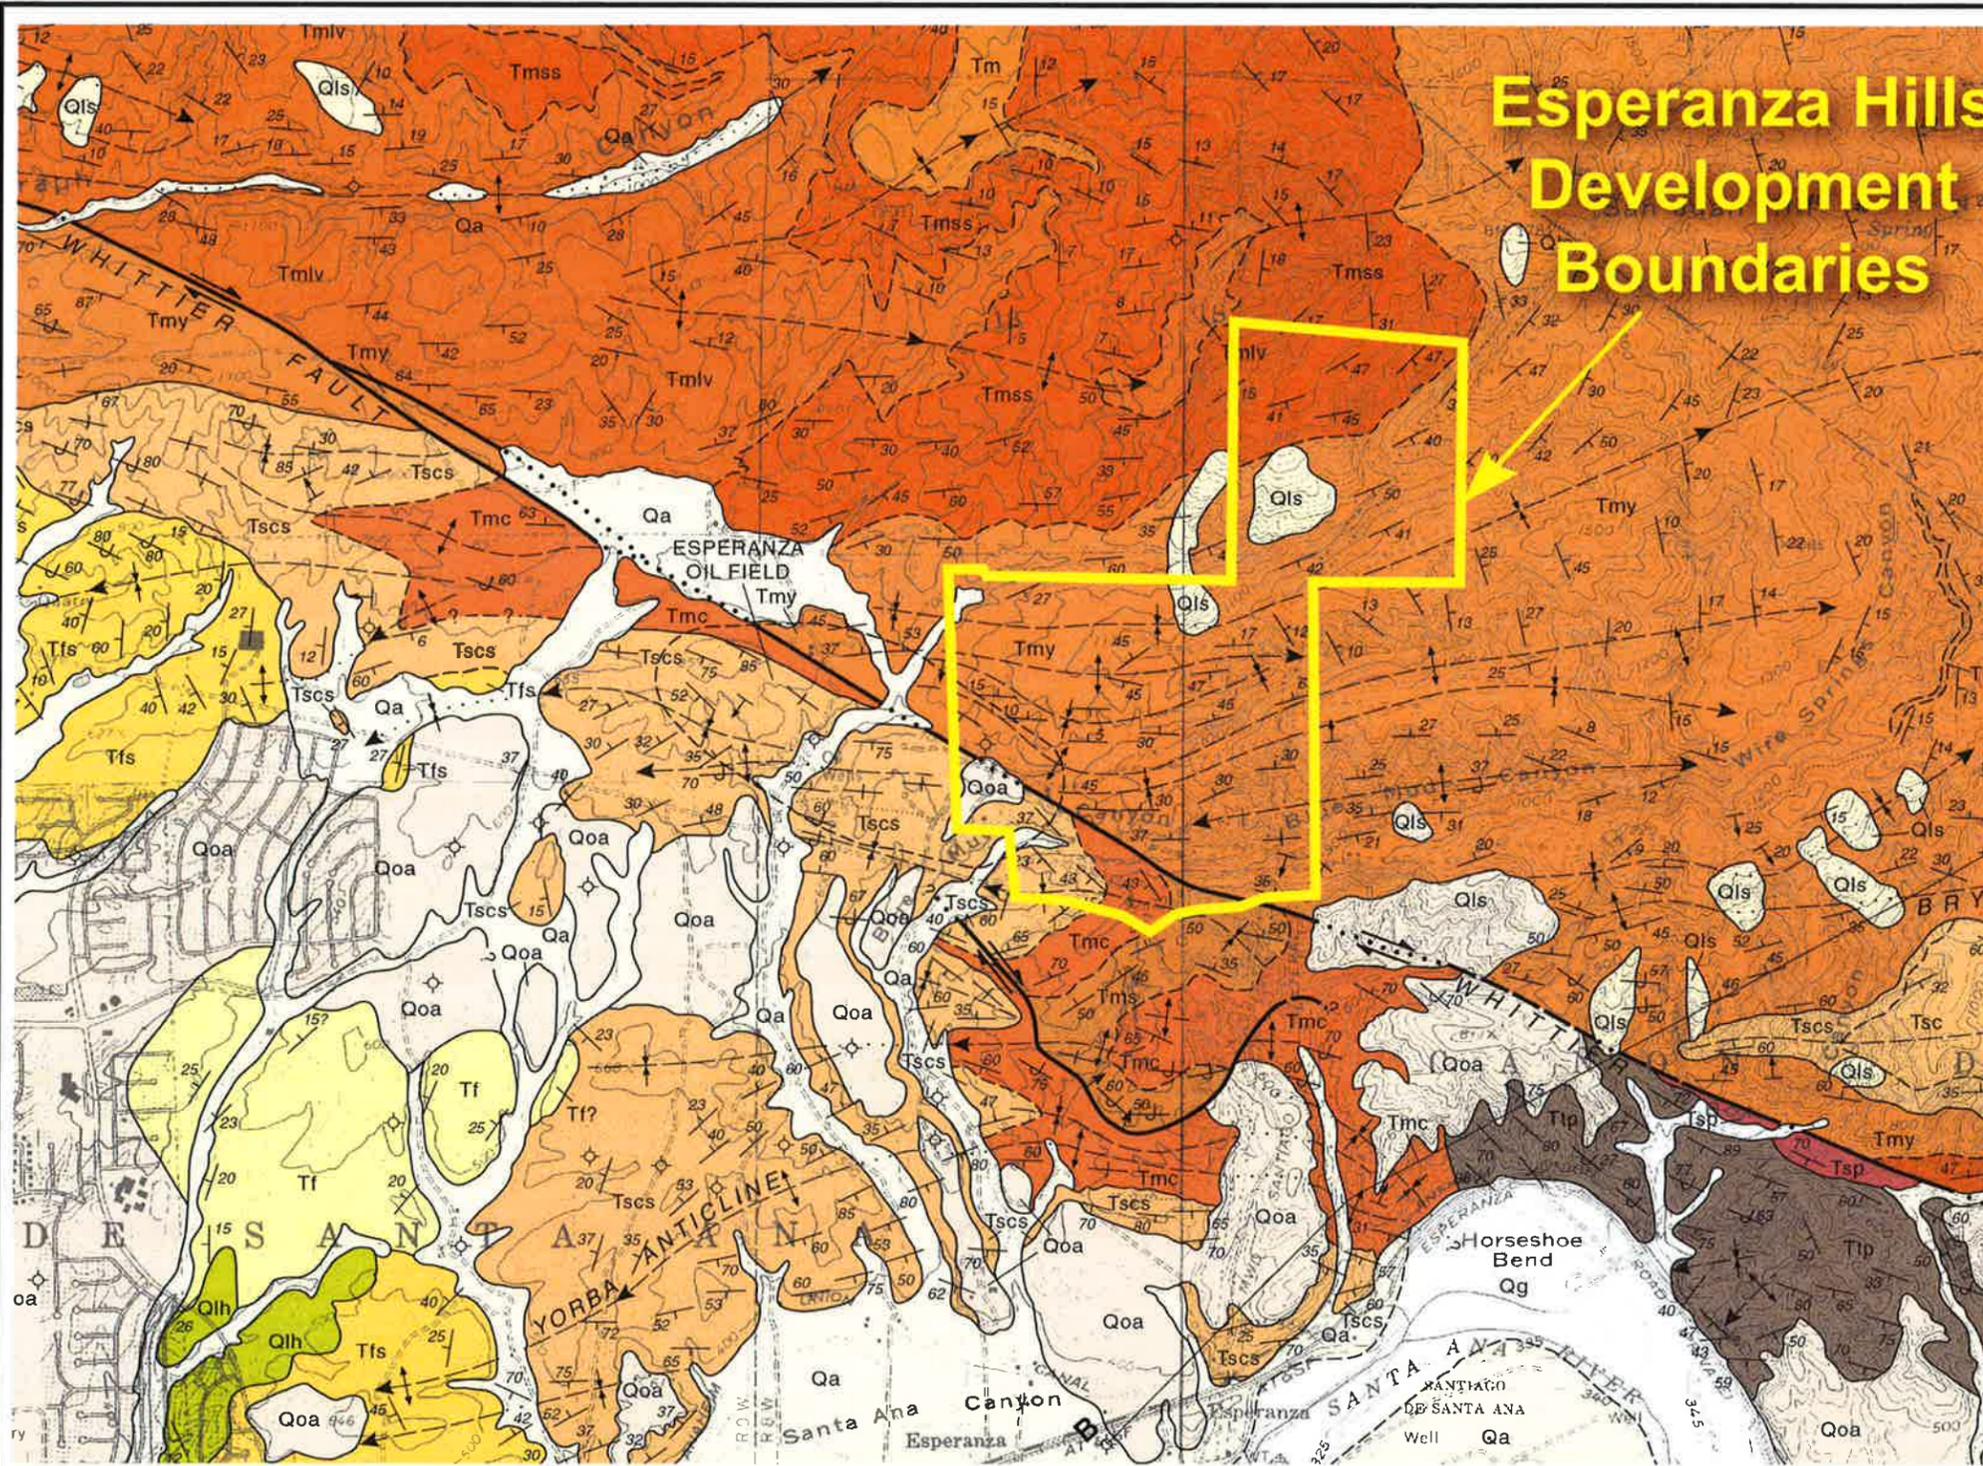
YORBA LINDA AND PRADO DAM MAP (DF-75)

Esperanza Hills Development Boundaries

Ref - Dibblee Foundation - Yorba Linda and Prado Dam Map DF-75 (2001)

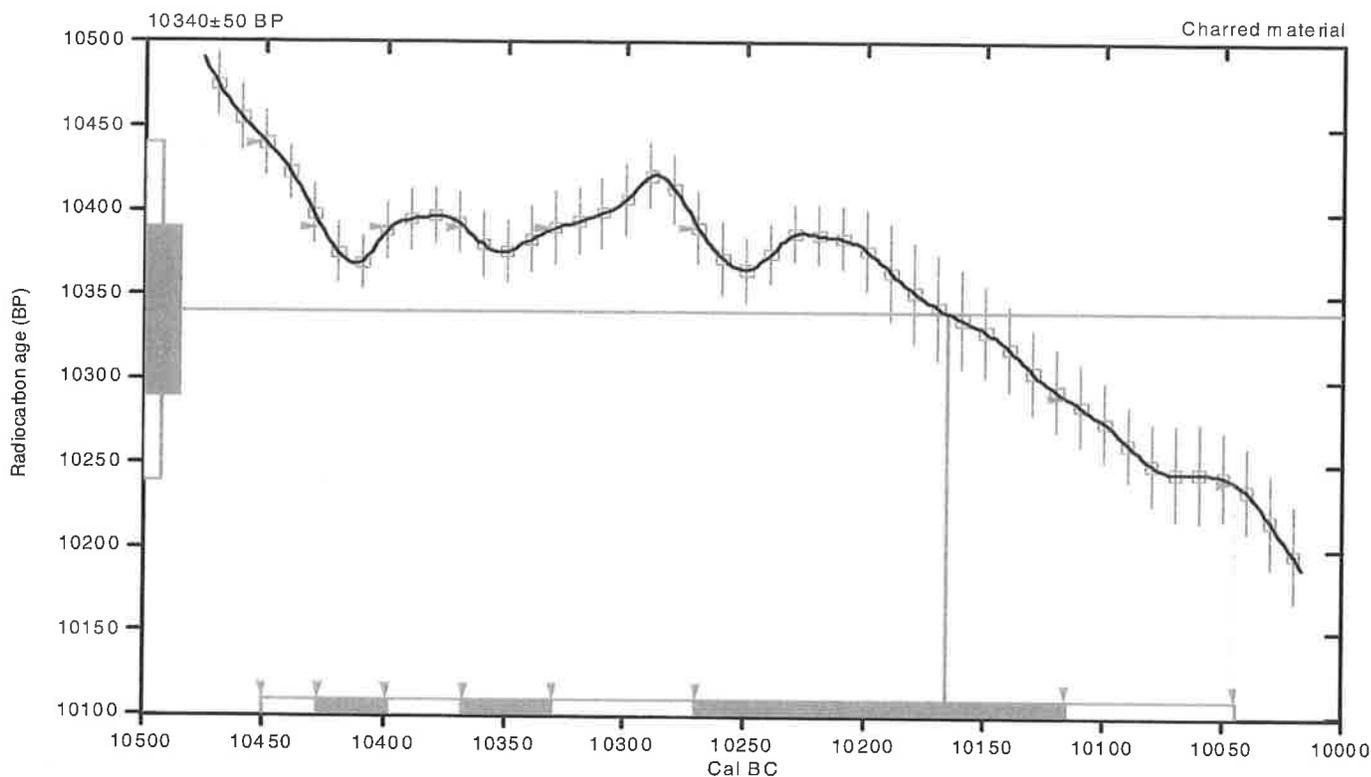
Intercept of radiocarbon age
with calibration curve: **Cal BC 10170 (Cal BP 12120)**

1 Sigma calibrated results: **Cal BC 10430 to 10400 (Cal BP 12380 to 12350) and**
(68% probability) **Cal BC 10370 to 10330 (Cal BP 12320 to 12280) and**
Cal BC 10270 to 10120 (Cal BP 12220 to 12070)

As explained in Section 2.10.3, an age range of 12,000 to 13,310 years before present (ybp) was established for this deposit. The unit was not observed to be broken by any faults.

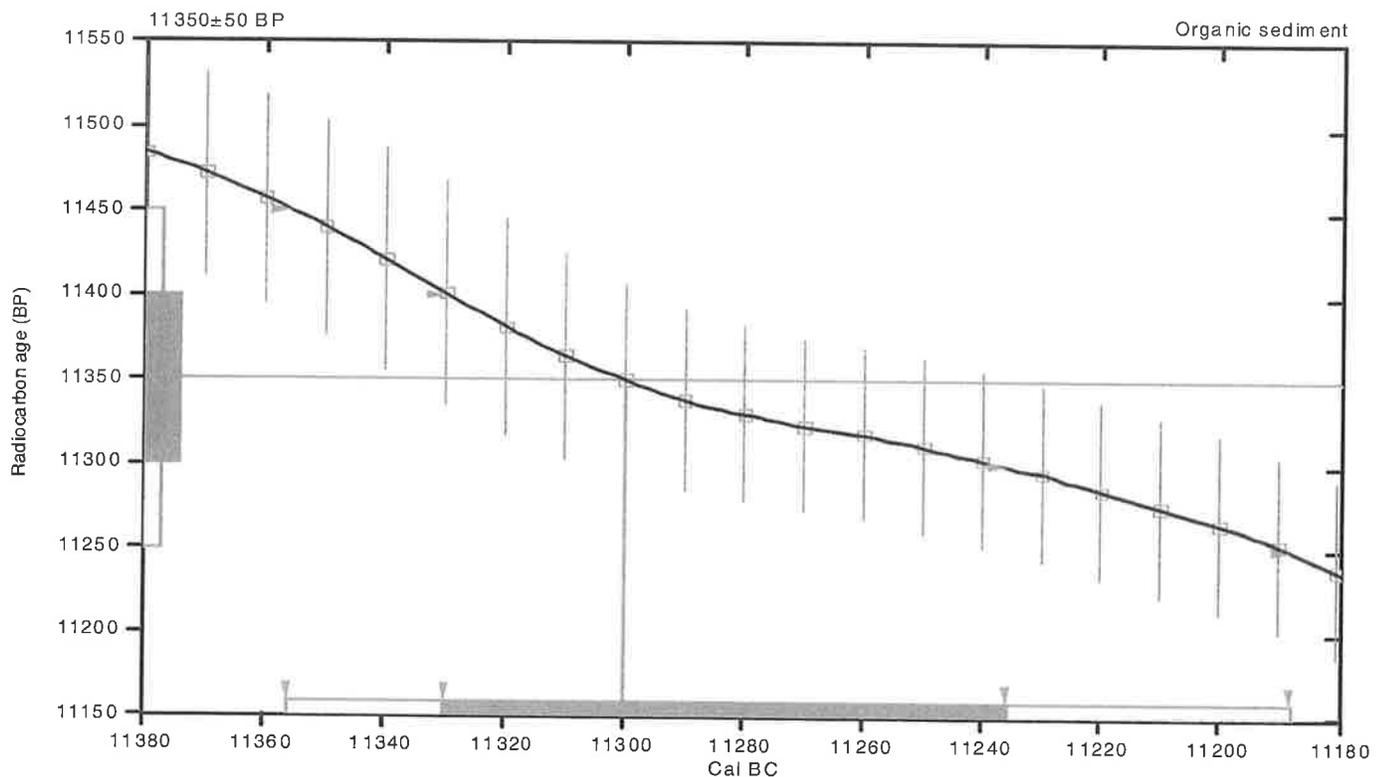
Intercept of radiocarbon age
with calibration curve: **Cal BC 11300 (Cal BP 13250)**

1 Sigma calibrated result: **Cal BC 11330 to 11240 (Cal BP 13280 to 13190)**
(68 % probability)

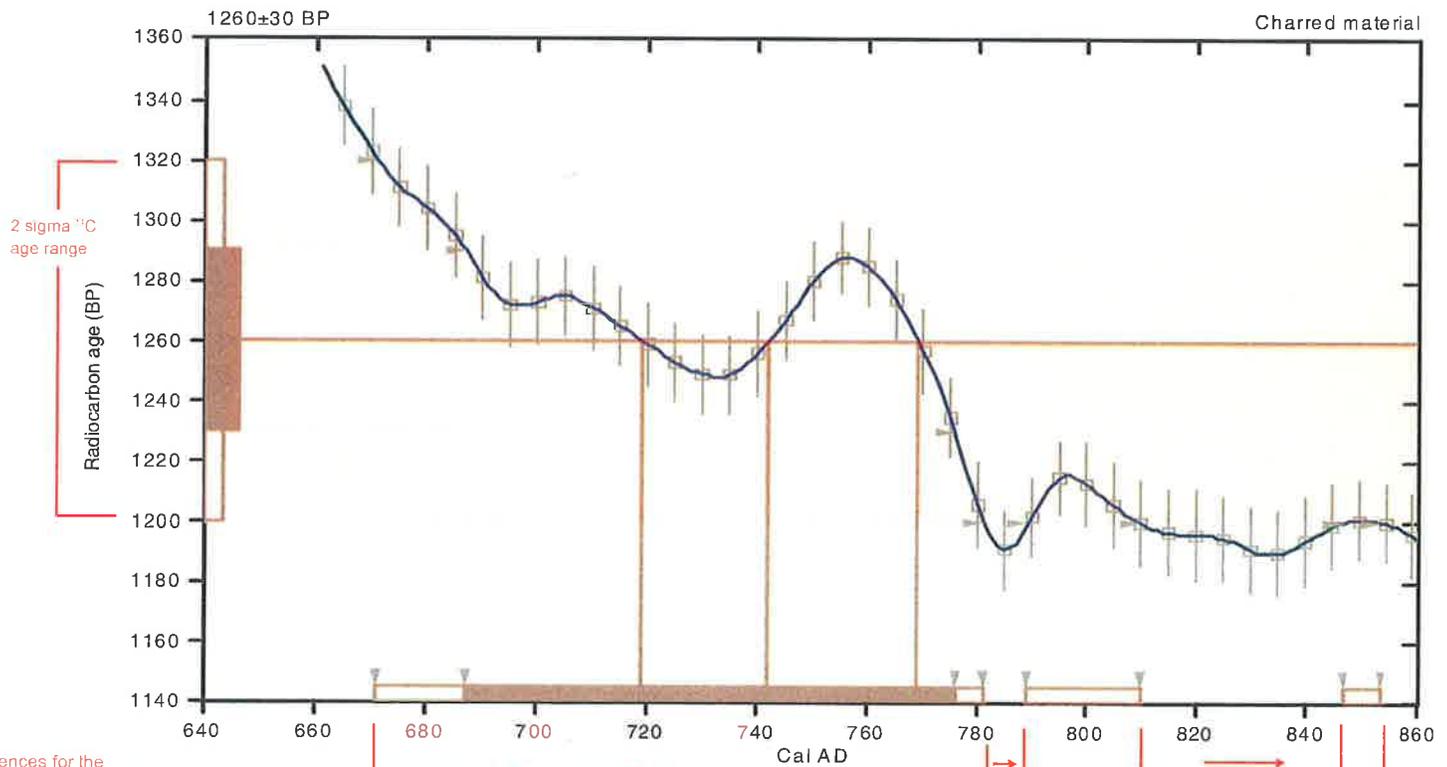
The intercept between the average radiocarbon age and the calibrated curve time scale. This value is illustrative and should not be used by itself.

1 Sigma calibrated result: (68% probability)
 Cal AD 690 to 780 (Cal BP 1260 to 1170)
