**JURISDICTIONAL DELINEATION
OF AREAS SUBJECT TO THE JURISDICTION OF
THE U.S. ARMY CORPS OF ENGINEERS**

**PURSUANT TO
SECTION 404 OF THE CLEAN WATER ACT**

**RANCHO MISSION VIEJO
P.O. BOX 9
SAN JUAN CAPISTRANO
CALIFORNIA 92639
CONTACT: LAURA COLEY EISENBERG
(949) 240-3363**

**November 17, 2003
[Revised December 1, 2003]
[Revised April 18, 2004]**

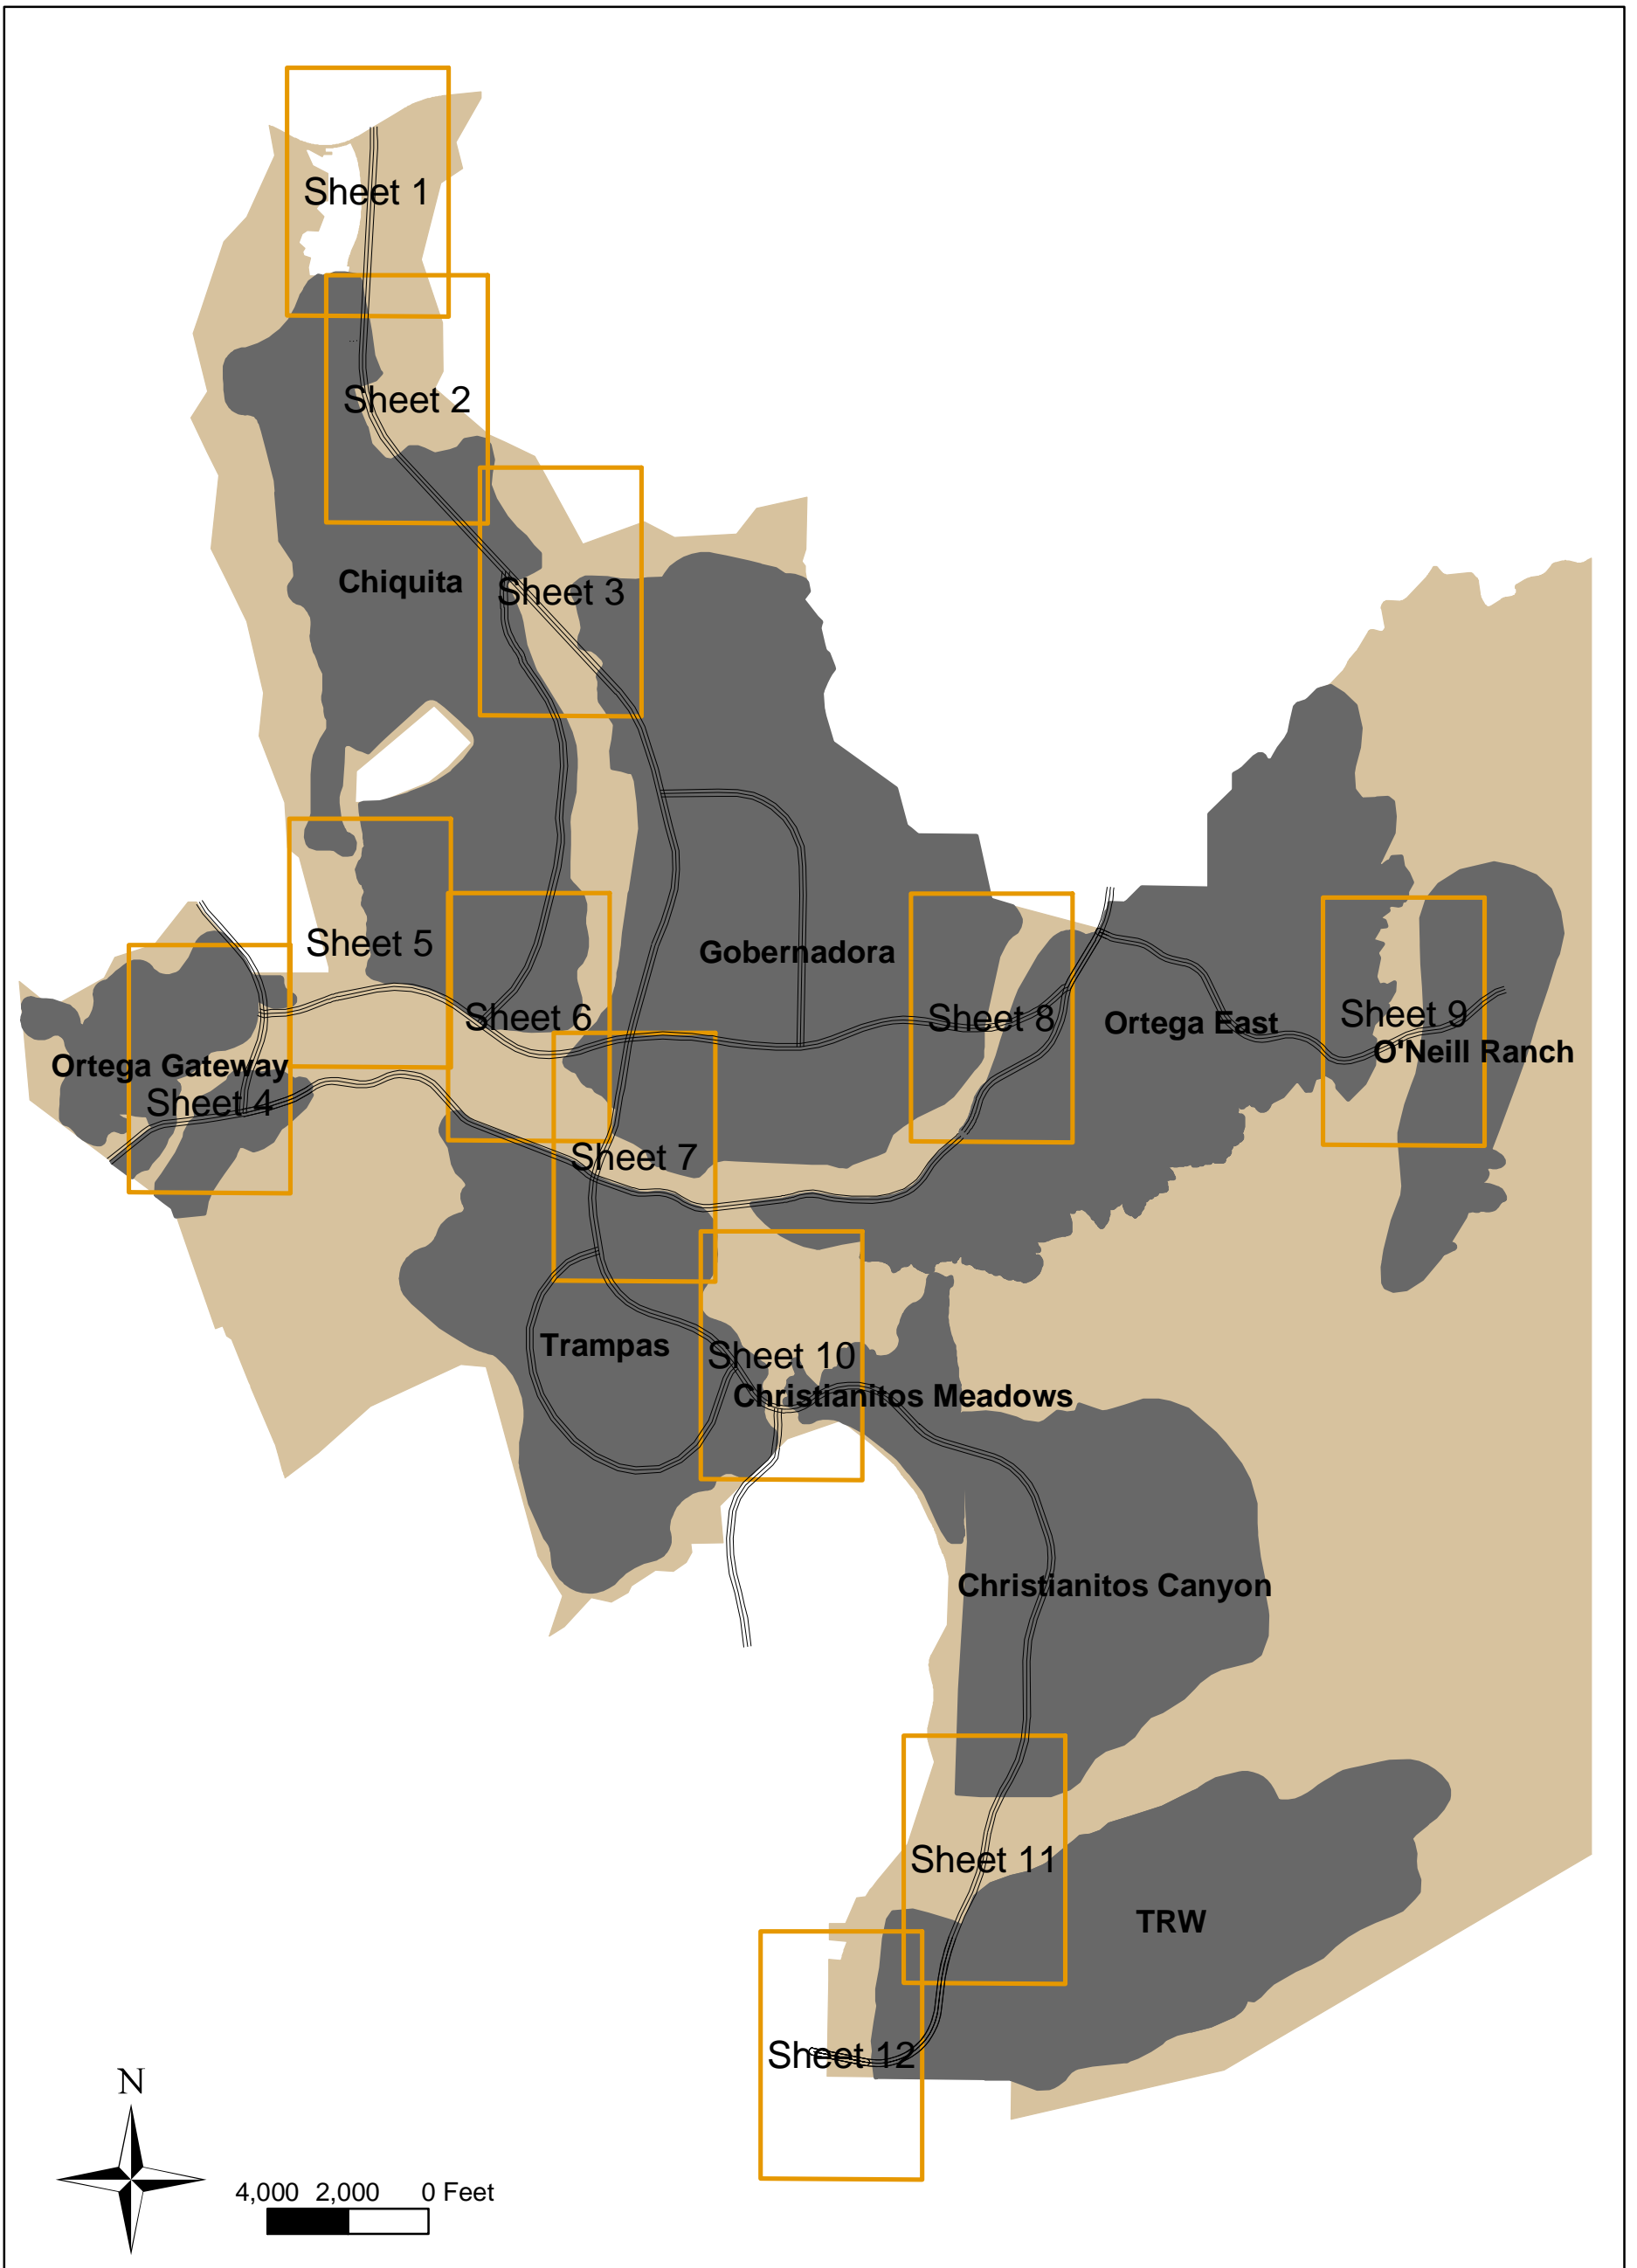
Jurisdictional Delineation Key Map

This gap analysis was based on the conceptual road alignments above, which have not yet been subject to final engineering.
